Turkey Point

Units 6 & 7

Mitigation Plan

093-87652

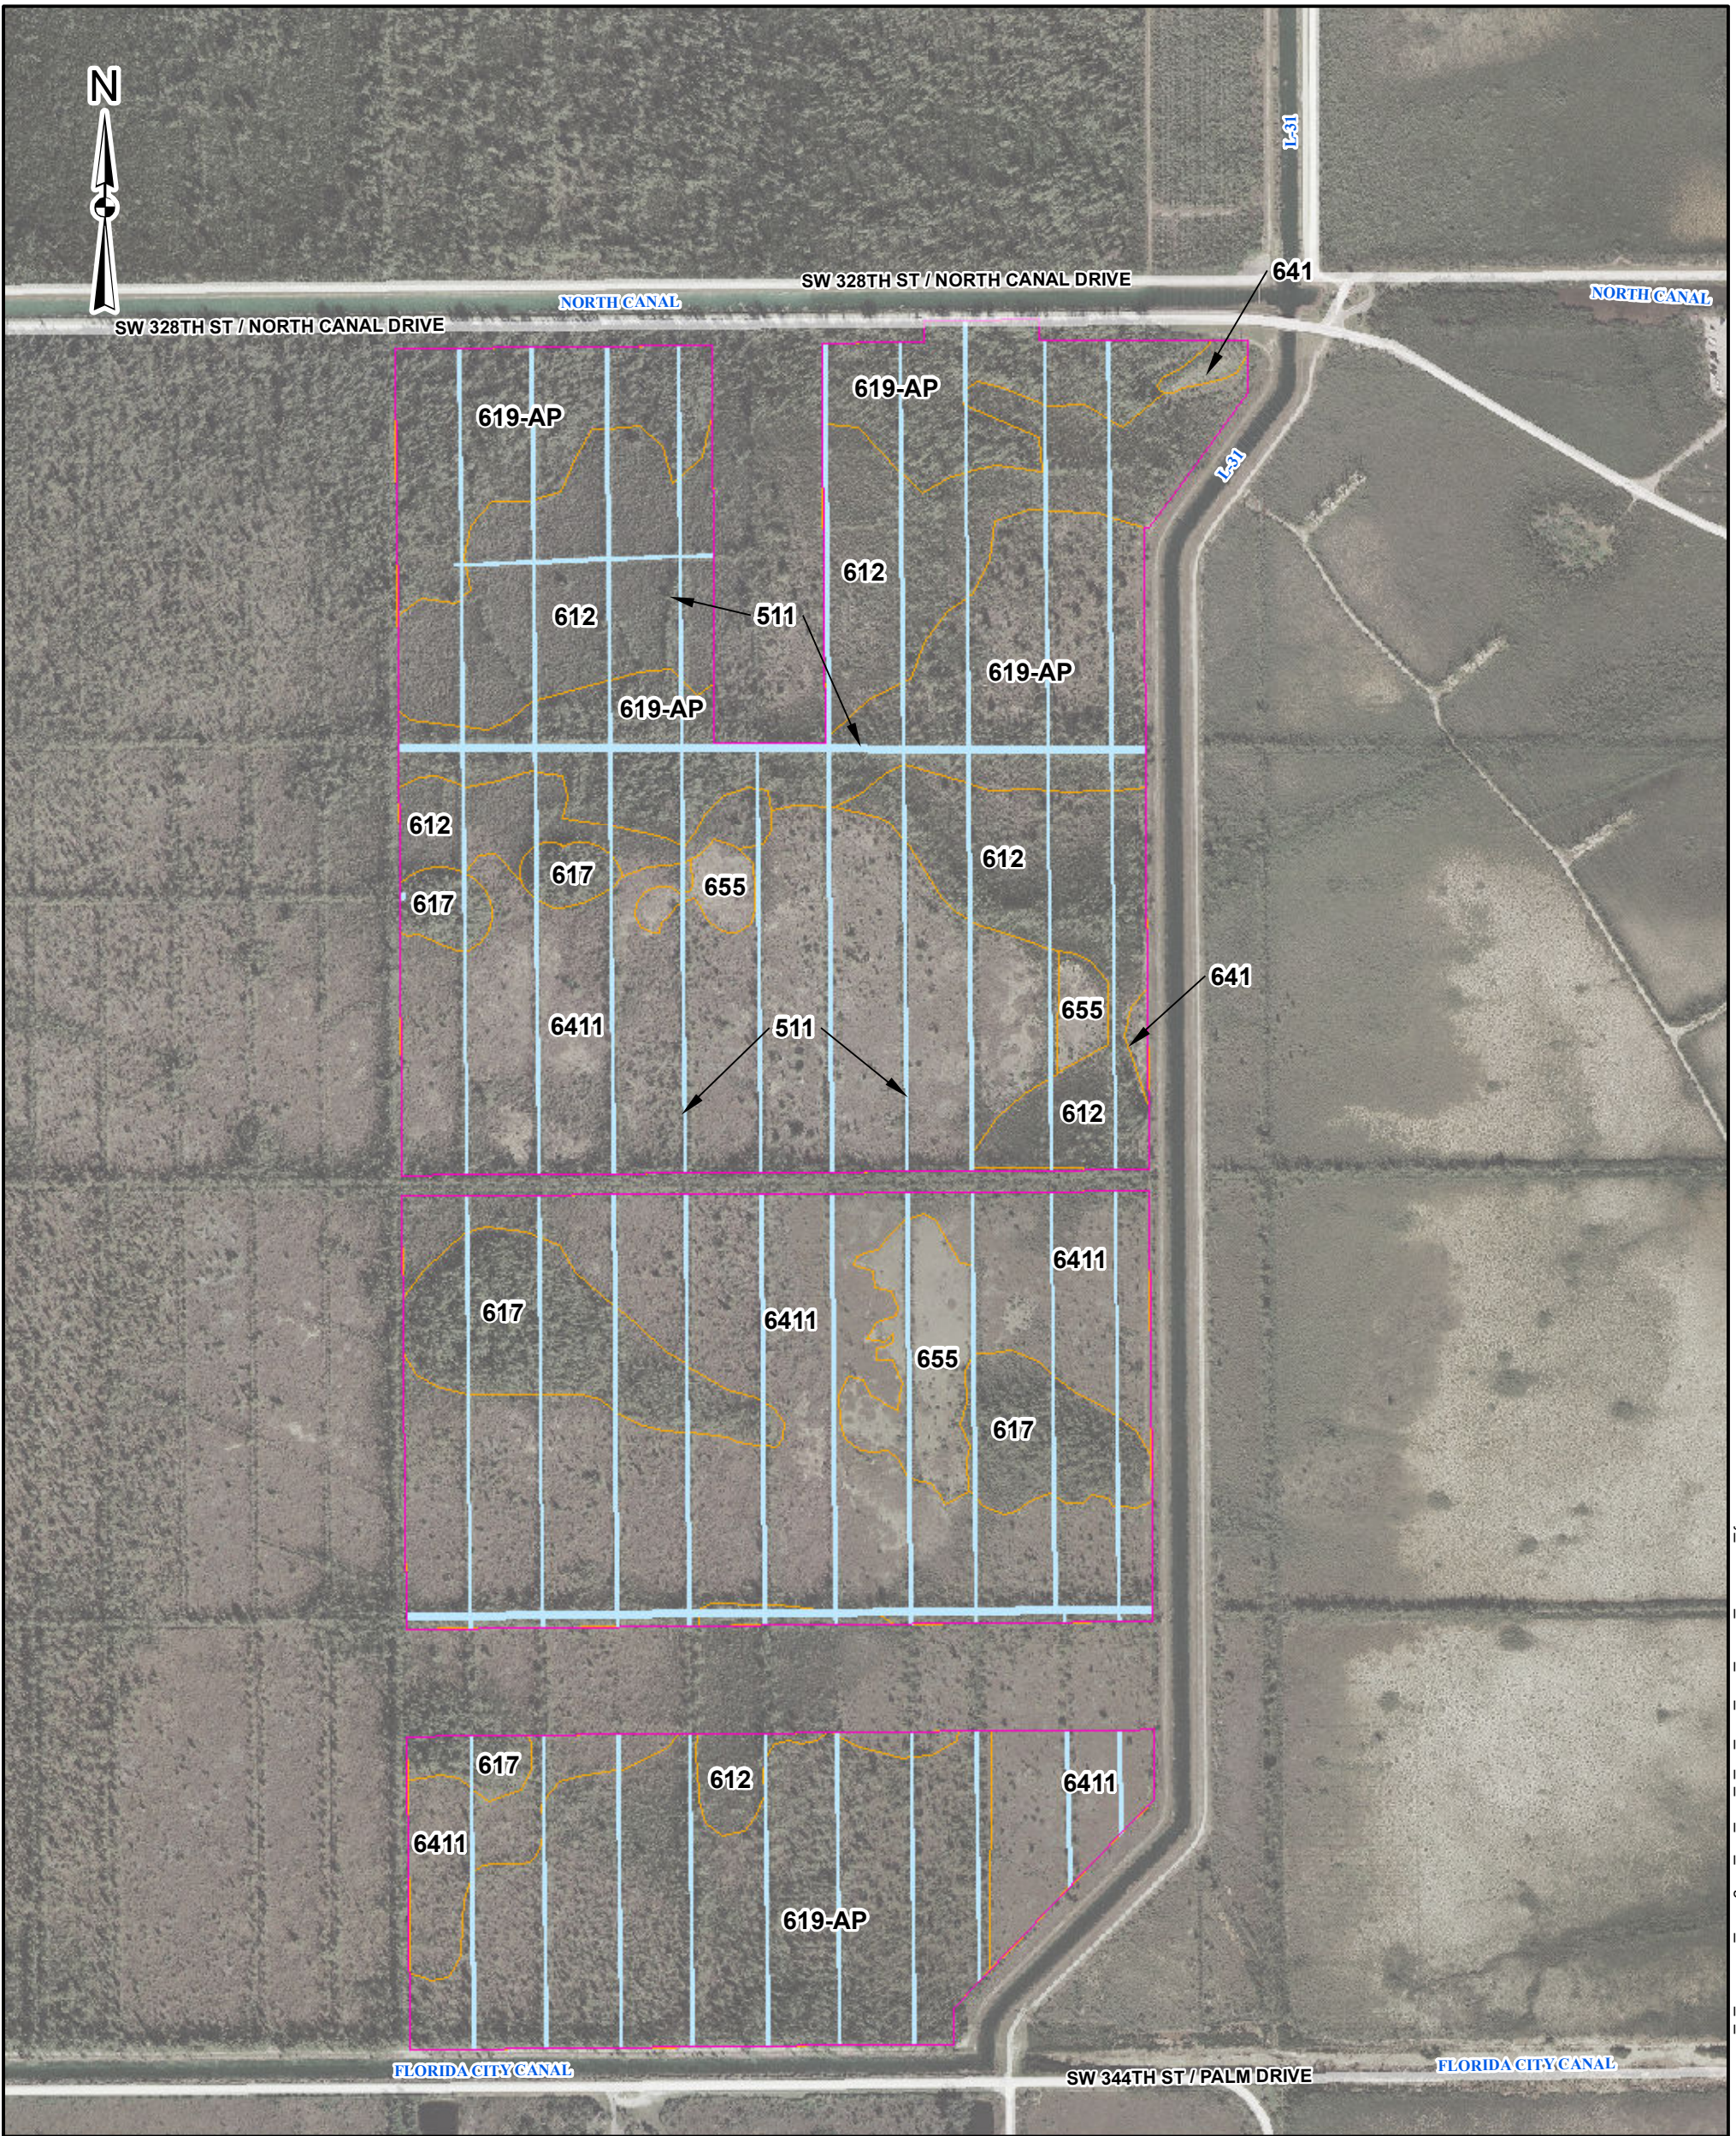
FIGURE 7	FILE No. 08387584_K003 REV. 3 PLOT DATE 6/23/2011	TITLE NORTHWEST RESTORATION SITE EXISTING LAND USE / LAND COVER	PROJECT TURKEY POINT UNITS 6 & 7 PROJECT

- Northwest Restoration Site
- Habitat Classification
- 511 - Ditches
- 612 - Mangrove Swamps
- 617 - Mixed Wetland Hardwoods
- 619-AP - Exotic Wetland Hardwoods-Australian Pine
- 641 - Freshwater Marshes
- 6411 - Sawgrass Marsh
- 655 - Periphyton Mat

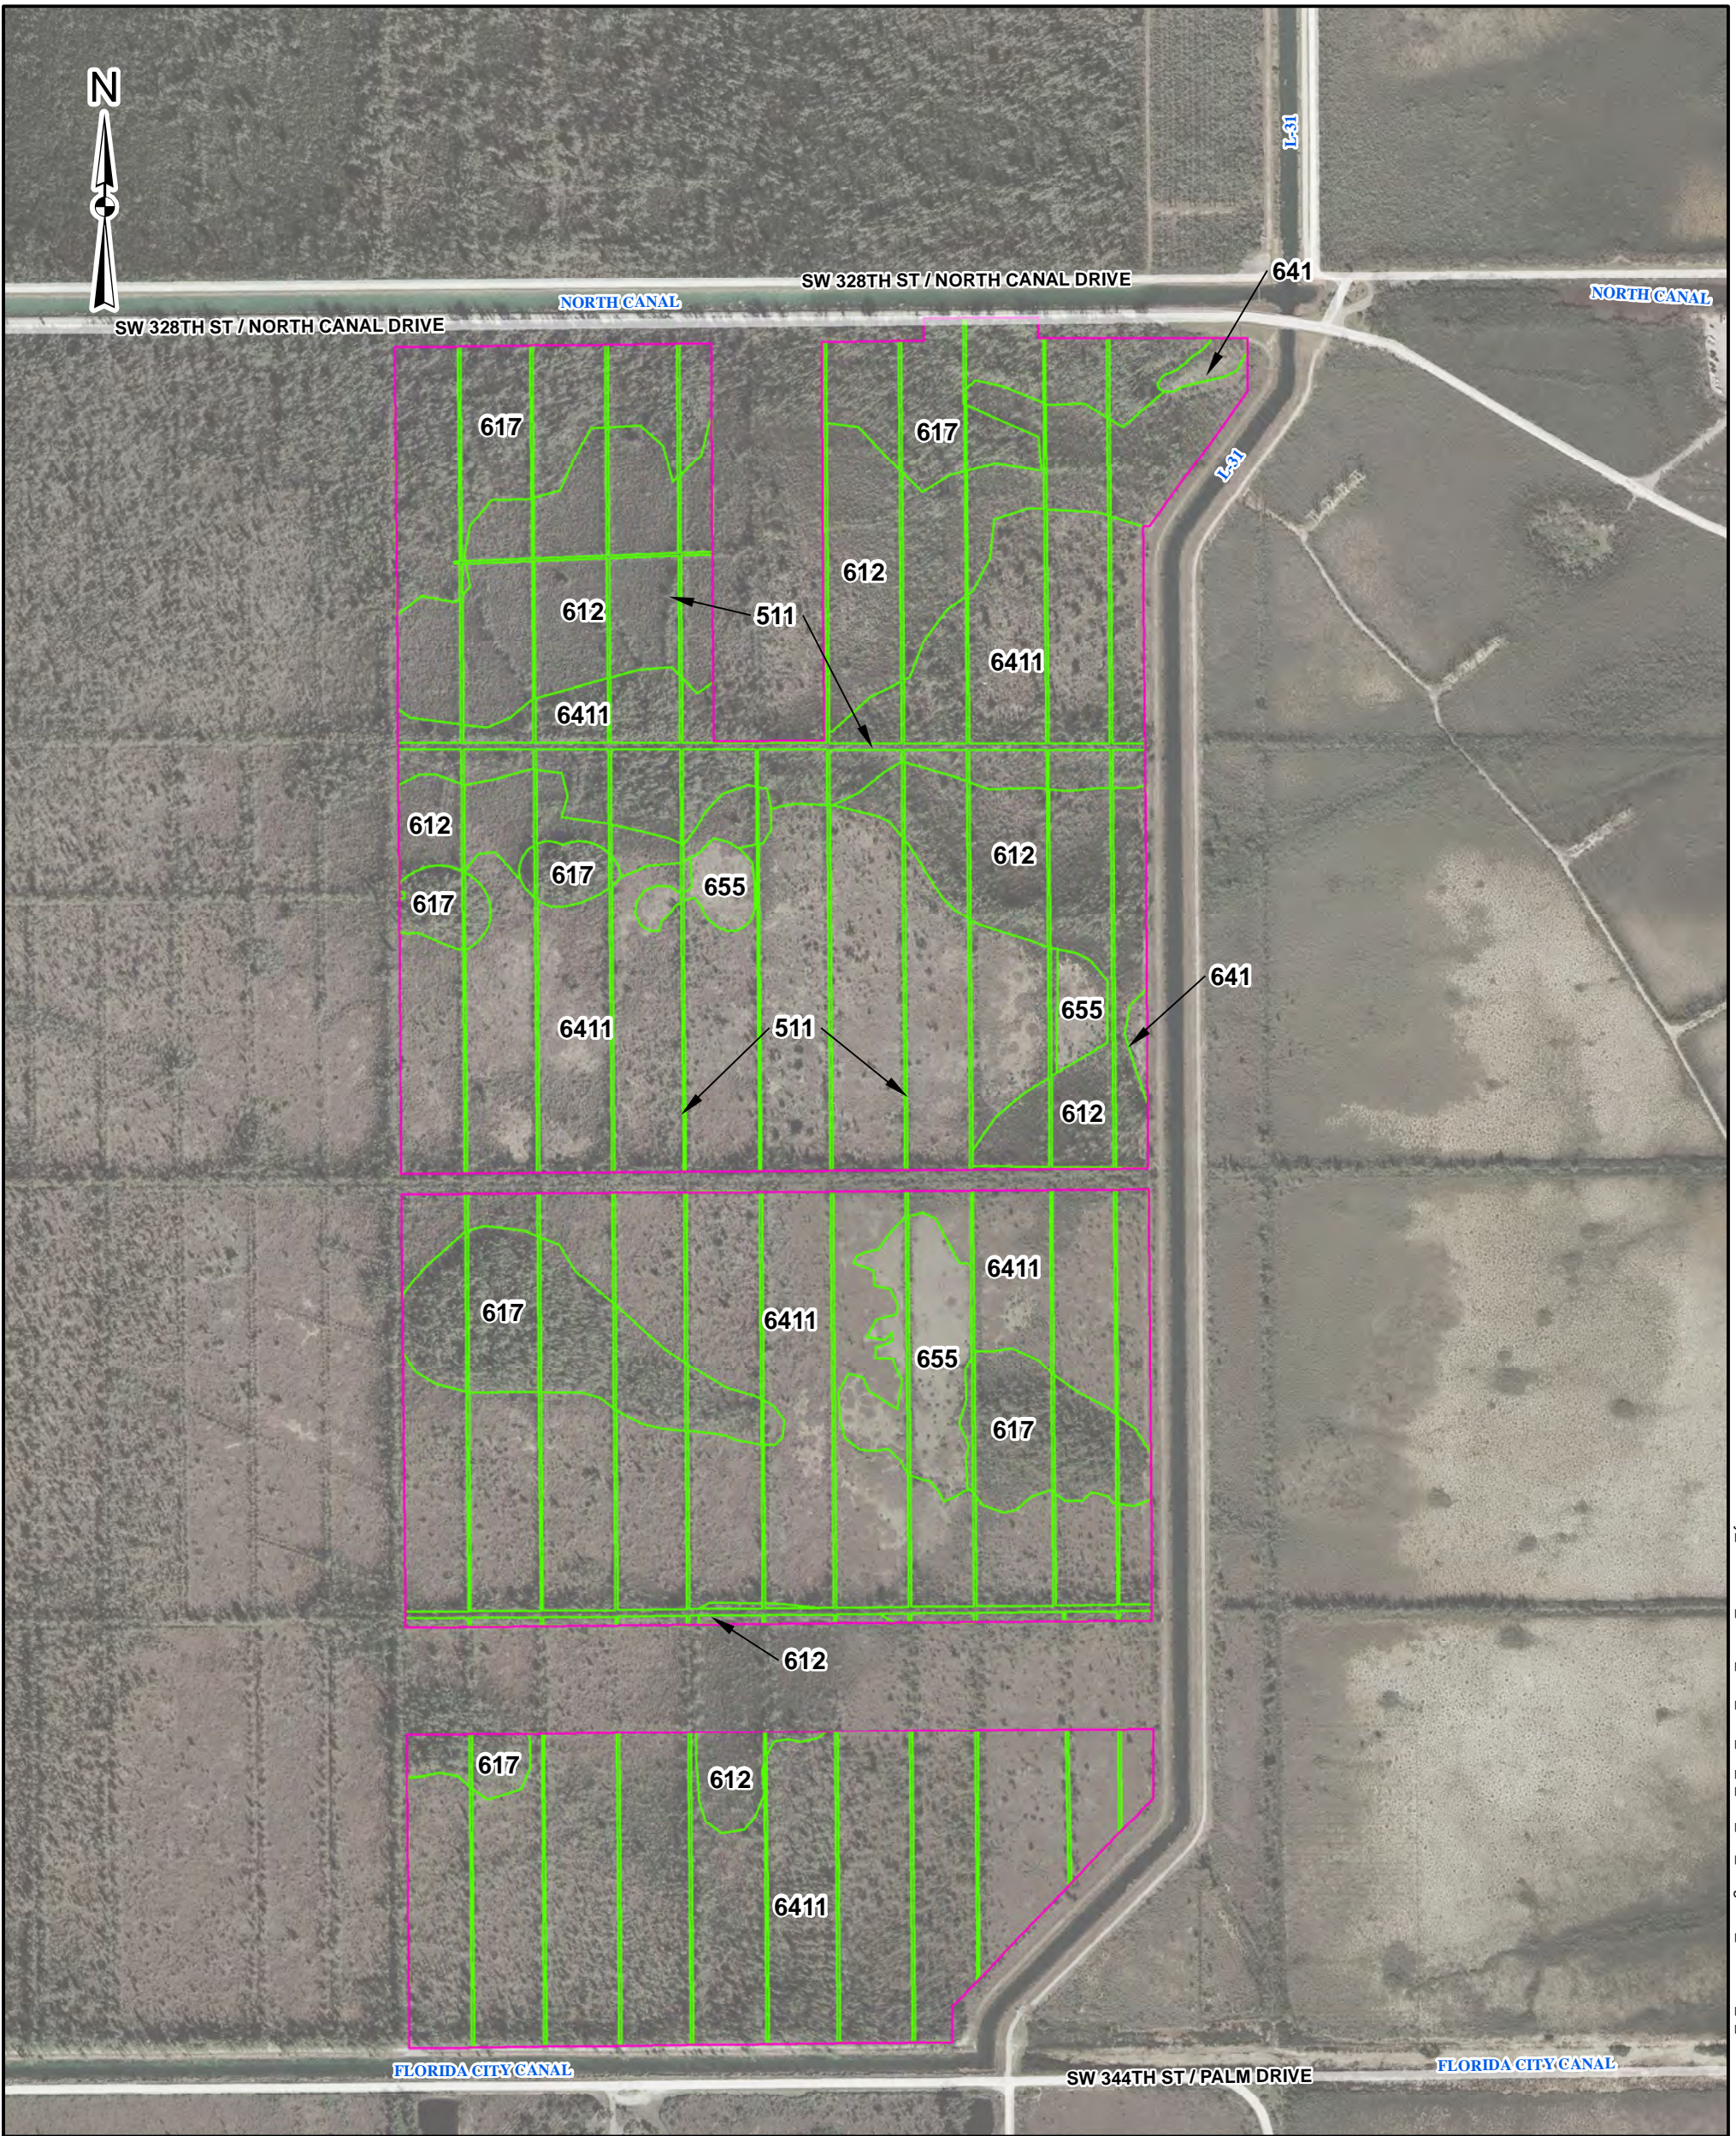
FIGURE 8	FILE No. 08387584_K004 REV. 3 PLOT DATE 6/23/2011	TITLE NORTHWEST RESTORATION SITE PROPOSED LAND USE / LAND COVER	PROJECT TURKEY POINT UNITS 6 & 7 PROJECT

- Northwest Restoration Site
- Habitat Classification
- 511 - Ditches
- 612 - Mangrove Swamps
- 617 - Mixed Wetland Hardwoods
- 641 - Freshwater Marshes
- 655 - Periphyton Mat
- 6411 - Sawgrass Marsh

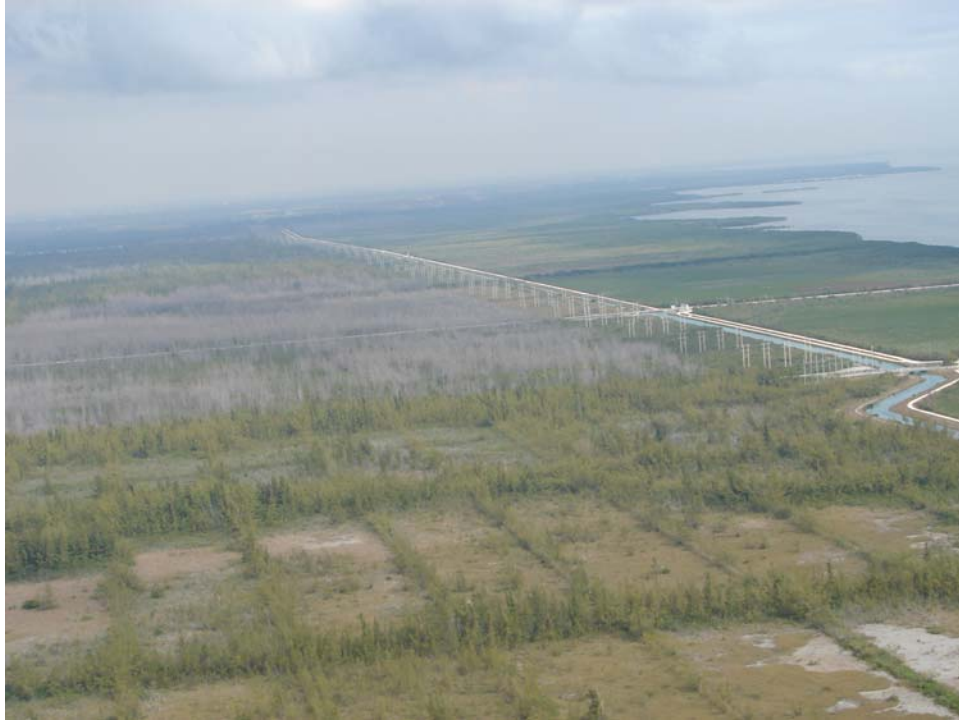
Photograph 1. Aerial view of Northwest Restoration Site, facing north. Sawgrass marsh historically impacted by network of mosquito ditches dominated by exotic Australian pine. Transmission corridor, L-31E Canal, and Biscayne Bay visible to east. Areas of exotic vegetation control on SFWMD parcels visible to the north, adjacent to C-103 Canal.

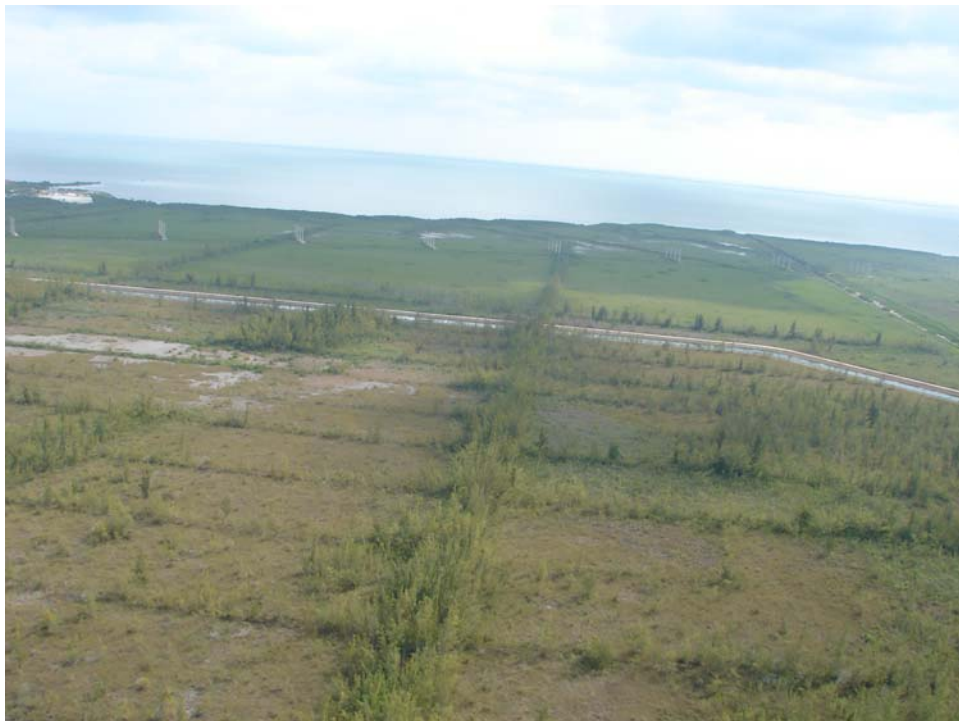
Photograph 2. Aerial view of Northwest Restoration Site, facing east. L-31E Canal and Biscayne Bay in background.

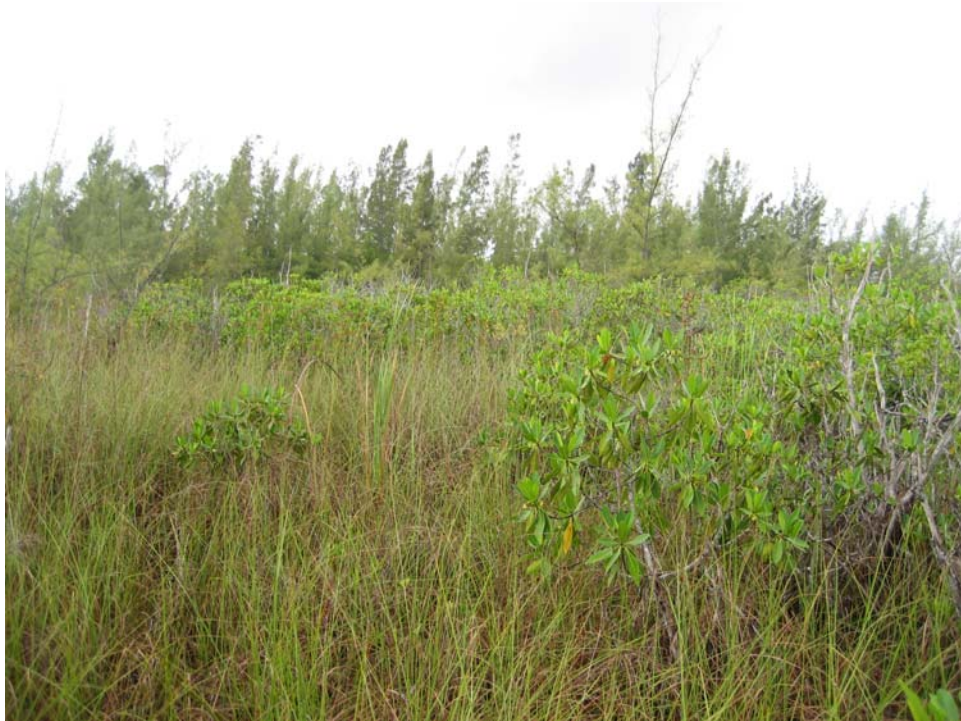
Photograph 3. Northwest Restoration Site – sawgrass marsh, mangroves, and Australian pine.

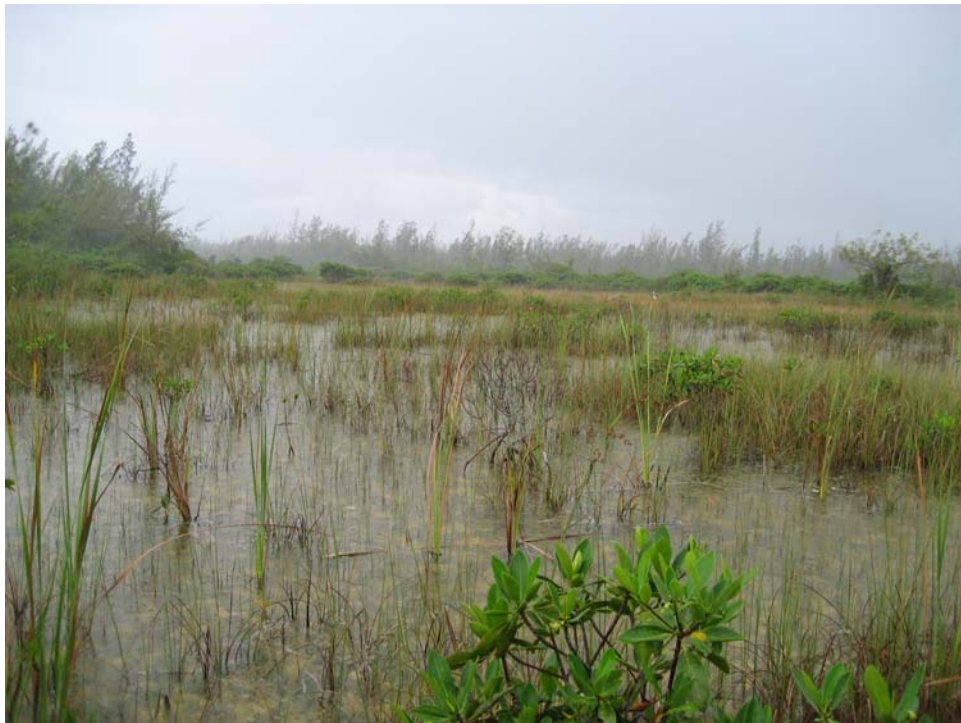
Photograph 4. Northwest Restoration Site – sparsely vegetated open water area supporting thick periphyton mat. Red mangrove in foreground, Australian pine in background.

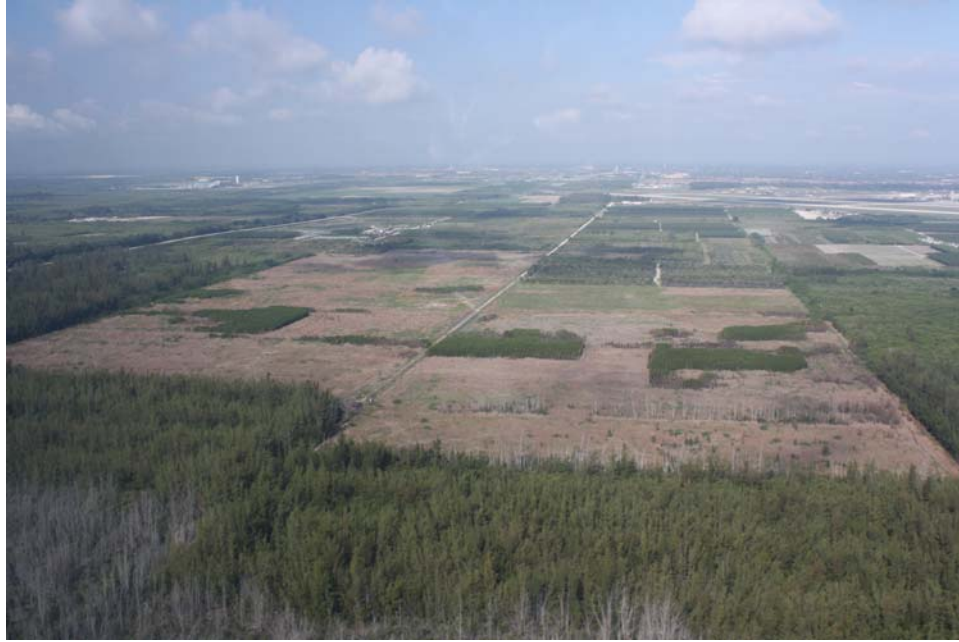
Photograph 5. Aerial view of SW 320th Street Restoration Site, facing west. 219 acre marsh restoration area and adjacent exotic wetland hardwoods dominated by Australian pine and Brazilian pepper.

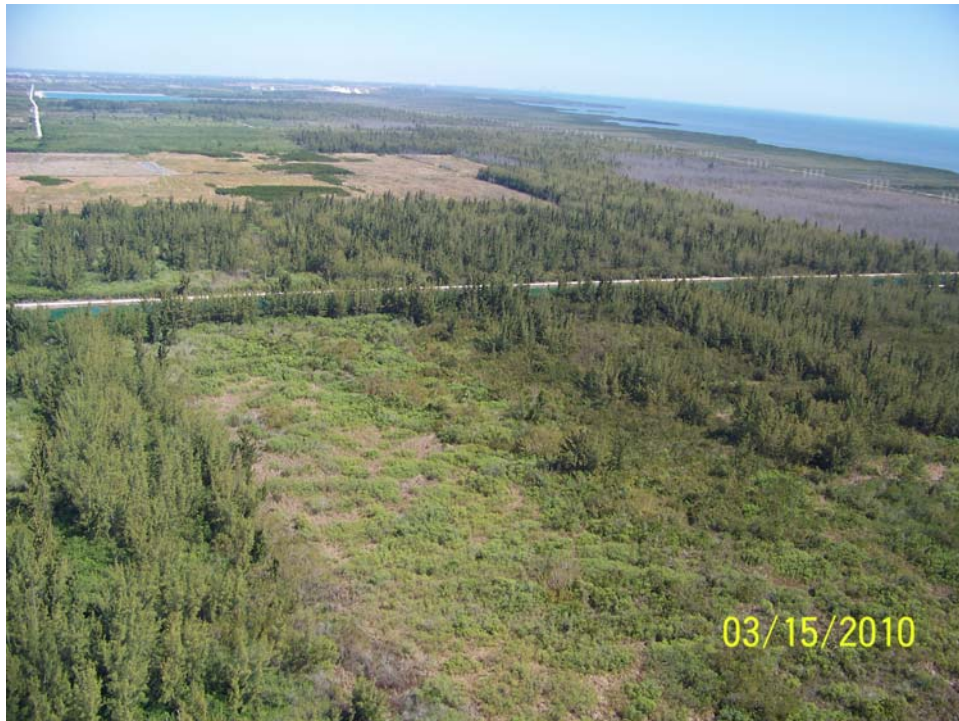
Photograph 6. Aerial view of SW 320th Street Restoration Site, facing north. Exotic wetland hardwoods to north and south of C-103 Canal. Areas of exotic vegetation control on SFWMD owned parcels visible to the northeast.

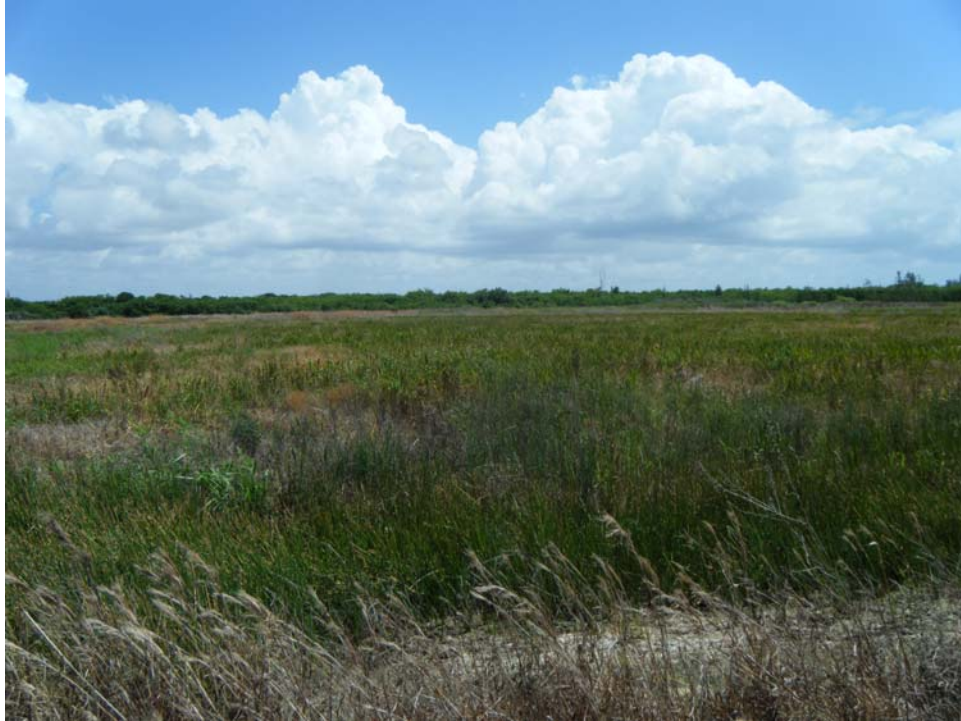
Photograph 7. SW 320th Street Restoration Site – former palm tree nursery restored to freshwater marsh. Knotted spikerush (*Eleocharis interstincta*) and bushy broomsedge (*Andropogon glomeratus*) in foreground; exotic wetland hardwoods in background.

The northern and central portion of the Site is comprised of approximately 219 acres of former palm tree nurseries that have been restored to freshwater marsh and buttonwood. A variety of herbaceous species occur within the marsh (Appendix C, Photograph 7), including several species of spikerush (*Eleocharis cellulosa*; *E. geniculata*; *E. interstincta*), arrowhead (*Sagittaria lancifolia*), giant leather fern (*Acrostichum danaeifolium*), southern amaranth (*Amaranthus australis*), bushy bluestem (*Andropogon glomeratus*), spangletop (*Leptochloa nealleyi*; *L. fusca fascicularis*), Mexican primrose willow (*Ludwigia*

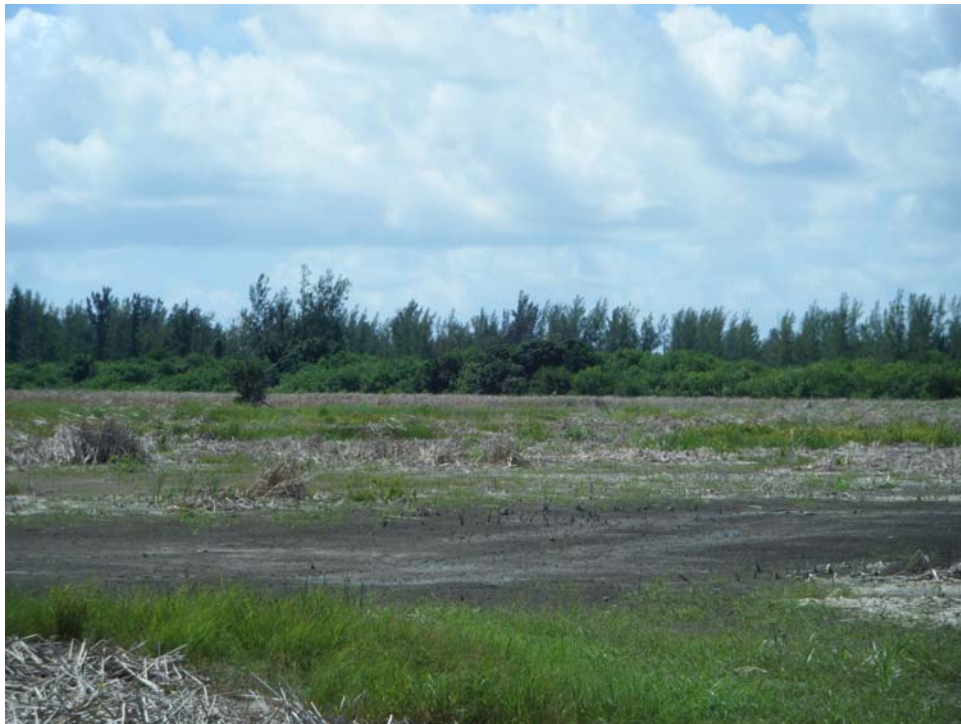
Photograph 8. SW 320th Street Restoration Site – sparsely vegetated mudflats within freshwater marsh restoration area.

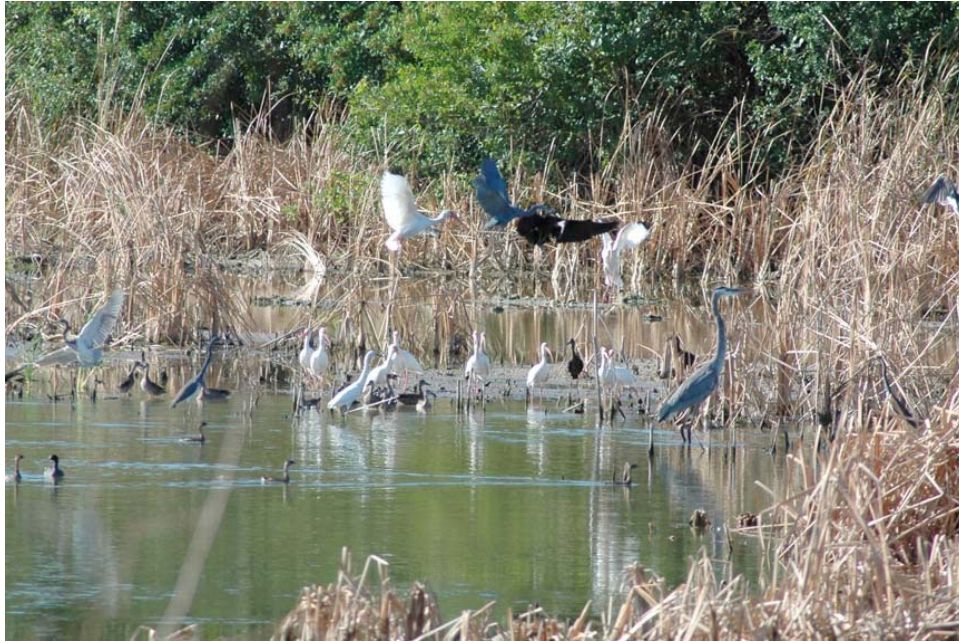
Photograph 9. SW 320th Street Restoration Site – wading bird utilization of freshwater marsh restoration area.

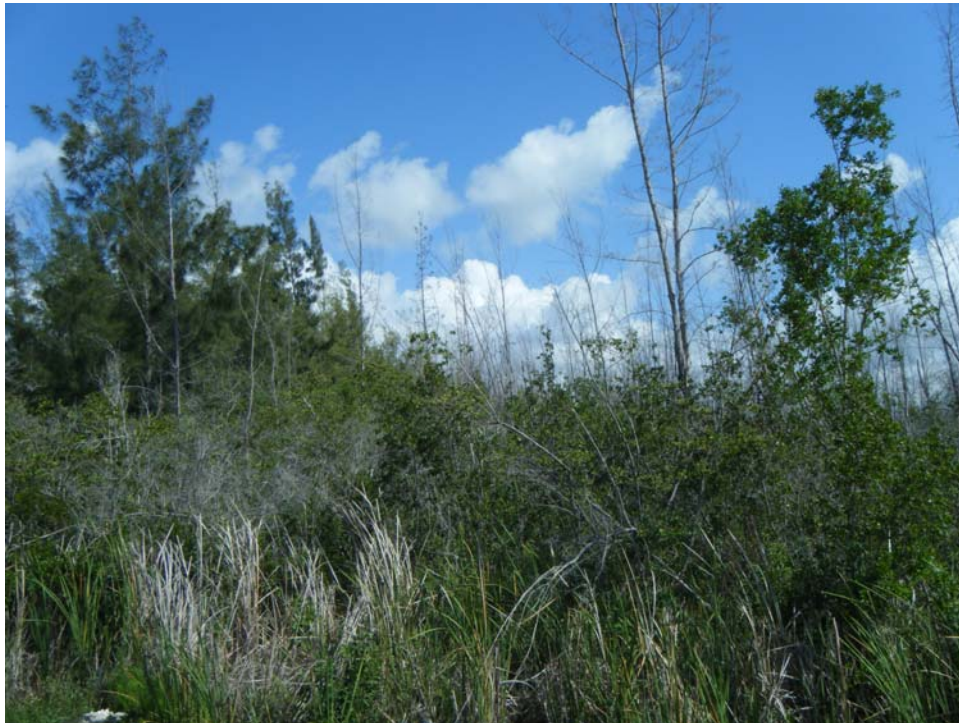
Photograph 10. SW 320th Street Restoration Site – mixed wetland hardwoods/exotic wetland hardwoods on eastern edge of Site adjacent to C-103 Canal, facing north. SFWMD parcel with treated Australian pine to east, untreated Australian pine to west.

The eastern portion of the SW 320th Street Restoration Site supports native mixed wetland hardwoods interspersed with exotics, including Australian pine, Brazilian pepper, and shoebutt on ardisia. The canopy is comprised of buttonwood, white mangrove, dahoon holly, cocoplum, Australian pine, wax myrtle, myrsine, and poisonwood, with understory vegetation including sawgrass, camphorweed, arrowhead, leather fern, mangrove vine, nettletree, spikerush, and cattail. The eastern edge of the SW 320th Street Restoration Site abuts SFWMD parcels of mixed wetland hardwoods currently being treated for Australian pine and Brazilian pepper (Appendix C, Photograph 10).

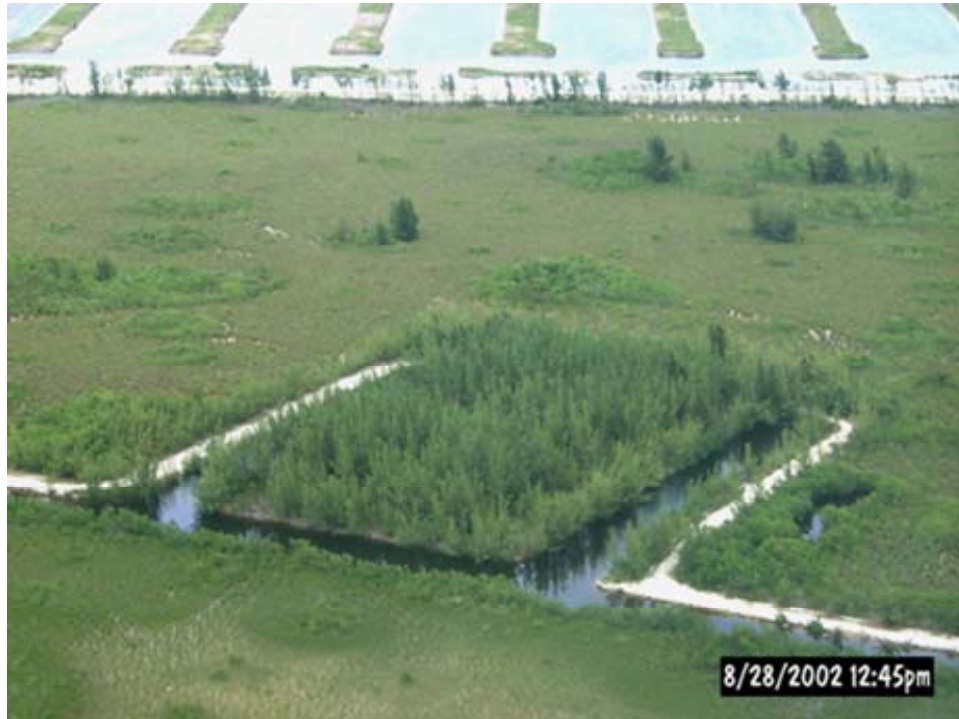
Photograph 11. Aerial photograph of Everglades Mitigation Bank crocodile sanctuary area prior to enhancement. Area dominated by the exotic species Australian pine. Industrial wastewater treatment facility in background.

The Sea Dade Canal Crocodile Sanctuary will be created in accordance with the methodology used to create the EMB crocodile sanctuary in 2008. Photographs of the crocodile sanctuary prior to enhancement and immediately following creation are presented in Appendix C (Photographs 11 and 12). This approximately 5-acre area was cleared of exotic vegetation, topographically graded to create freshwater ponds and nesting areas with a specific mixture of peat, marl, and sand to create ideal nesting substrate, and planted with native species of vegetation. The success of the design is evidenced through documented utilization of the area by a nesting female crocodile within the first year after construction.

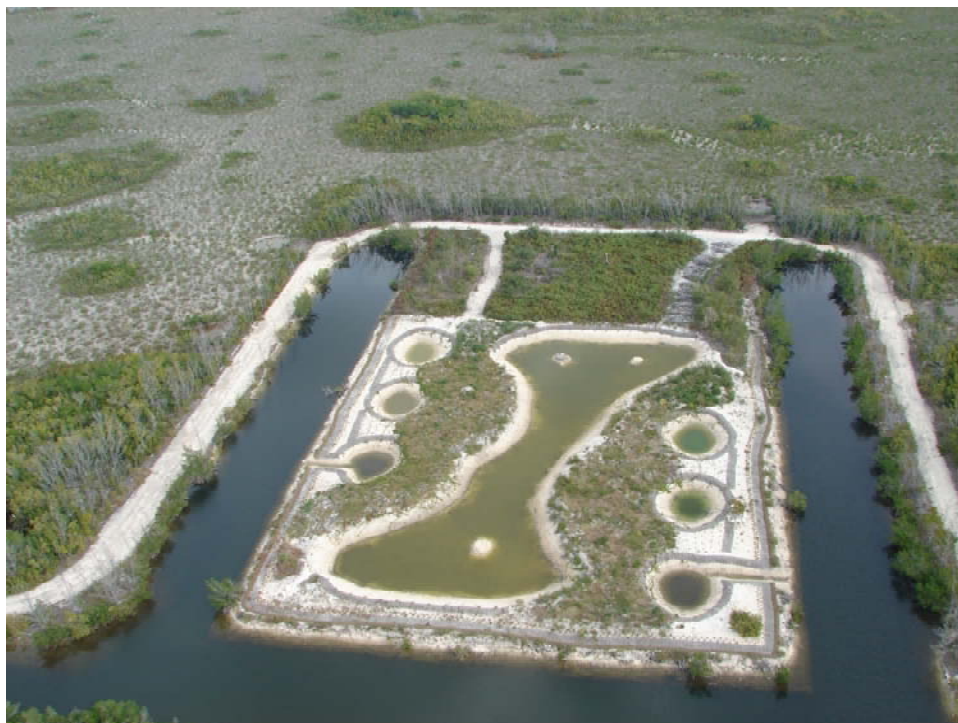
Photograph 12. Aerial view of Everglades Mitigation Bank crocodile sanctuary area following creation of crocodile habitat. Exotic species of vegetation replaced with natives, freshwater ponds excavated and perimeter of peat/marl/sand nesting substrate installed.
