Browns Ferry Nuclear Plant, Unit 2
Facility Operating License No. DPR-52
NRC Docket No. 50-260

Subject: Tennessee Valley Authority - Supplemental Response to NRC Request for Information Pursuant to Title 10 of the Code of Federal Regulations 50.54(f) Regarding the Browns Ferry Nuclear Plant, Unit 2 Seismic Walkdown Results of Recommendation 2.3 of the Near-Term Task Force Review of Insights from the Fukushima Dai-ichi Accident

**BROWNS FERRY NUCLEAR PLANT, UNIT 2
FUKUSHIMA NEAR-TERM TASK FORCE
RECOMMENDATION 2: SEISMIC RESPONSE REPORT**

**BROWNS FERRY NUCLEAR PLANT – UNIT 2
FUKUSHIMA NEAR-TERM TASK FORCE
RECOMMENDATION 2.3: SEISMIC
RESPONSE REPORT**

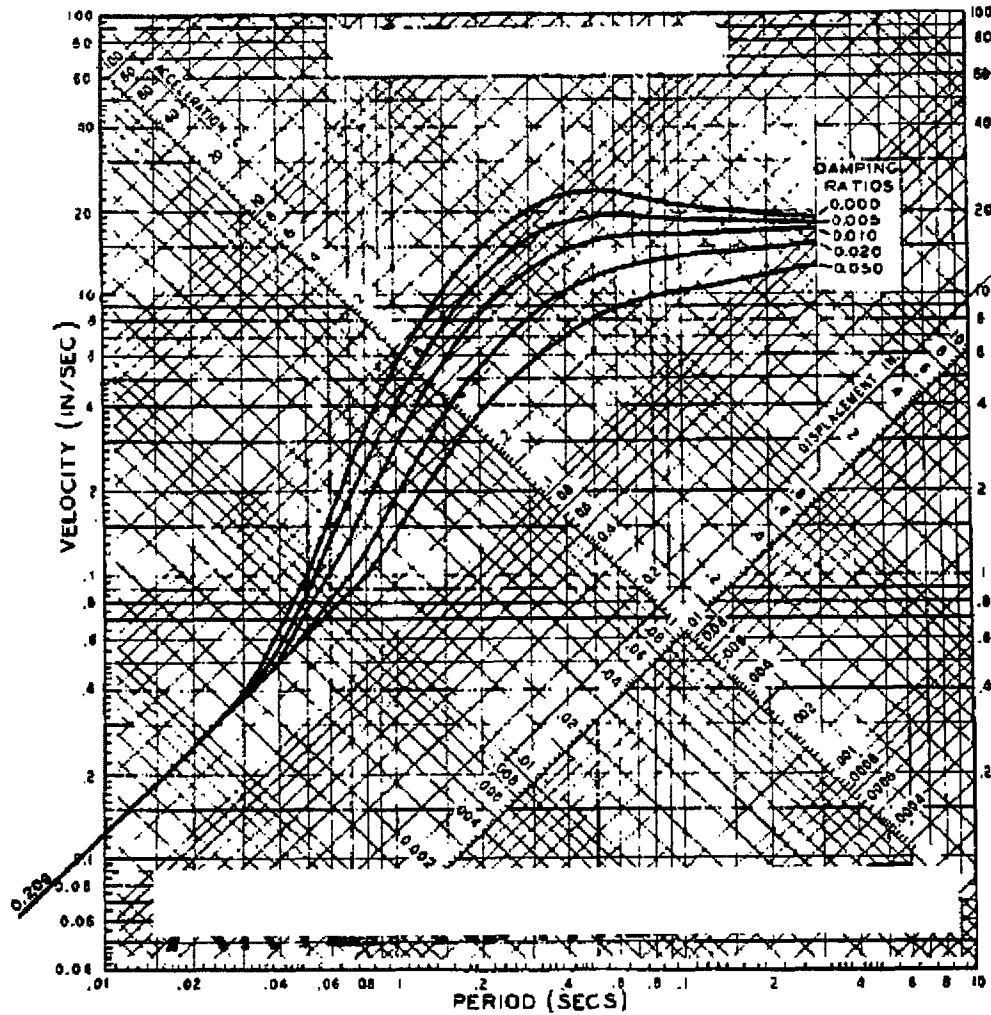
The BFN licensing-basis Operating Basis Earthquake (OBE) and Design Basis Earthquake (DBE) ground motion acceleration response spectra are defined in Sections 2.5.4 and 12.2 of the BFN Final Safety Analysis Report (FSAR). The site design ground spectrum is that of a Housner shaped spectrum with horizontal peak ground acceleration (PGA) corresponding to the OBE is 0.10g and the DBE is 0.20g, defined at the top of the sound rock. Vertical ground motion is two-thirds of the horizontal ground motion as specified in the FSAR. Figure 1 shows the OBE and Figure 2 shows the DBE input spectra with various damping.

SITE DESIGN SPECTRUM
DESIGN BASIS EARTHQUAKE
HORIZONTAL
