**Fukushima -
Flooding Hazard Reevaluation**
Upstream Dam Failure Analysis

**NCR
Technical
Presentation**

March 25, 2013

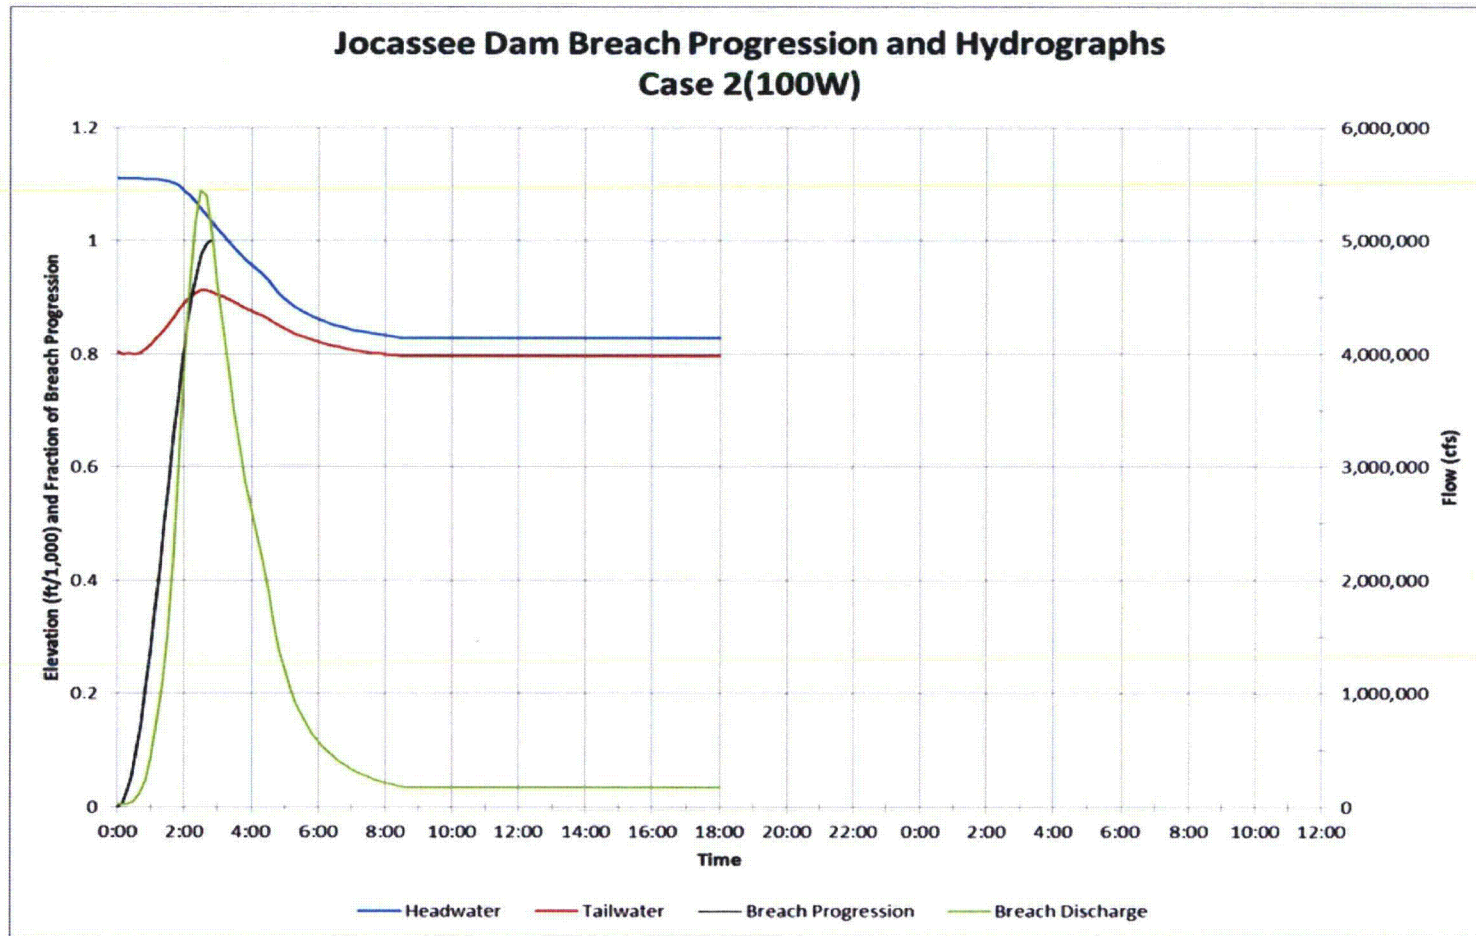
2011 SE Jocassee Dam Breach Progression and Stage-Discharge Hydrographs

- ❖ Initial breach derived primarily from Froehlich regression equations.
- ❖ Breach dimensions were adjusted based on physical constraints of natural valley
- ❖ Jocassee breach parameters:
 - Top Width - 1156 (64% of overall crest)
 - Bottom Width – 431 feet
 - Bottom Elevation – 800 msl
 - Breach Formation Time - 2.8 hrs,
 - Peak outflow 5,400,000 cfs

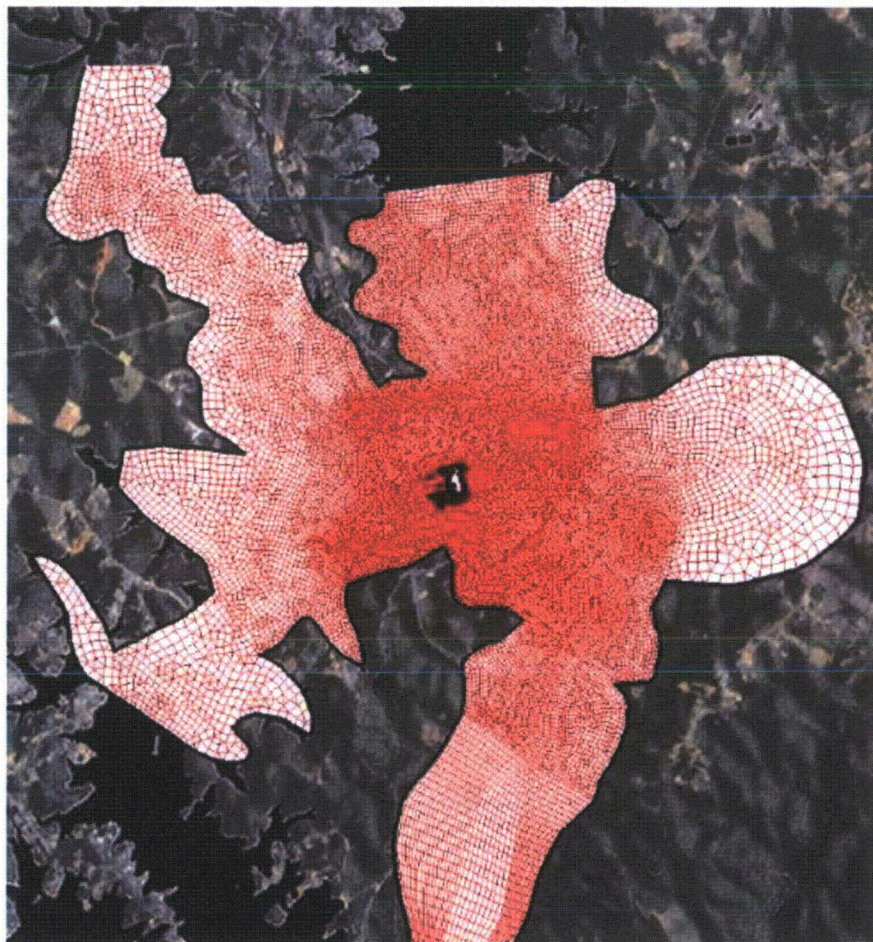
Model Development

SRH 2D Model

(57 thousand elements)

REVISED COMPUTATIONAL MESH

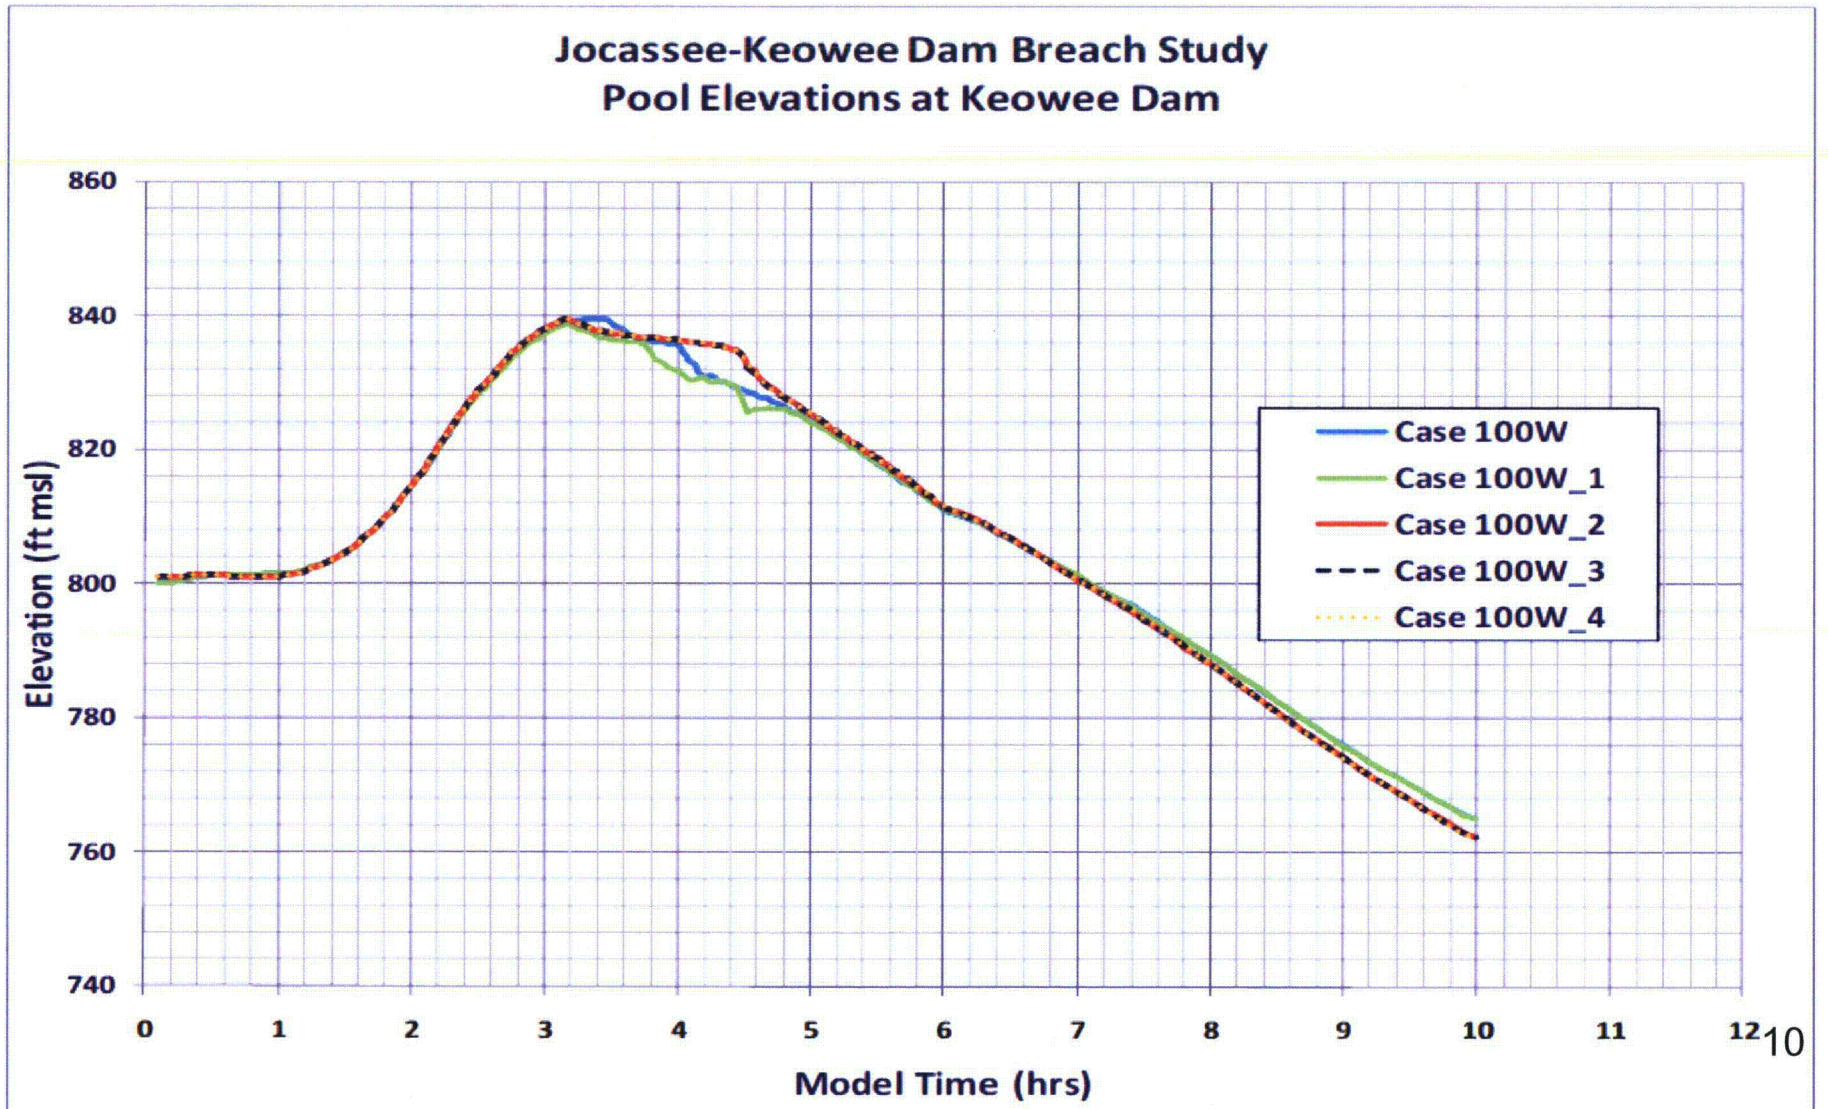
2011 Breach Analysis Summary

2D Model

WATER SURFACE ELEVATIONS AT KEOWEE DAM

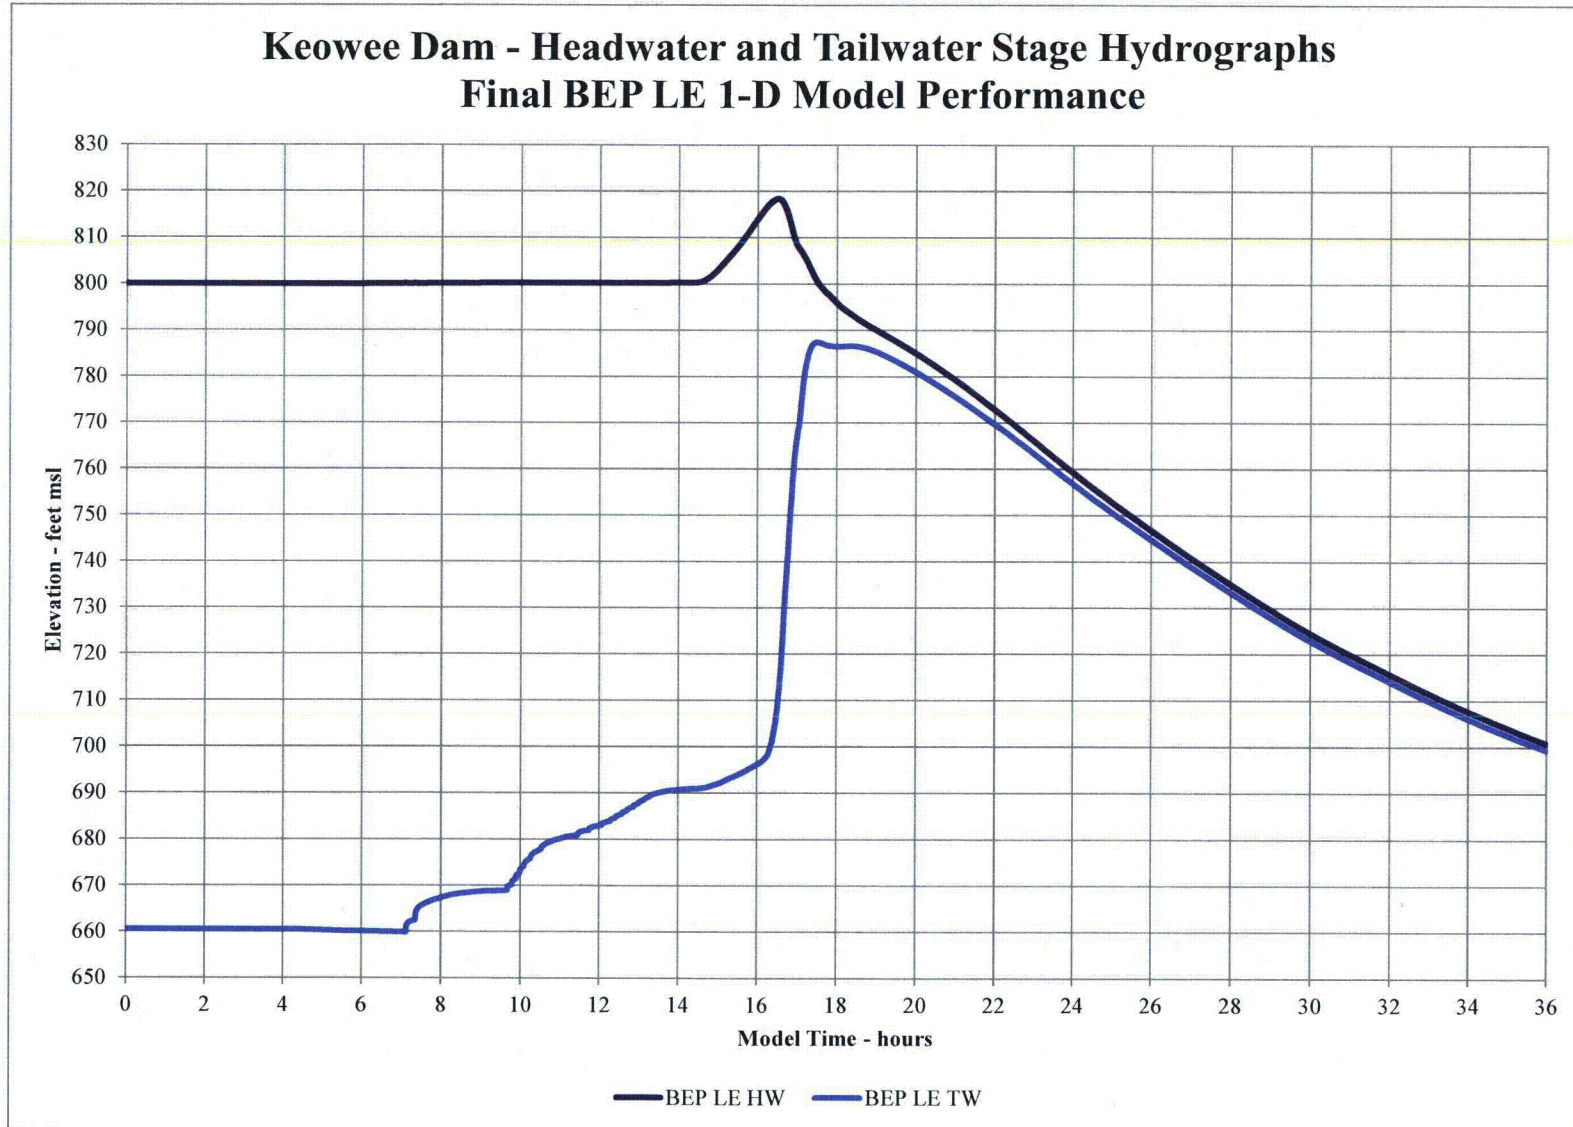
Keowee Dam - Headwater and Tailwater Stage Hydrographs Final BEP LE 1-D Model Performance
