GEOTECHNICAL INVESTIGATION FOR
THE RANCHERS WESTERN COLORADO PROJECT
IN THE EAST HALF OF SECTION 34,
TOWNSHIP 46 NORTH, RANGE 16 WEST,
NEW MEXICO PRINCIPAL MERIDIAN,
SOUTHERN MONTROSE COUNTY, COLORADO

Ortloff Mineral Services Corporation

Job No. 1331-2955
March 29, 1977

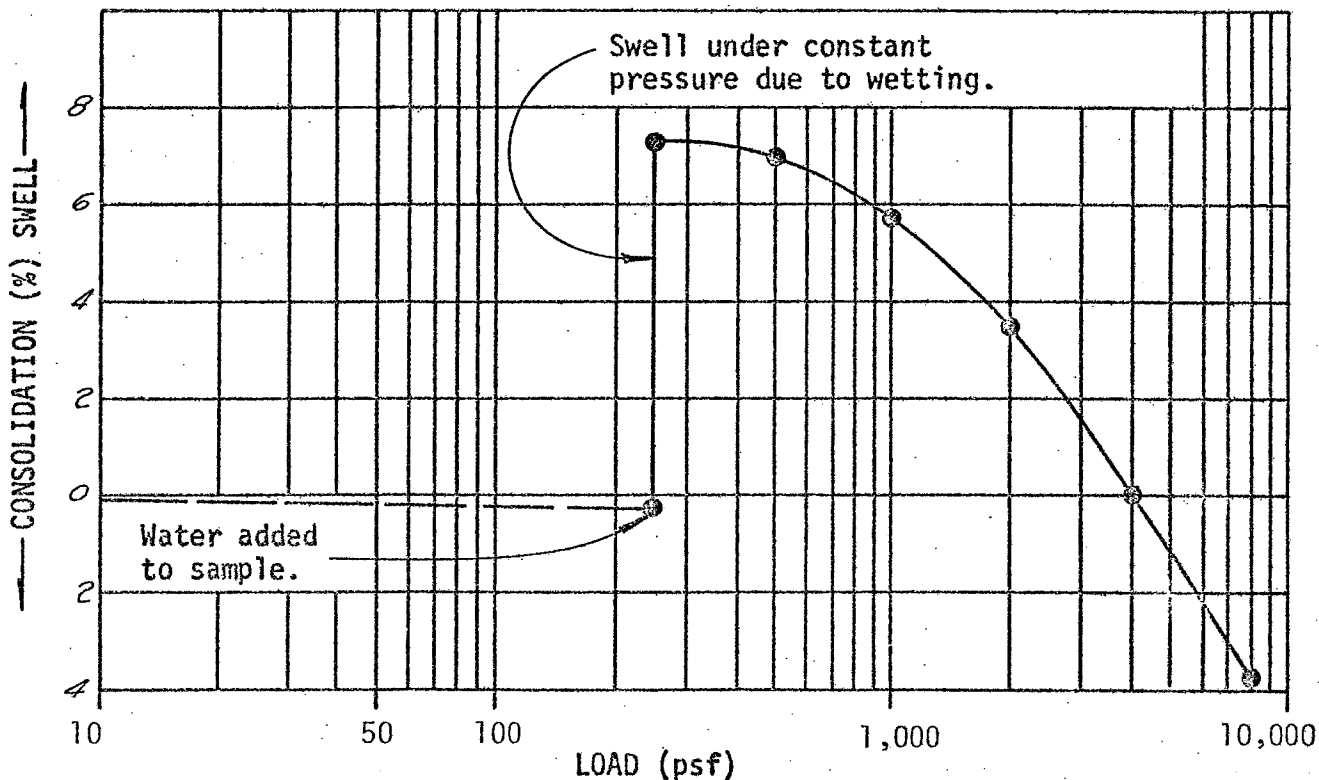
Sample of CLAY from test hole 12 from depth 4 feet.

Natural Moisture Content 11.6% Natural Dry Density 105 pcf

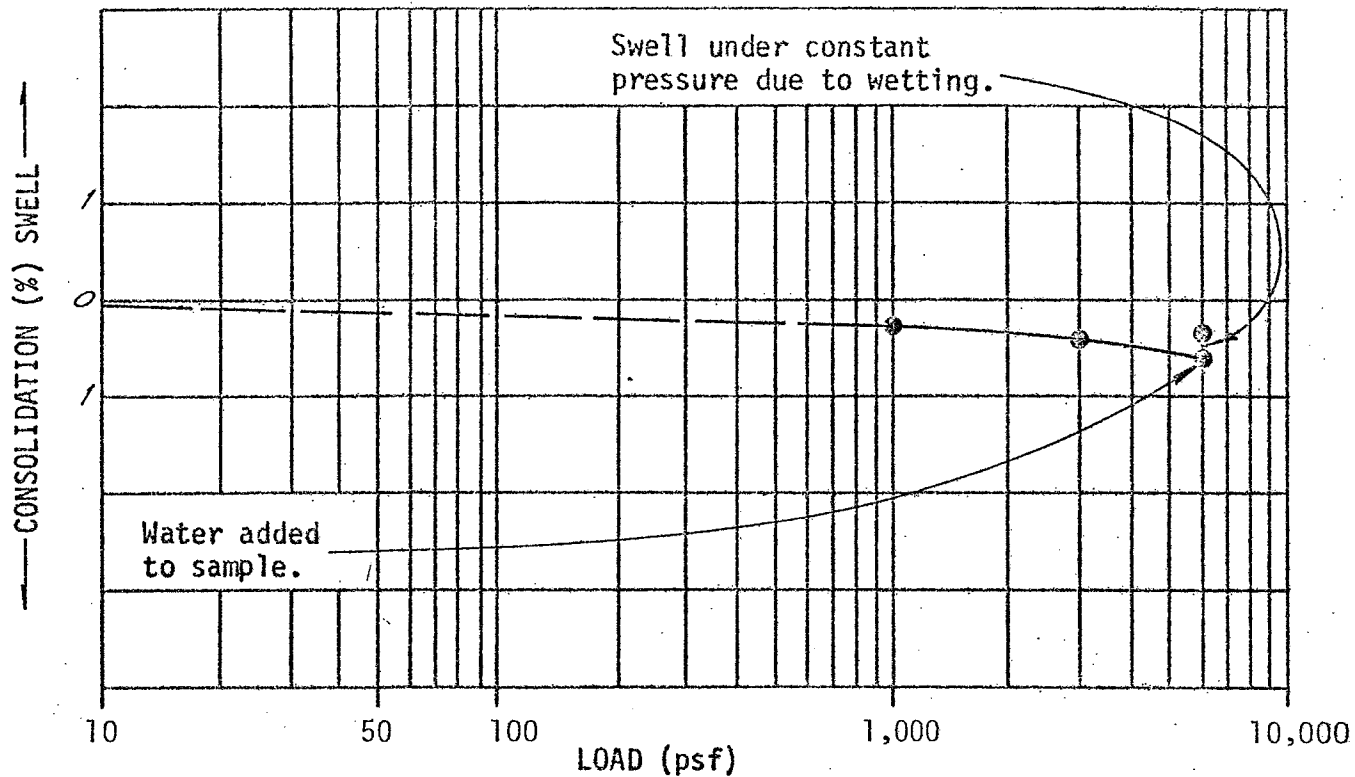
Sample of MUDSTONE from test hole 15 from depth 9 feet.

Natural Moisture Content 10.7% Natural Dry Density 126 pcf

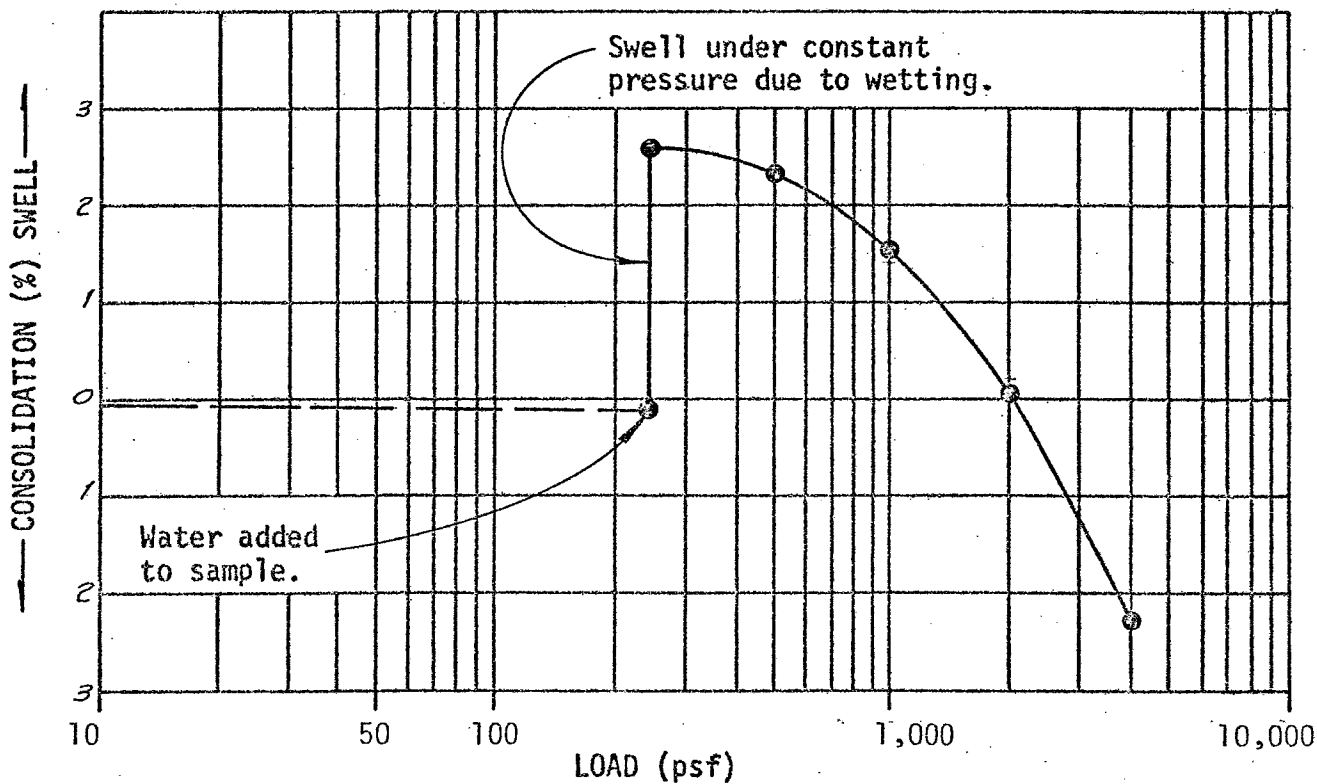
Sample of CLAY from test hole 19 from depth 4 feet.

Natural Moisture Content 7.2% Natural Dry Density 106 pcf

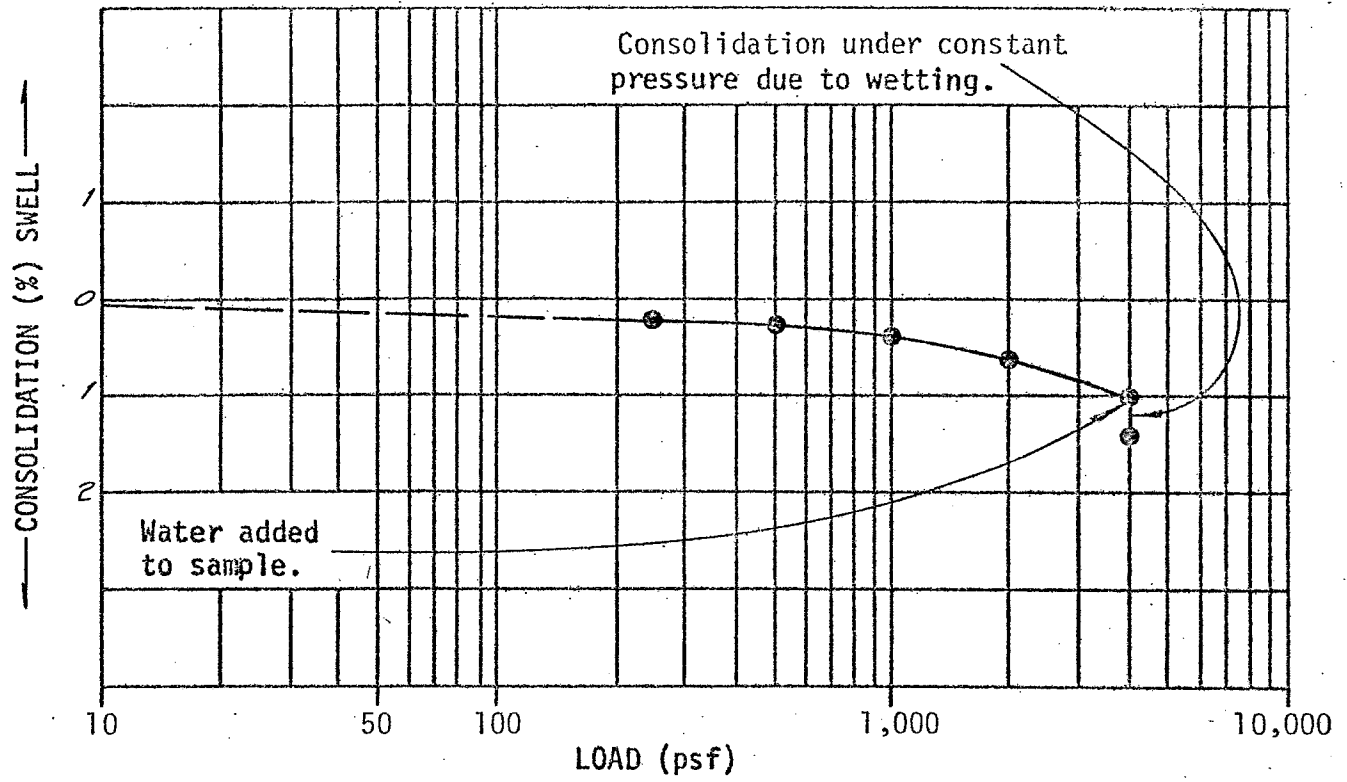
Sample of SAND, clayey from test hole 20 from depth 4 feet.

Natural Moisture Content 6.2% Natural Dry Density 108 pcf
