**UNITED STATES
NUCLEAR REGULATORY COMMISSION**
REGION IV
1600 E. LAMAR BLVD.
ARLINGTON, TX 76011-4511

**SUBJECT: ARKANSAS NUCLEAR ONE – NRC INSPECTION REPORT 05000313/2014005
and 05000368/2014005**

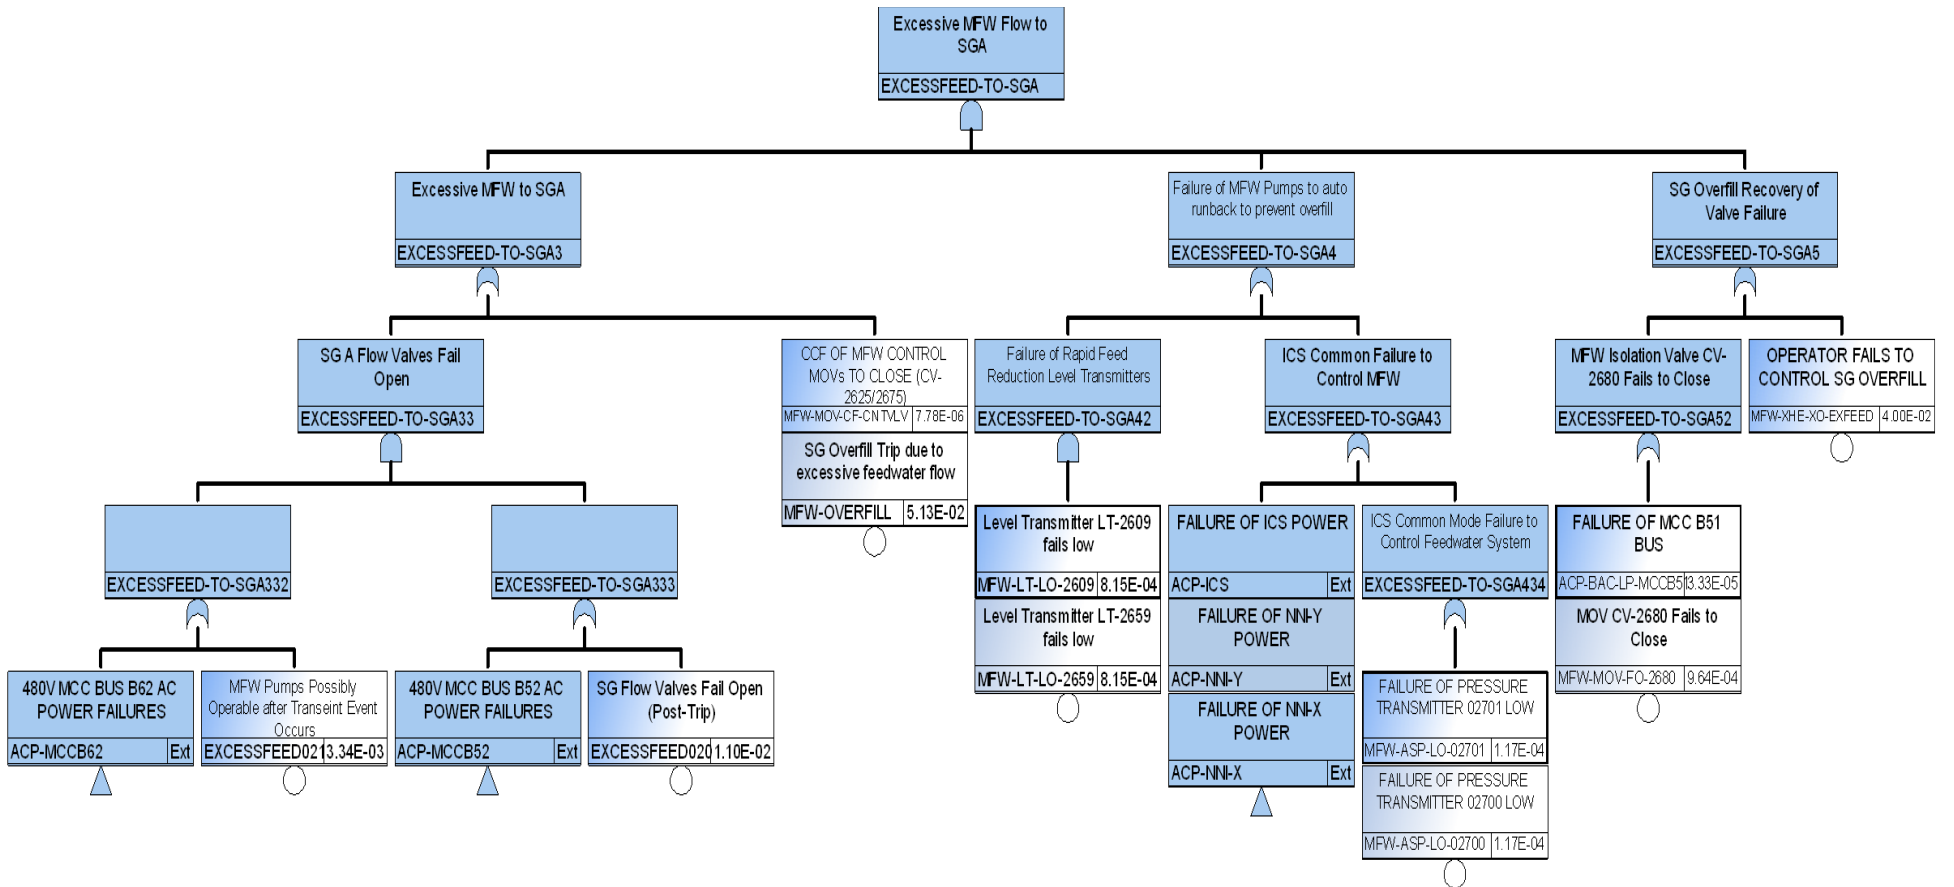
3. Adjustment of value for Excess Feed of the Steam Generators. Basic Events MFW-SYS-FC-EXFEEDA, "Main Feedwater System Excessively Feeds Steam Generator A," and MFW-SYS-FC-EXFEEDB, "Main Feedwater System Excessively Feeds Steam Generator B," were adjusted. After review of the design and operation of the ANO Unit 1 main feedwater system and its response during postulated events, the analyst determined that the existing SPAR model overestimated the probability of excessively feeding the steam generators. The analyst constructed new fault trees to better estimate the probability of excessive feeding the steam generators taking into account the system design and operation. The new fault tree used for Steam Generator A (which is functionally the same as the new fault tree for Steam Generator B) is depicted below.
