VIRGINIA ELECTRIC AND POWER COMPANY
RICHMOND, VIRGINIA 23261

Serial No.: 18-360
NRA/RAP: Rev. 0
Docket Nos.: 50-338/339
License Nos.: NPF-4/7

VIRGINIA ELECTRIC AND POWER COMPANY (DOMINION ENERGY VIRGINIA)
NORTH ANNA POWER STATION UNITS 1 AND 2
AMENDMENT FOR FLOOD PROTECTION DIKE MODIFICATION

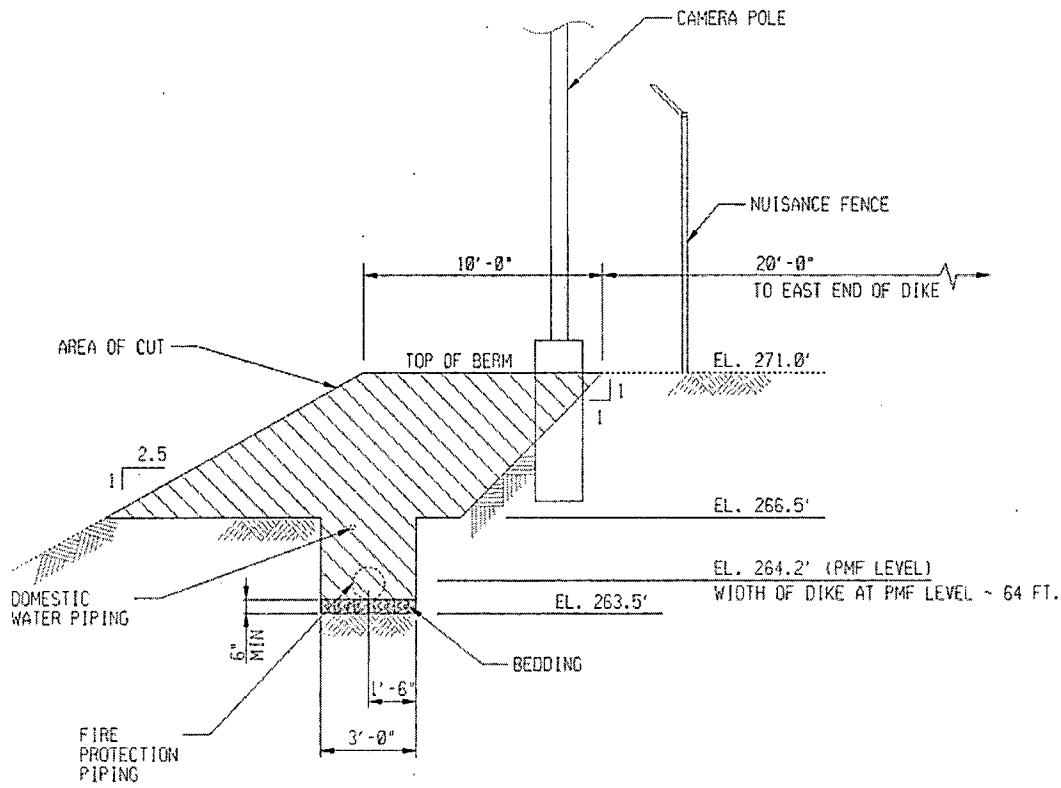
Figure 1: Trench Detail for FPS and DWS Installation in Flood Protection Dike

A Slope Stability Analysis for the flood protection dike was performed that includes an evaluation of the flood protection dike during construction and in its final configuration. As shown in Figure 1, a 3 ft. wide by 3 ft. deep trench was excavated from the western slope and part of the crest of the dike to allow installation of the 12-inch pipe and 2-inch pipe during installation. The elevation of the domestic water system piping varies from 4 to 6 feet below the top of the flood protection dike.

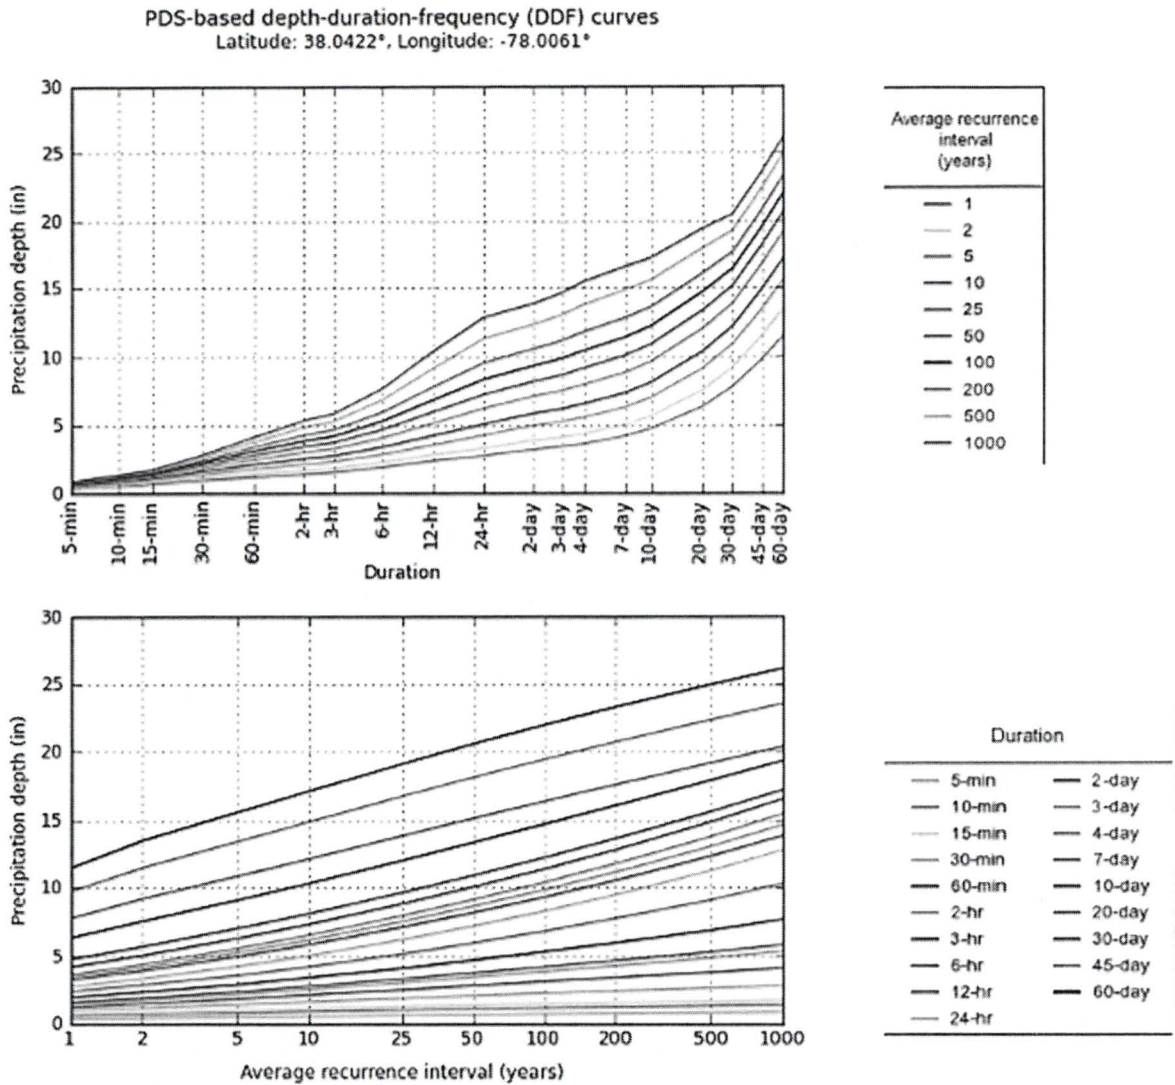
Figure 1: NOAA Precipitation Depth-Duration-Frequency Curves for Louisa, VA

The frequency of a "significant rainfall event" is estimated to be $1E-3$ /yr., or 1 in every 1000 years. This value was based on point precipitation frequency estimates for Louisa, Virginia performed by the National Oceanic and Atmospheric Administration (NOAA). This data source is referred in NRC Risk Assessment of Operational Events (RASP) Handbook. A graph depicting the precipitation depth-duration-frequency curves that was used to derive the precipitation frequency is shown below in Figure 1.
