Re: Florida Power & Light Company
Turkey Point Units 3 and 4
Docket Nos. 50-250 and 50-251
Turkey Point Units 3 and 4 Subsequent License Renewal Application Safety
Review - November 15, 2018 Public Meeting Action Item Responses

Turkey Point Units 3 and 4
Docket Nos. 50-250 and 50-251
FPL Revised Response to NRC On-Site Audit Follow Up Item 2
L-2018-223 Attachment 8 Page 10 of 18

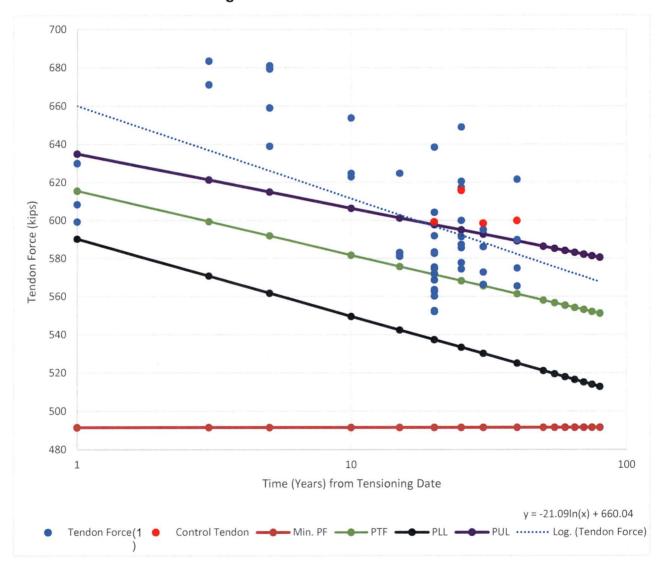
Figure 4.5-1
Unit 3 Hoop Tendons
1st Through 45th Year Tendon Surveillance

Notes:

(1) After the 30th surveillance year, the Tendon Force is only represented for the 30th and 40th year since Turkey Point meets the criteria of Section IWL-2421, which

Revise Figures 4.5-1, 2, 3, 4, 5, 6 pages 4.5-4 – 4.5-9 as follows:

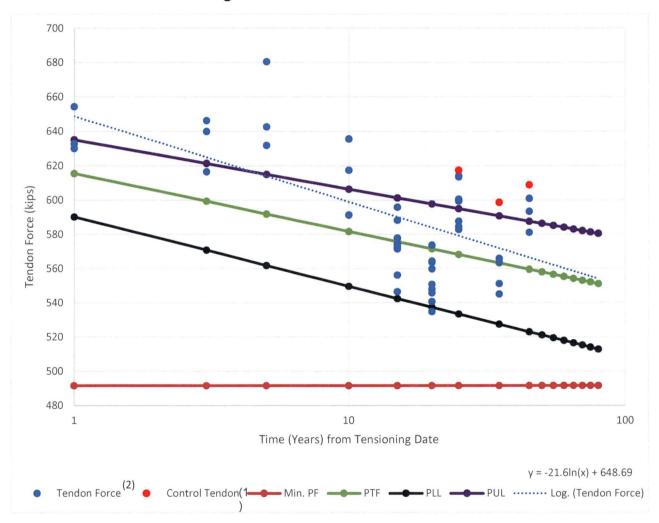
Figure 4.5-2
Unit 4 Hoop Tendons
1st Through 45th Year Tendon Surveillance

- (1) The control tendon for the 20th year surveillance is not shown since the initial control tendon selection was revised due to difficult access.
- (2) After the 30th surveillance year, the Tendon Force is only represented for the 30th and 40th year since Turkey Point meets the criteria of Section IWL-2421, which allows the two units alternate between "physical" and "visual" inspections at each surveillance period. Unit 4 underwent a "physical" inspection 35th and 45th surveillance years and will continue every ten years throughout the SPEO.

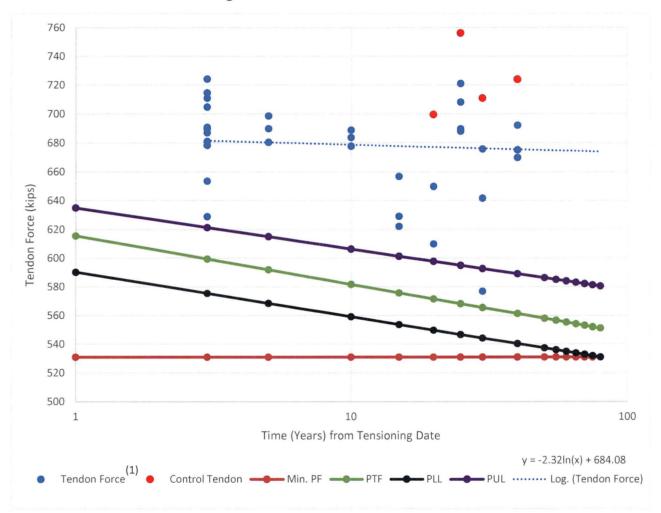
Figure 4.5-3
Unit 3 Dome Tendons
3rd Through 45th Year Tendon Surveillance

Notes:

(1) After the 30th surveillance year, the Tendon Force is only represented for the 30th and 40th year since Turkey Point meets the criteria of Section IWL-2421, which allows the two units alternate between "physical" and "visual" inspections at each surveillance period. Unit 3 underwent a "physical" inspection 30th and 40th surveillance years and will continue every ten years throughout the SPEO.

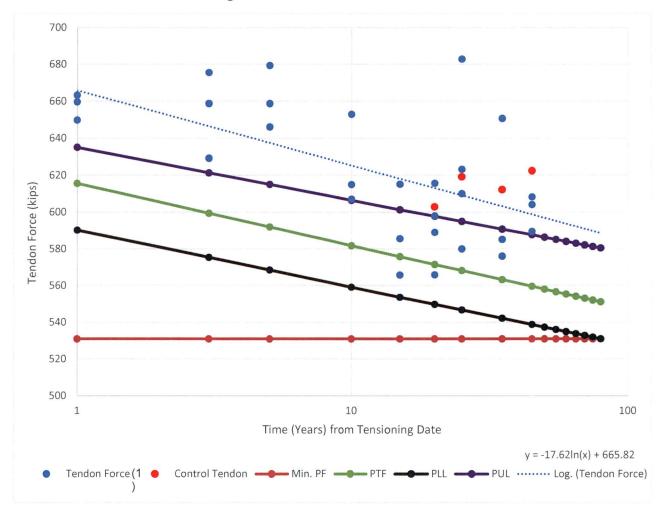
Figure 4.5-4
Unit 4 Dome Tendons
1st Through 45th Year Tendon Surveillance

Notes:

(1) After the 30th surveillance year, the Tendon Force is only represented for the 30th and 40th year since Turkey Point meets the criteria of Section IWL-2421, which allows the two units alternate between "physical" and "visual" inspections at each surveillance period. Unit 4 underwent a "physical" inspection 35th and 45th surveillance years and will continue every ten years throughout the SPEO.

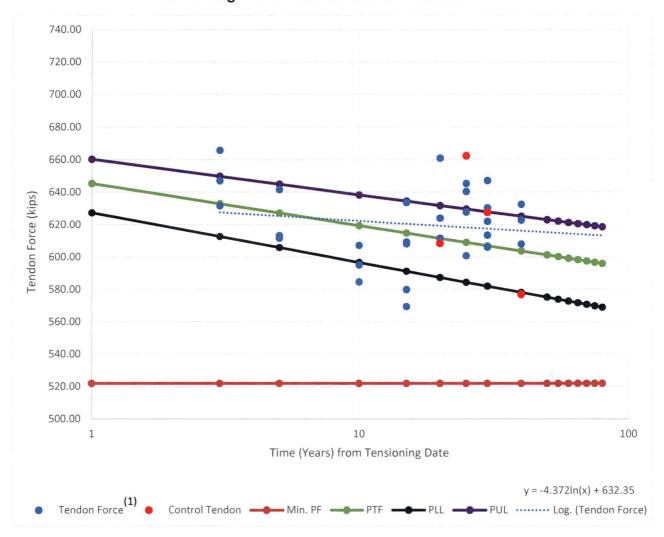
Figure 4.5-5
Unit 3 Vertical Tendons
3rd Through 45th Year Tendon Surveillance

Notes:

(1) After the 30th surveillance year, the Tendon Force is only represented for the 30th and 40th year since Turkey Point meets the criteria of Section IWL-2421, which allows the two units alternate between "physical" and "visual" inspections at each surveillance period. Unit 3 underwent a "physical" inspection 30th and 40th surveillance years and will continue every ten years throughout the SPEO.

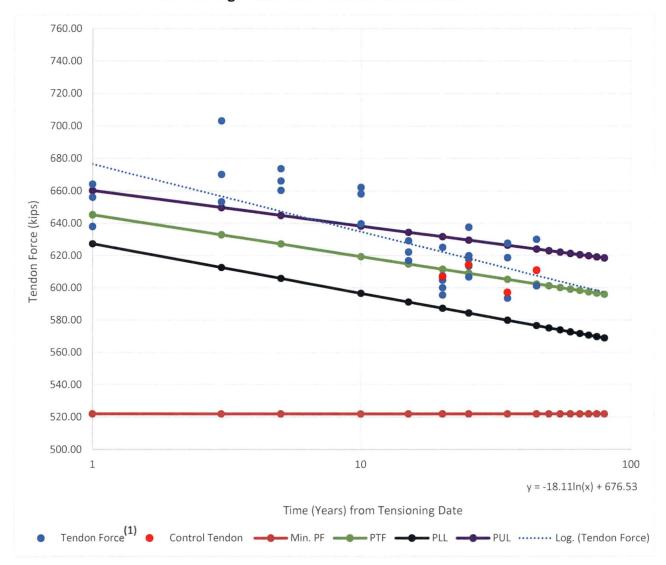
Figure 4.5-6
Unit 4 Vertical Tendons
1st Through 45th Year Tendon Surveillance

Notes:

(1) After the 30th surveillance year, the Tendon Force is only represented for the 30th and 40th year since Turkey Point meets the criteria of Section IWL-2421, which allows the two units alternate between "physical" and "visual" inspections at each surveillance period. Unit 4 underwent a "physical" inspection 35th and 45th surveillance years and will continue every ten years throughout the SPEO.

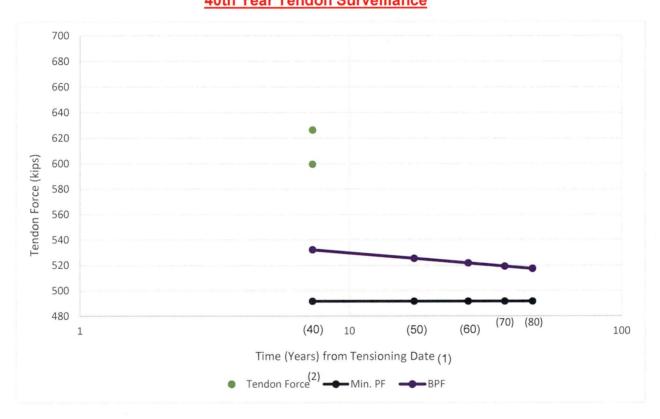
Figure 4.5-7
Unit 3 RVCH Hoop Tendons
40th Year Tendon Surveillance

- (1) Years in the parenthetical represent the IWL tendon surveillance year.
- (2) After the 30th surveillance year, the Tendon Force is only represented for the 30th and 40th year since Turkey Point meets the criteria of Section IWL-2421, which allows the two units alternate between "physical" and "visual" inspections at each surveillance period. The Unit 3 RVCH tendons underwent a "physical" inspection the 40th surveillance year and will continue every ten years throughout the SPEO.

Figures 4.5-7 through 4.5-10 contain the reanalyzed regression analysis for the tendon groups affected by the RVCH replacement project. The surveillance data is plotted with the MRVs over the 80-year period. The number of tendons selected for the augmented RVCH scope is defined by IWL2521.2 and Table IWL-21521-2.

Revise Figures 4.5-7, 8, 9, 10 as follows:

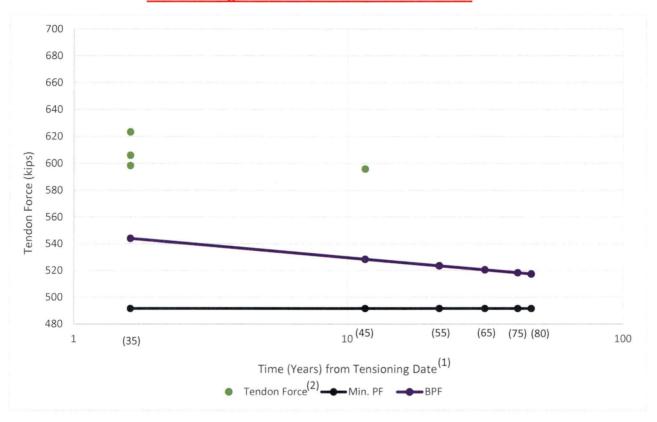
Unit 4 RVCH Hoop Tendons

35th Through 45th Year Tendon Surveillance

- (1) Years in the parenthetical represent the IWL tendon surveillance year.
- (2) After the 30th surveillance year, the Tendon Force is only represented for the 30th and 40th year since Turkey Point meets the criteria of Section IWL-2421, which allows the two units alternate between "physical" and "visual" inspections at each surveillance period. The Unit 4 RVCH tendons underwent a "physical" inspection the 35th and 45th surveillance years and will continue every ten years throughout the SPEO.

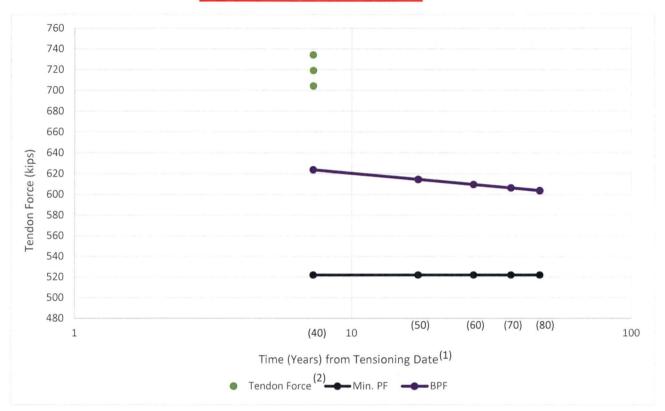
Figure 4.5-9
Unit 3 RVCH Vertical Tendons
40th Year Tendon Surveillance

- (1) Years in the parenthetical represent the IWL tendon surveillance year.
- (2) After the 30th surveillance year, the Tendon Force is only represented for the 30th and 40th year since Turkey Point meets the criteria of Section IWL-2421, which allows the two units alternate between "physical" and "visual" inspections at each surveillance period. The Unit 3 RVCH tendons underwent a "physical" inspection the 40th surveillance year and will continue every ten years throughout the SPEO.

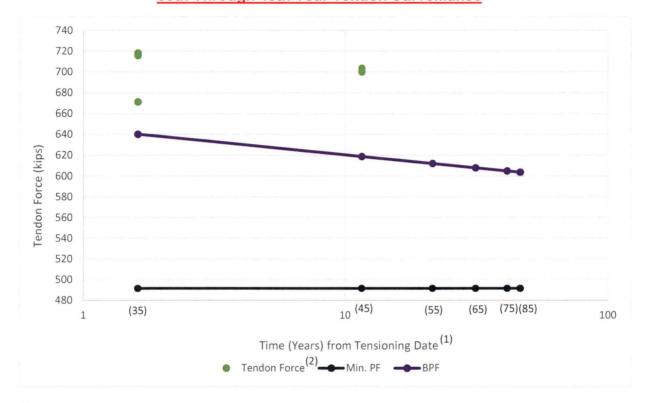
Unit 4 RVCH Vertical Tendons

35th Through 45th Year Tendon Surveillance

Notes:

- (1) Years in the parenthetical represent the IWL tendon surveillance year.
- (2) After the 30th surveillance year, the Tendon Force is only represented for the 30th and 40th year since Turkey Point meets the criteria of Section IWL-2421, which allows the two units alternate between "physical" and "visual" inspections at each surveillance period. The Unit 4 RVCH tendons underwent a "physical" inspection the 35th and 45th surveillance years and will continue every ten years throughout the SPEO.
