Joseph M. Farley Nuclear Plant
Request for Additional Information Regarding
Southern Nuclear Operating Company Responses To
Issues Related to FNP Electrical Distribution System Functional Inspection

Inspection Follow-up Item 348, 364/92-17-13, Inadequate Motor Overload Protection

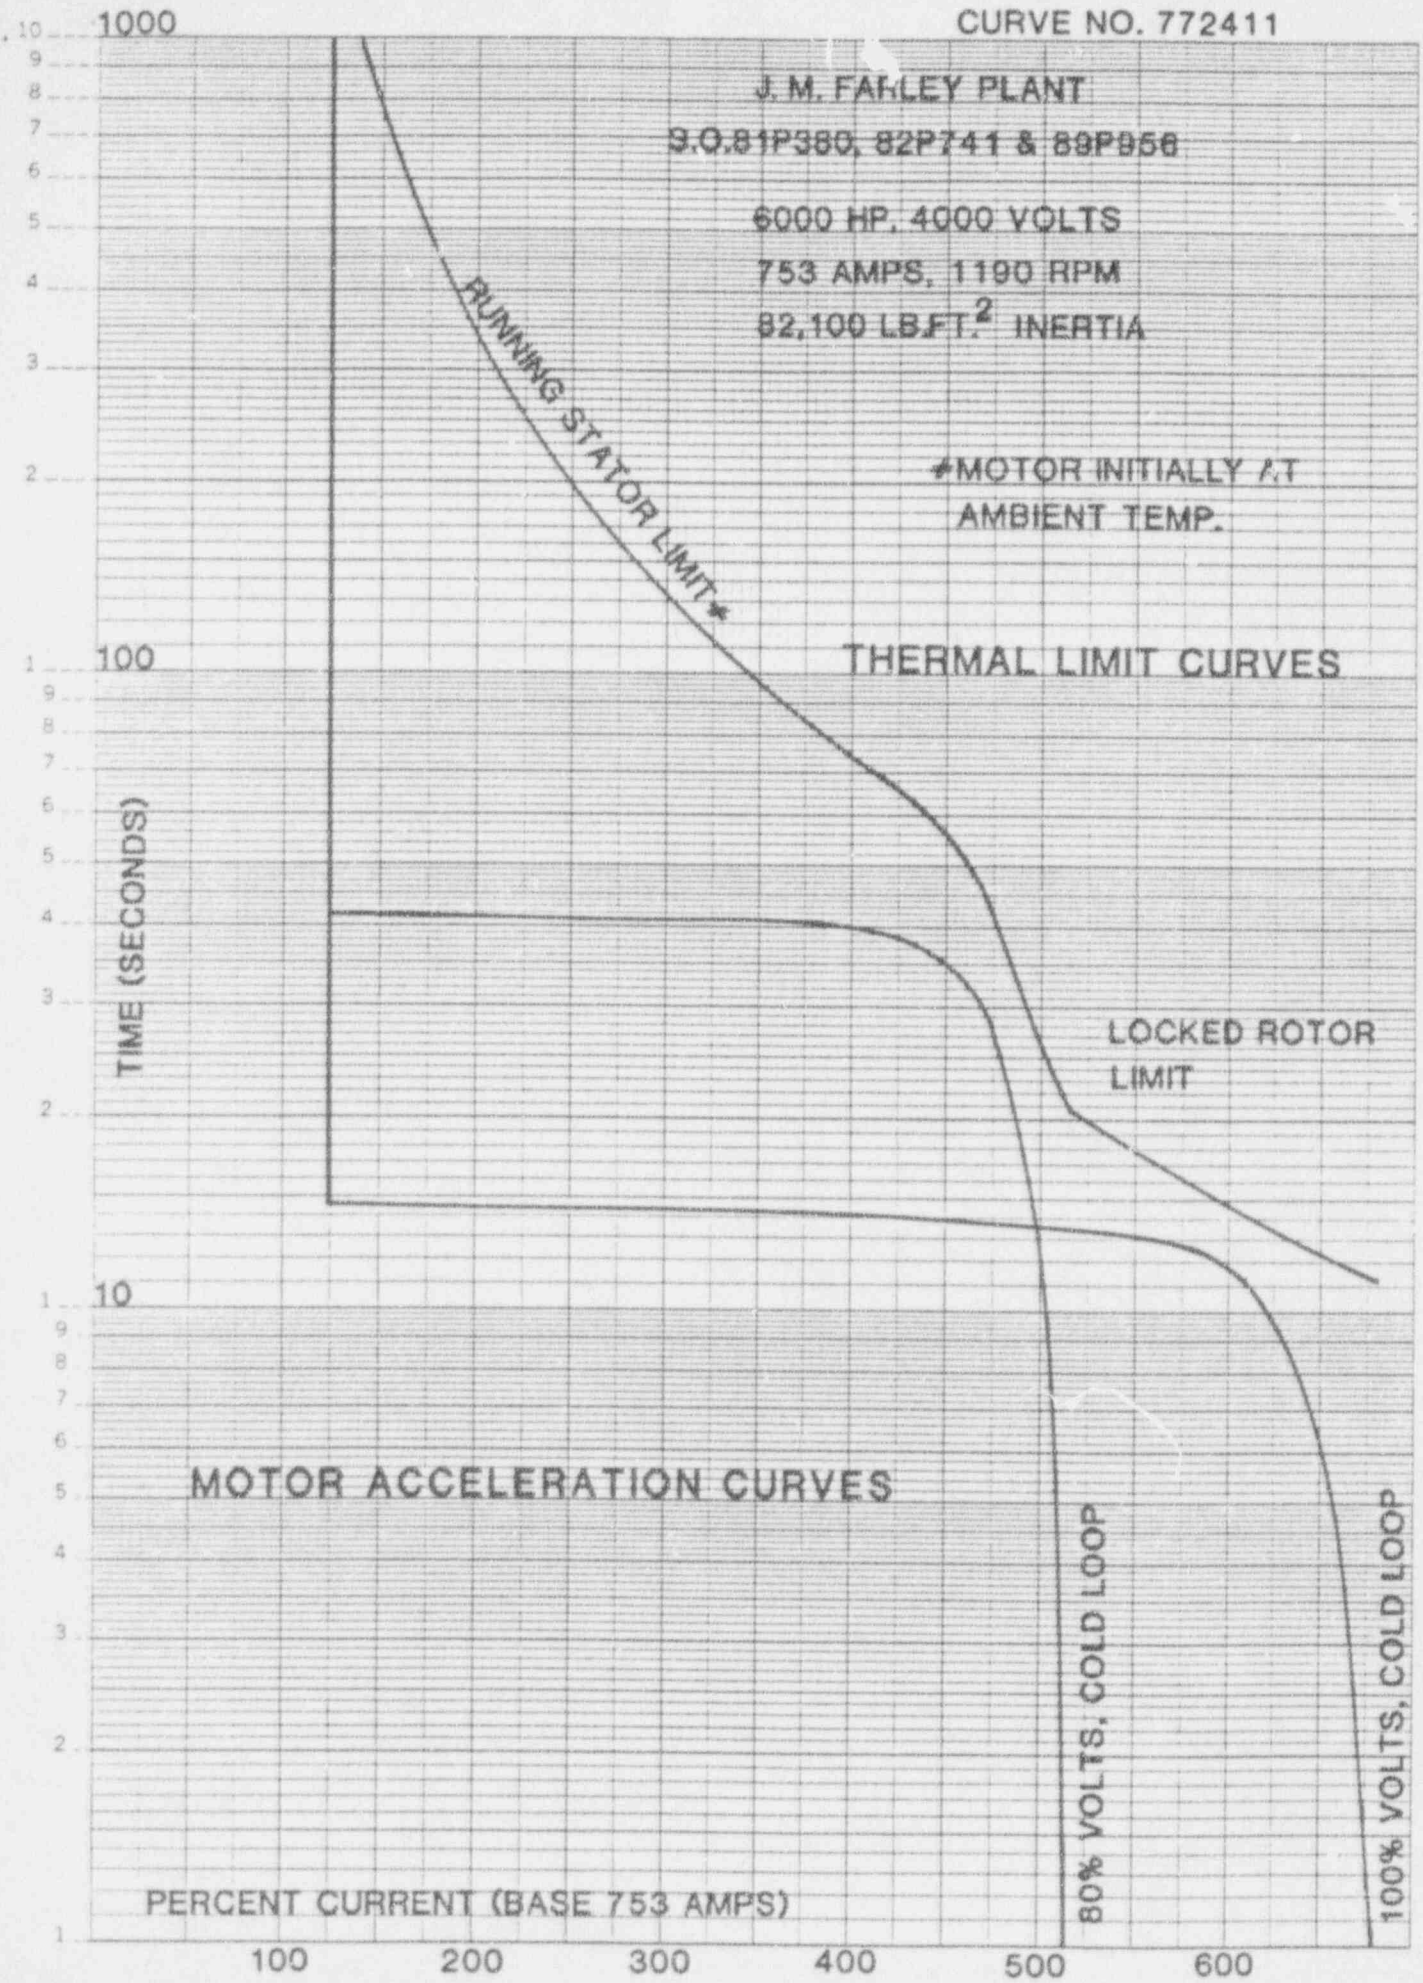
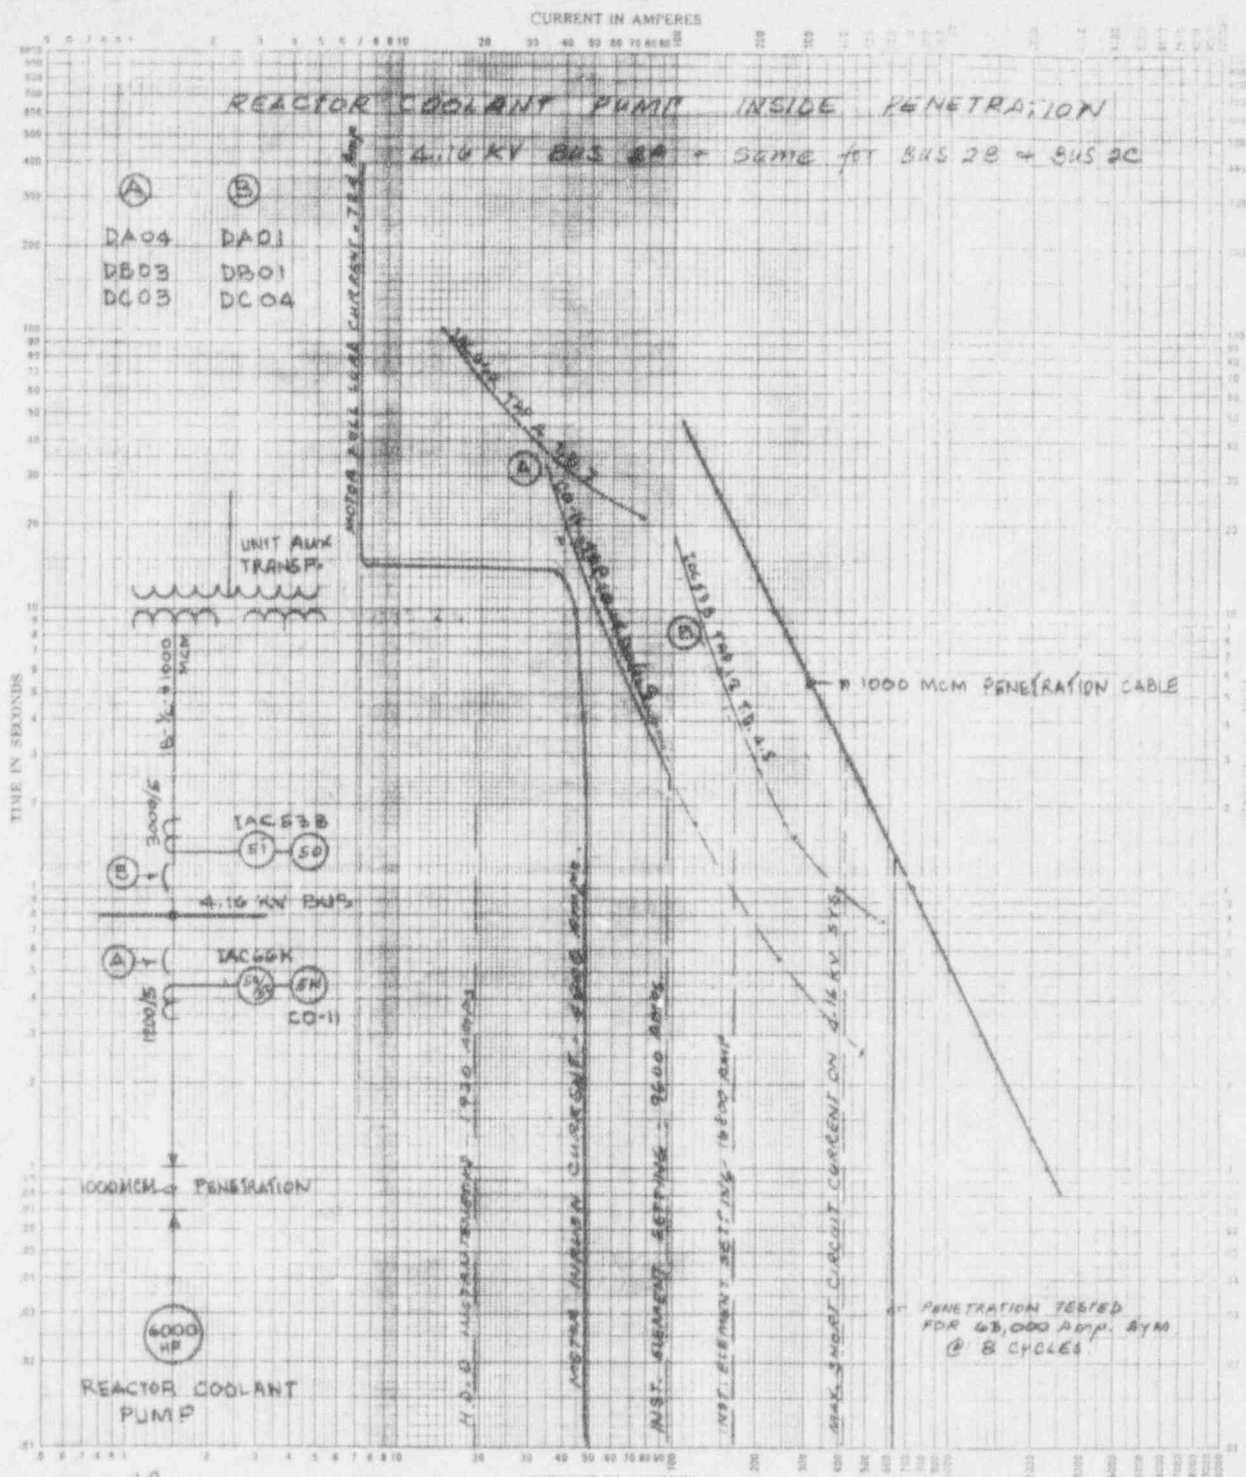
FIGURE 1

CALC. 4-B
 #1000 MCM O/C TIME-CURRENT CHARACTERISTIC CURVES
 For MEDIUM VOLTAGE PENETRATION (4.16KV) Fuse Links In
 BASIS FOR DATA Standards Dated
 1. Tests made at _____ Volts a.c. at _____ p.l. Starting at 25C with no initial load
 2. Curves are plotted to _____ Test points so variations should be _____
 N. _____
 Date _____

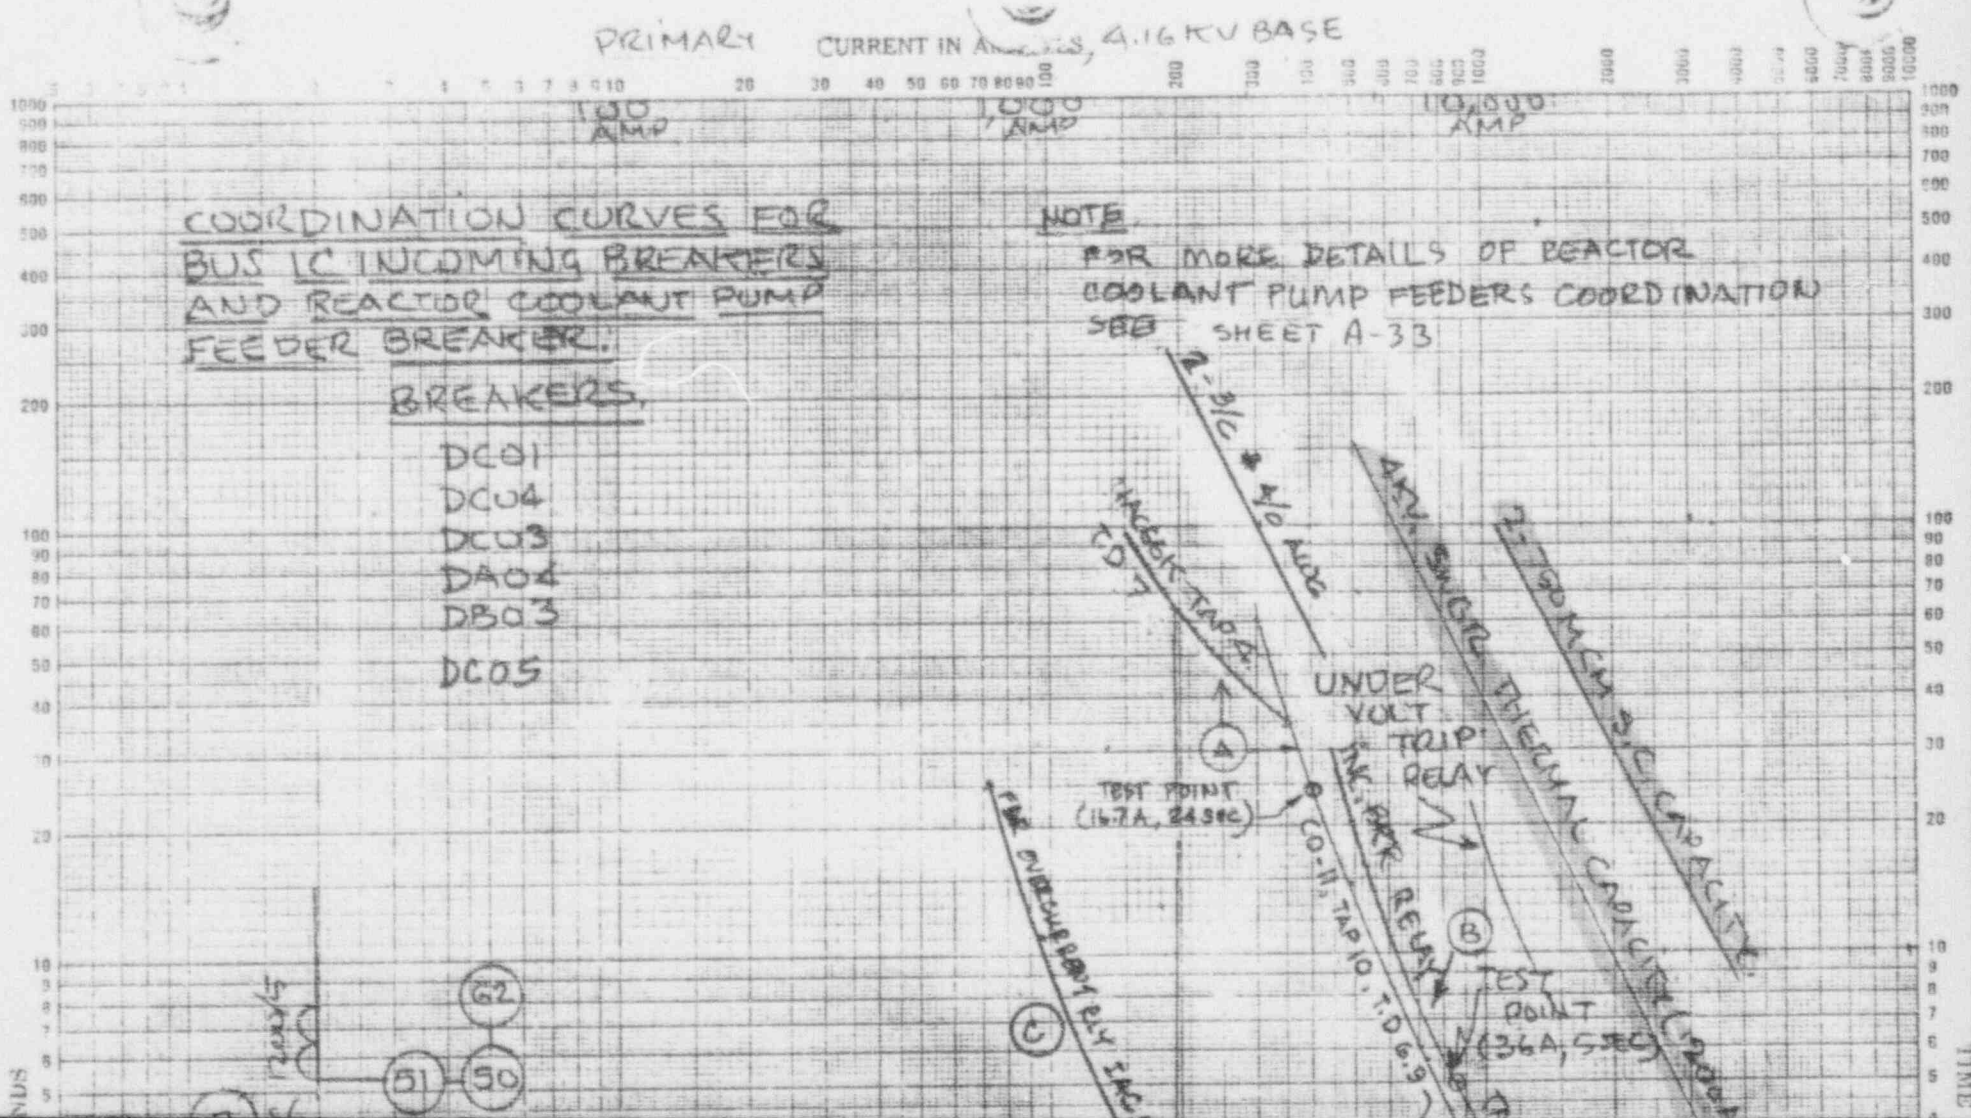
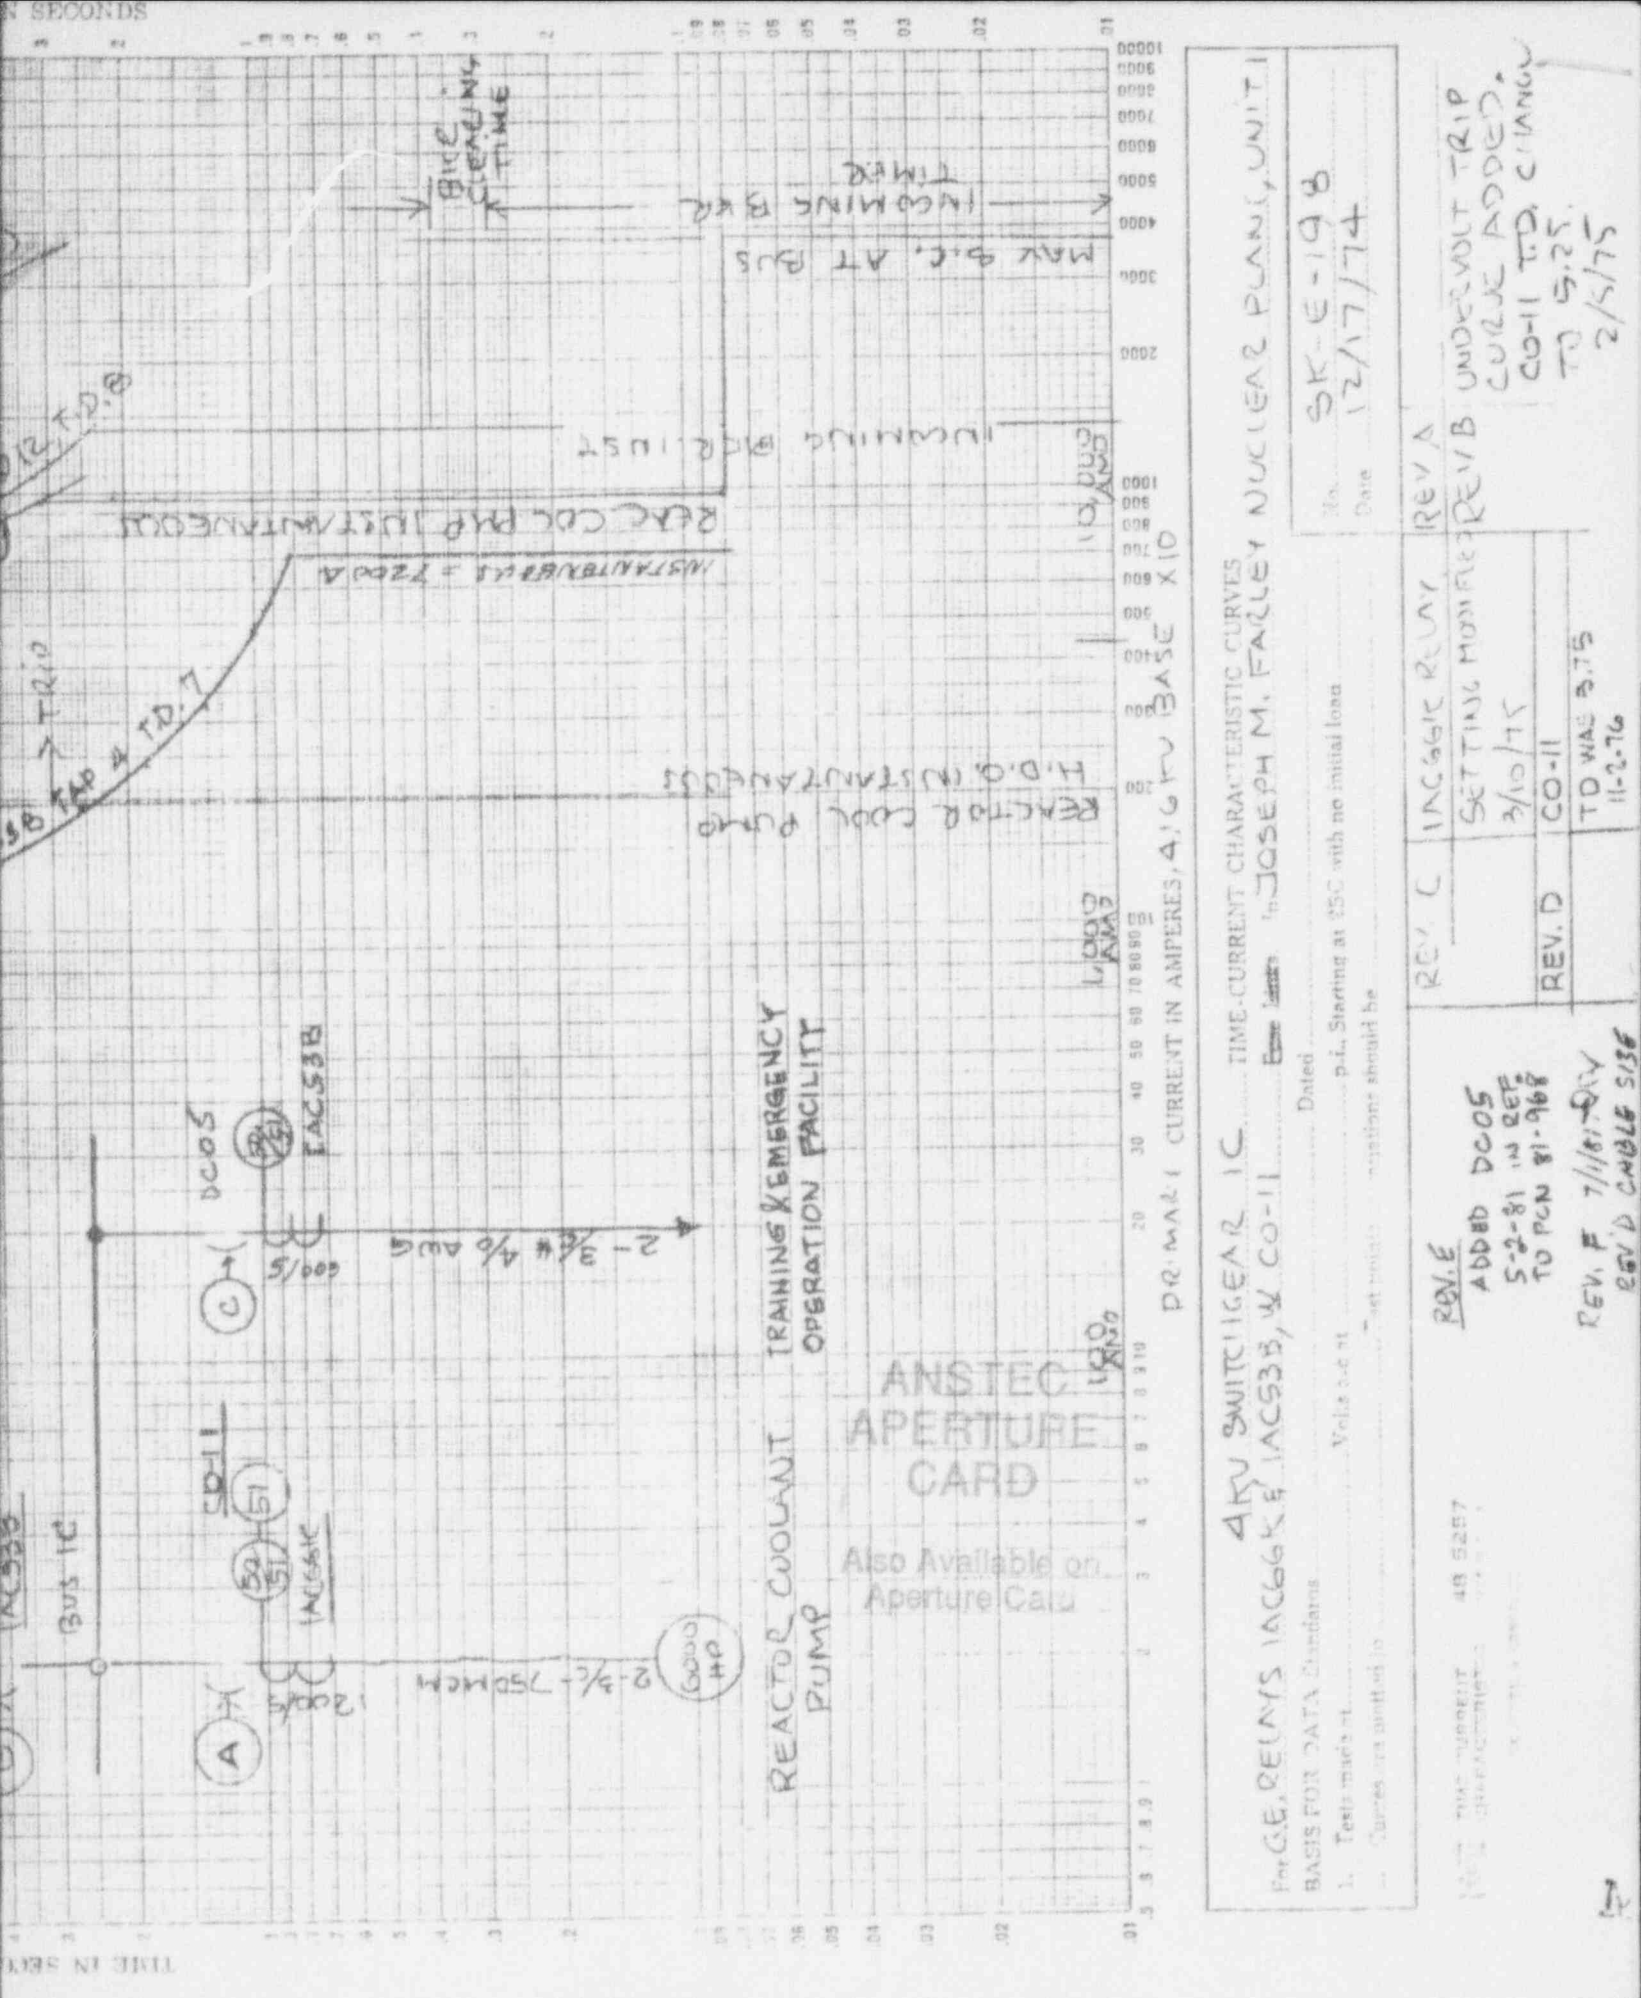
4KV SWITCHGEAR IC TIME-CURRENT CHARACTERISTIC CURVES
 FOR GE RELAYS IAC66K & IAC53B, W/ CO-11
 Dated: _____ p.i., Starting at 25C with no initial load
 Tests made at _____ Volts a-c at _____ p.f. Target primary _____ positions should be _____
 Carries a unit of 10 _____

REV. E	ADD'D DC05 5-2-81 IN REF TO PGN 81-968	REV. C	IAC66K RELAY	REV. A	NO. SK-E-19 B DATE 12/17/74
REV. F 7/1/81-DIV REV'D CABLE SIZE		REV. D	SETTING MODIFIED 3/10/75	REV. B	UNDERVOLT TRIP CURVE ADDED. CO-11 TD, CHANGE TO 5.25. 2/5/75
			CO-11		
			TD WAS 3.75 11-2-76
