Subject: Systematic Assessment of Licensee Performance (SALP)
Report No. 50-247/85-99

This refers to the evaluation we conducted of the activities at Indian Point Nuclear Generating Station, Unit 2, for the period of August 1, 1984 through July 31, 1985 and discussed with members of your staff on October 25, 1985 at the Region I office in King of Prussia, Pennsylvania. The list of meeting attendees is attached as Enclosure 1. The NRC Region I SALP Report is provided as Enclosure 2. Our letter of October 11, 1985 (Enclosure 3) forwarded the SALP Board Report and solicited comments within 20 days of our meeting. As discussed during the October 25 meeting and subsequently documented in your November 13, 1985 letter (Enclosure 4), the comments relative to reactor vessel surveillance have been clarified in the enclosed report. Your comment relative to improved performance in radiological control is noted.

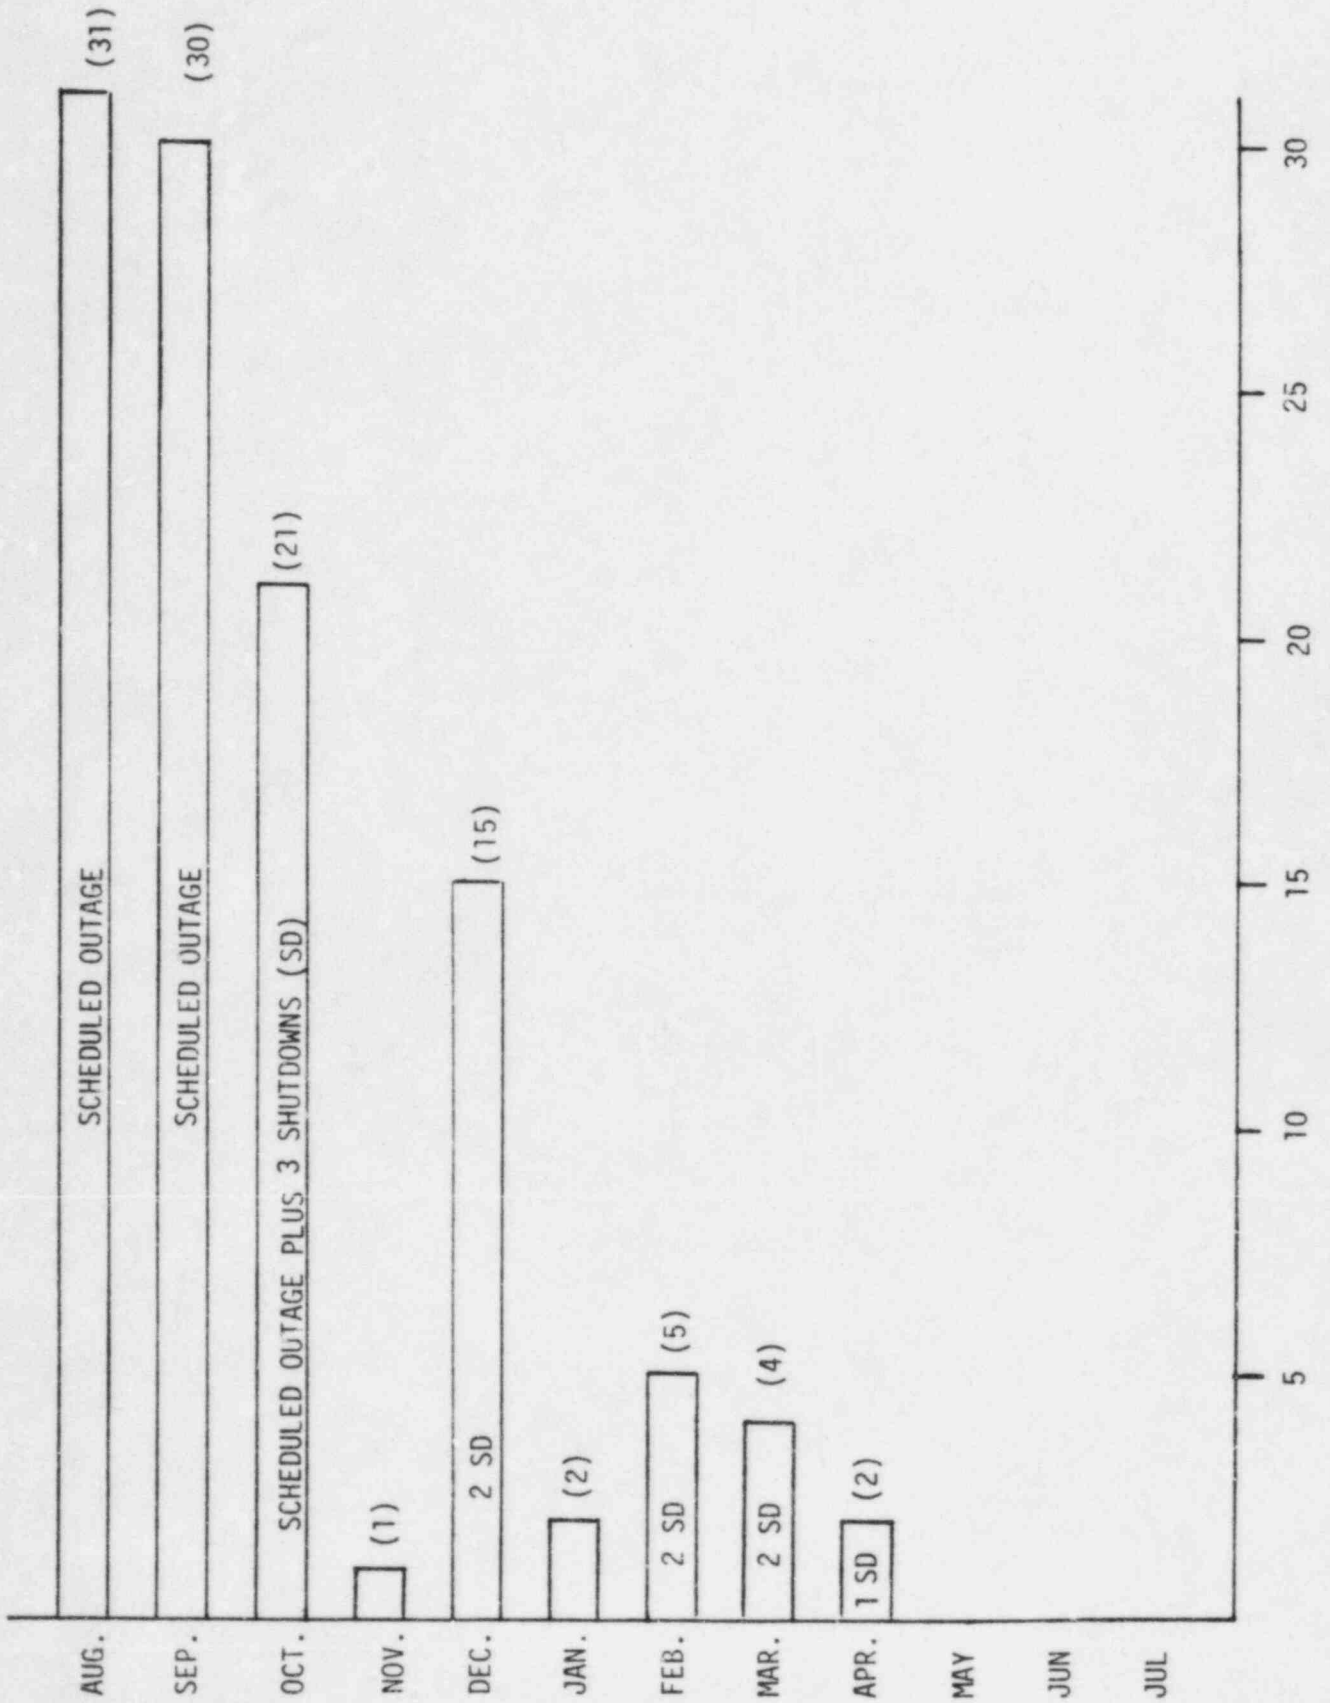
FIGURE 1

NUMBER OF DAYS SHUTDOWN

Figure 1-Number of Days Shutdown	F1-1
--	------
