South Texas Project
Unit 2
Docket No. STN 50-499
2RE22 Inspection Summary Report
for Steam Generator Tubing Rev 1 (EPID: L-2023-LRO-0029)

**2RE22 INSPECTION SUMMARY REPORT
FOR STEAM GENERATOR TUBING (Rev. 1)**

SOUTH TEXAS PROJECT

ELECTRIC GENERATING STATION UNIT 2

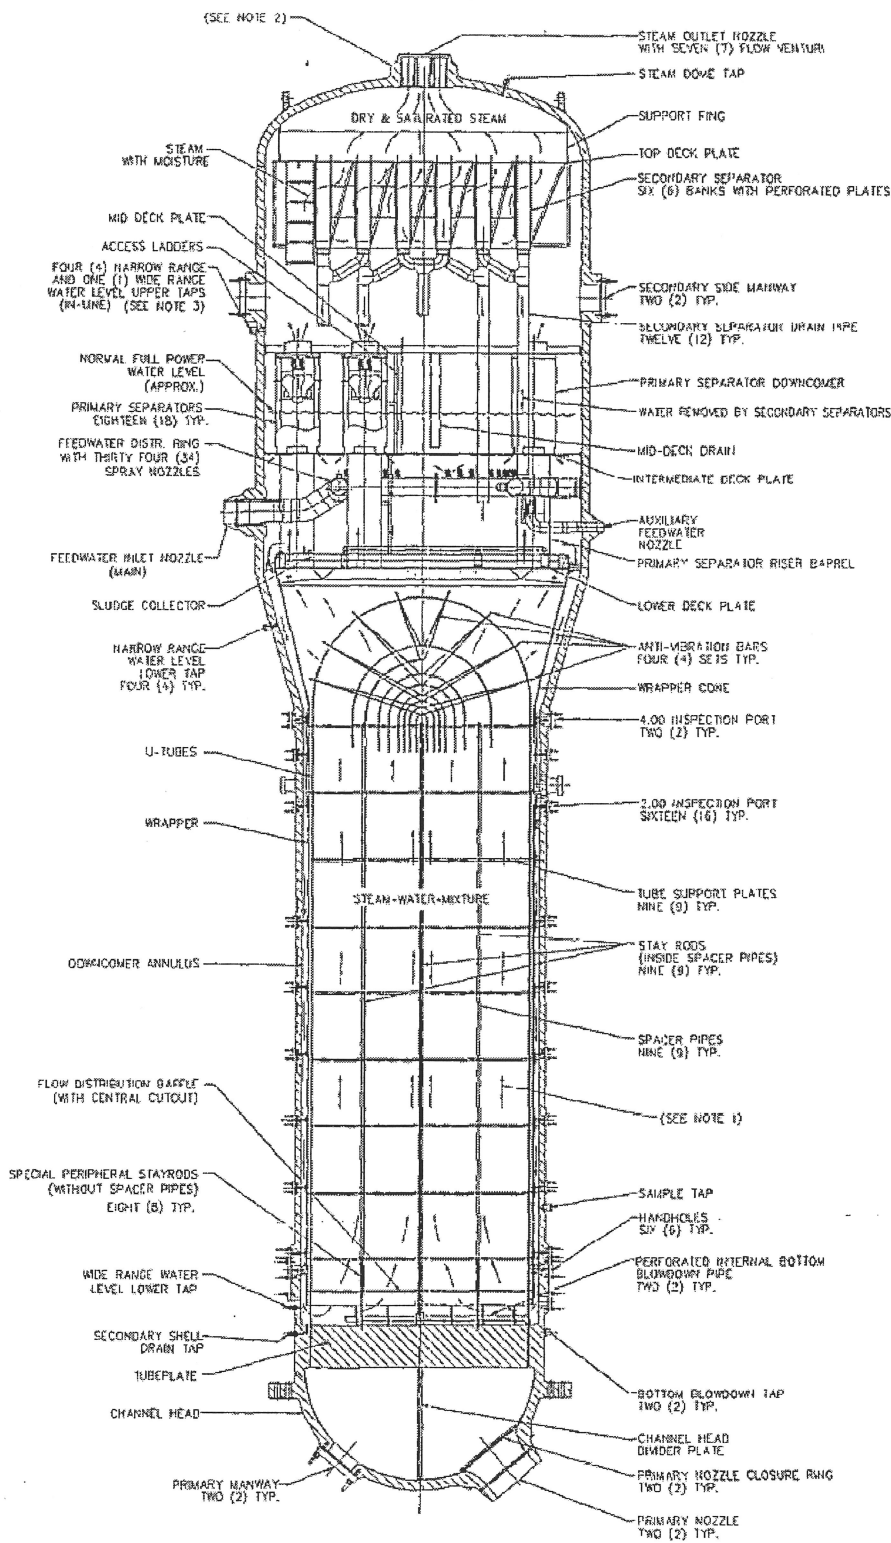
Steam Generator Schematic	Schematic is attached. See next page.

South Texas Delta 94 RSGs Fabricated by Equipos Nucleares, S.A. (ENSA)
