WESTERN NUCLEAR, INC.

SHERWOOD PROJECT

**RE: Radioactive Materials License WN-I0133-1; License Condition No. 29:
Request for Termination of License WN-I0133-1 Issued for the Sherwood
Project Operated by Western Nuclear, Inc.**

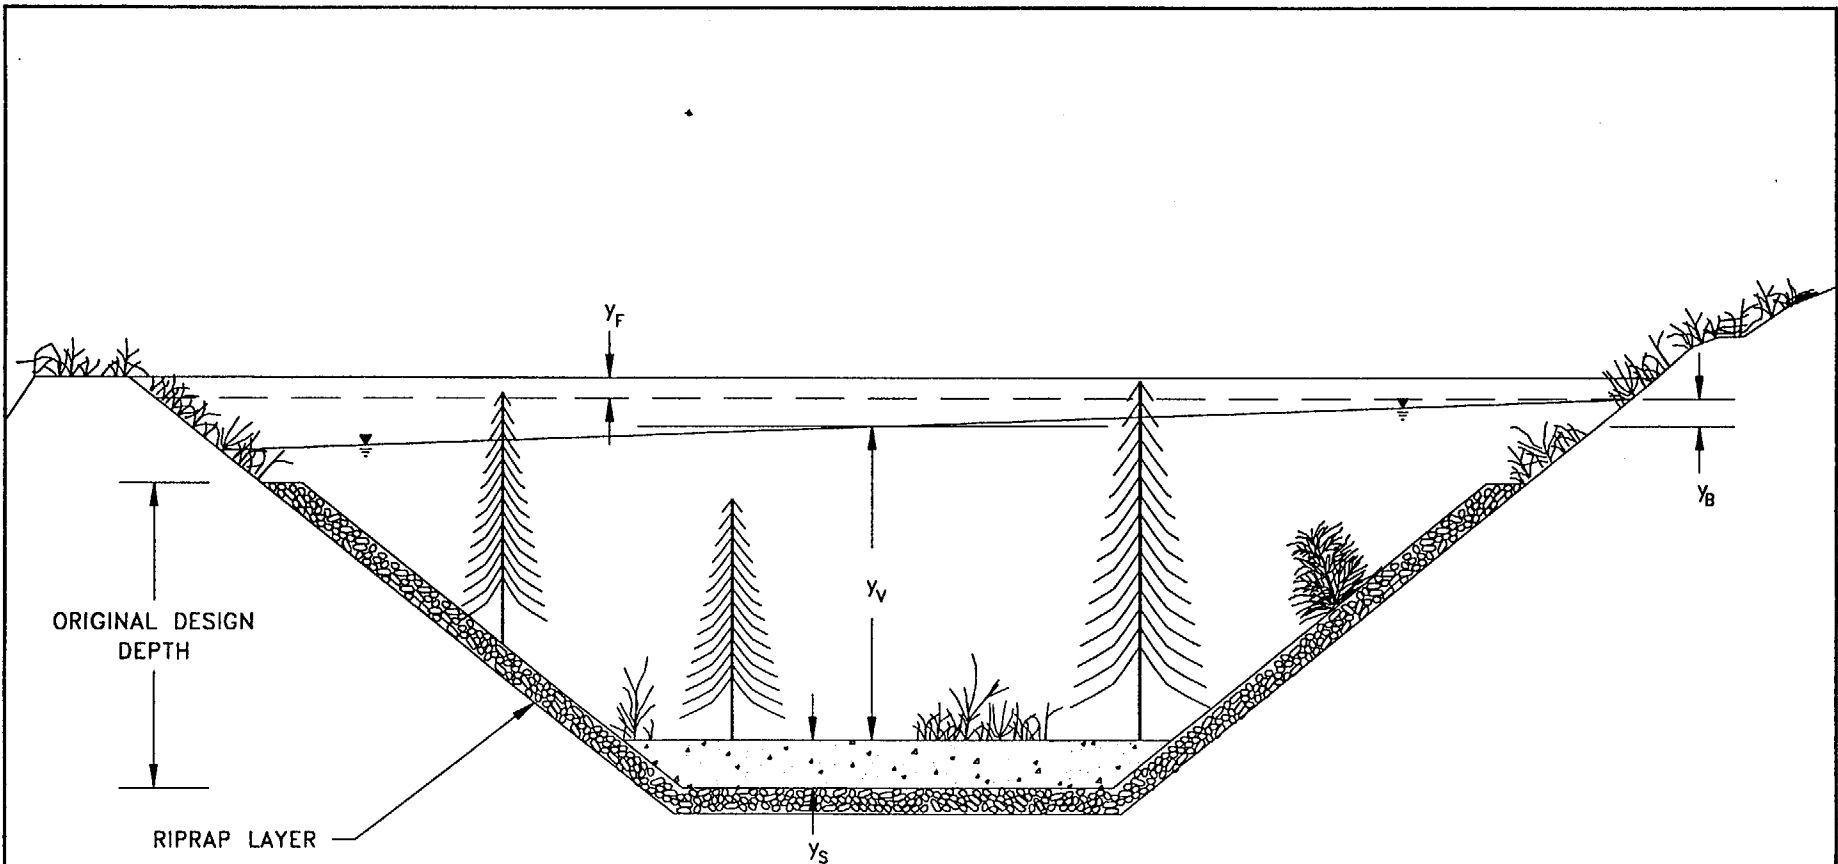
Figure 5.1 shows the modified channel design schematically. The design of the diversion channel is proposed to be modified by increasing the amount of compacted fill on the berm between the channel and the tailings impoundment. Table 5.1 summarizes the changes in design depth for the channel, comparing channel depth as presented in the 12/94 TRP to the modified channel depth designed for sediment, vegetation and superelevation. Table 5.2 is a more detailed summary of the issues investigated in this response report.

y_s = SEDIMENT DEPTH
 y_v = PMF DEPTH WITH VEGETATION IN CHANNEL
 y_b = AMOUNT OF SUPERELEVATION AT BENDS
 y_f = FREEBOARD = 1.0 FOOT

0.10, 3) superelevation, and 4) 1.0 foot of freeboard. The 1.0 foot of freeboard in addition to considerations for sediment, vegetation, and superelevation, is a final degree of conservatism and provides significant cross sectional area to the channel should it be needed. For example, at the downstream end of the channel, the depth is 22 feet and the top width is 140 feet wide. The cross sectional area in the upper 1-foot of channel is about 137 square feet. This area corresponds to a depth of over 5.8 feet at the bottom of the channel. Therefore, there could be as much as 5.8 feet of sediment in the channel and the PMF would still be contained within the channel freeboard.

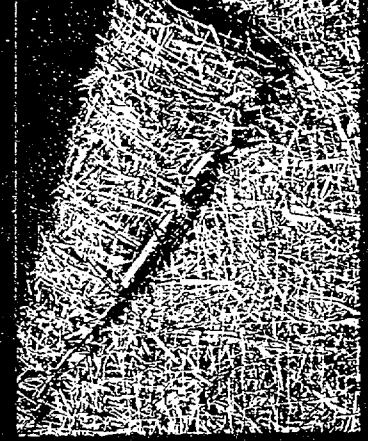
S150BN is a 100% biodegradable version of the standard S150. The blanket consists of a straw matrix sewn between two natural fiber nets. S150BN provides erosion protection on 3:1-2:1 slopes (33-60% slopes or 19-27 degree slopes) and moderate discharge swales. The functional longevity of the S150BN is approximately 10 months. Consult North America's Green software for specific recommendations.

1. Top Net
Woven, 100% biodegradable, natural organic fiber 9.3 lbs/1000 sq ft approx wt
2. Straw Fiber
0.5 lbs/sq yd (0.27 kg/sq m)
3. Bottom Net
Woven, 100% biodegradable, natural organic fiber 9.3 lbs/1000 sq ft approx wt
- Thread
Biodegradable

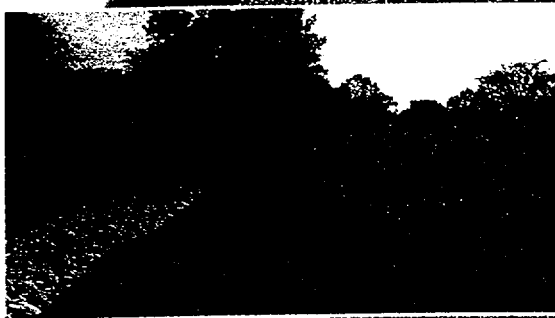
North American Green's C350 Erosion Control/Turf Reinforcement Mat combines the superior erosion control effectiveness of a coconut fiber blanket with the permanent stem and root reinforcement capabilities of a synthetic matting. The patent pending design of the C350 utilizes a coconut fiber matrix stitch-bonded between a heavy-duty bottom netting and a super heavy, crimped, intermediate net overlaid with a heavy-duty top net. This unique triple net construction forms prominent ridges across the matting to trap sediment and provide a permanent three dimensional structure for turf stem and root reinforcement. C350 Erosion Control/Turf Reinforcement Mat provides long-lasting erosion control and permanent vegetal stem and root reinforcement on severe slopes with heavy run-off, channels with super-critical flow velocities, and shorelines with elevated wave action. The C350 is designed for increasing the velocity and shear stress resistance of natural vegetation. C350 was developed specifically for use in the 3 Phase Reinforced Turf Design System. Consult North American Green software for specific design recommendations.

Width	6.5 feet (2m)
Length	55.5 feet (16.9m)
Weight	37 lbs ±10% (16.8 kg)
Area	40 sq yds (33m sq)

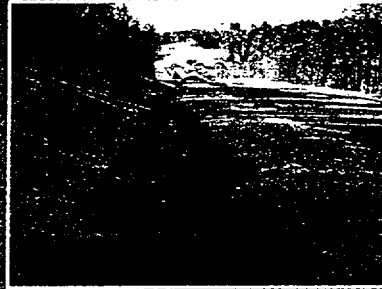
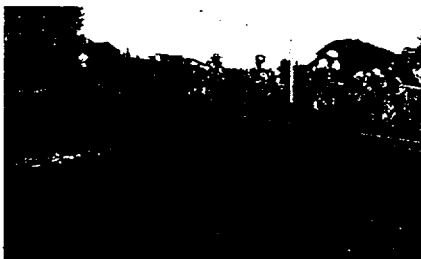
The P300 Erosion Control/Turf Reinforcement Mat features a 100% UV stabilized polypropylene fiber matrix encased in an extra heavy-duty, UV stabilized top net and a heavy, UV stabilized bottom net. The blanket is sewn together on 1.5 inch centers with black polypropylene thread to ensure long-lasting durability and performance. The P300 provides permanent erosion control and vegetal reinforcement on severe slopes, high discharge channels, and shorelines with wave action. P300 is designed for use where natural vegetation will not withstand design flow conditions. The P300 is ideal for use in the 3 Phase Reinforced Turf Design System. Consult North American Green software for specific design recommendations.

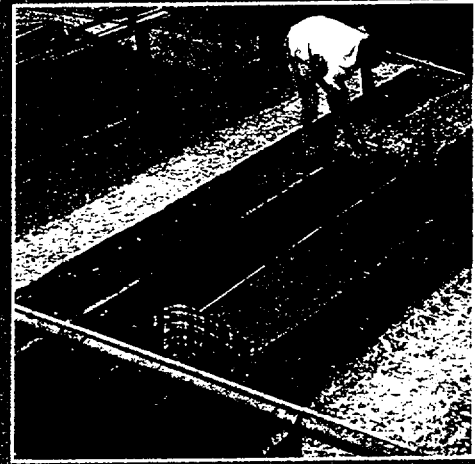
TABLE 4/SLOPE TEST #1

All tests were performed by installing each North American Green blanket type in 2 - 3 separate plots on a 20 feet long sandy loam test bed set at one of three slope gradients (3:1 - 1.5:1). After installation, the test plots were subjected to a simulated storm event with a rainfall intensity of 4 in/hr for one full hour. All runoff, infiltrated water, and sediment were collected at the end of each test plot and volumetrically measured and weighed. The following graphs display the test results in actual soil loss per hour from the respective material and bare soil control plots. For more detailed, performance guaranteed product recommendations for slope applications, refer to the North American Green Erosion Control Materials Design Software.

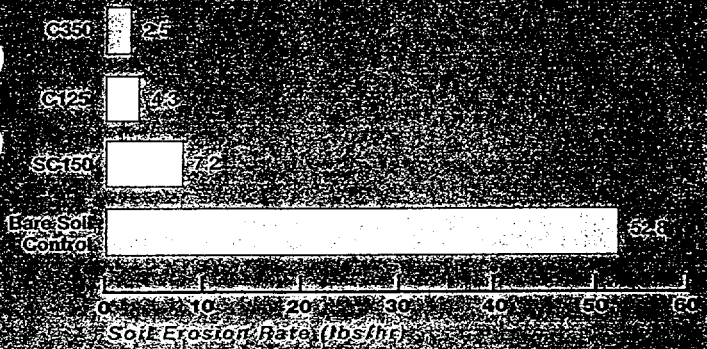
SLOPE TEST #3 SUMMARY

Slope Grade = 1.5:1 Slope Length = 20'
 Soil Type = Sandy Loam Rainfall Intensity = 4.0 in/hr

The North American Green SC150 was quite effective at reducing soil loss from the 1.5:1 test slope. The C125 and C350 showed even greater performance at over 90% effectiveness. The C125 is recommended for temporary long term protection of critical slopes where the established permanent

vegetation is expected to withstand design storm events. The C350 is recommended for severe slopes with heavy runoff necessitating both temporary/long term erosion protection and permanent turf reinforcement.
