THE RADIOLOGICAL ACCIDENT  
IN ISTANBUL

Printed by the IAEA in Austria  
September 2000  
STI/PUB/1102

INTERNATIONAL ATOMIC ENERGY AGENCY  
VIENNA, 2000

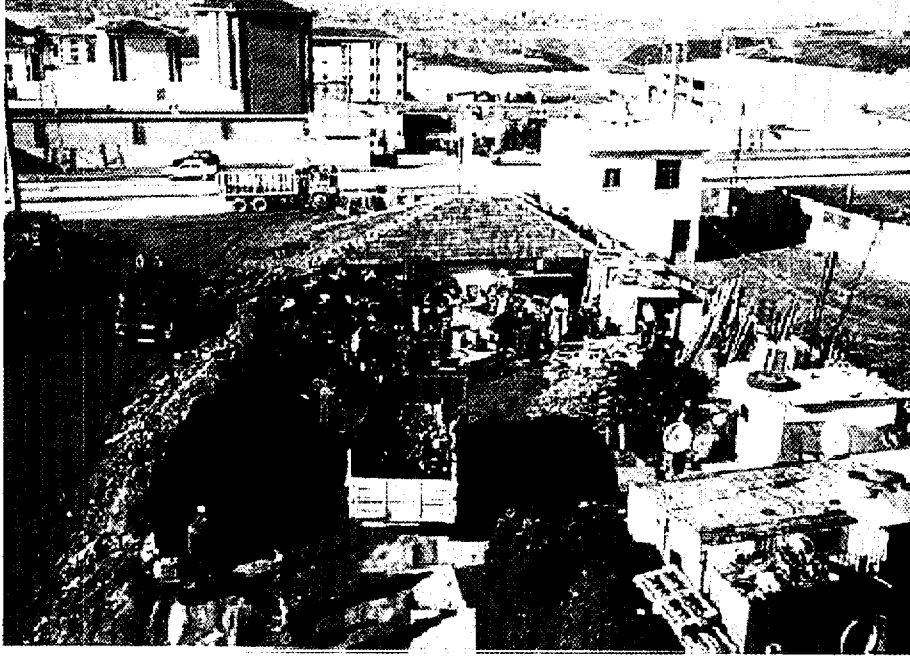
*Photograph 10. The scrapyard (Ziya Gökalp).*

- (14) The unshielded source(s) is/are thought to have remained in the yard until 27 or 28 December 1998. The scrap metal (apart from the lead: see item (16)) was then loaded by hand and with a shovel onto a truck and taken to a larger scrap metal dealer in the same area, Ziya Gökalp (see Fig. 5 and Photograph 10).

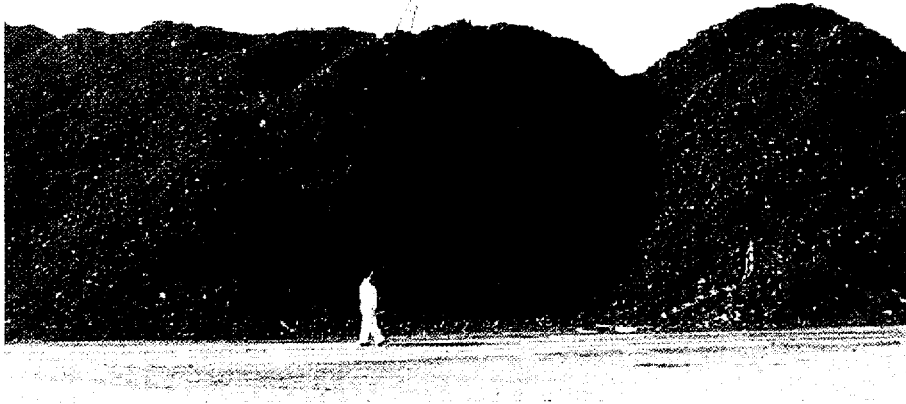
*Photograph 15. Scrap metal pile in the field of the smelting factory in Izmit.*

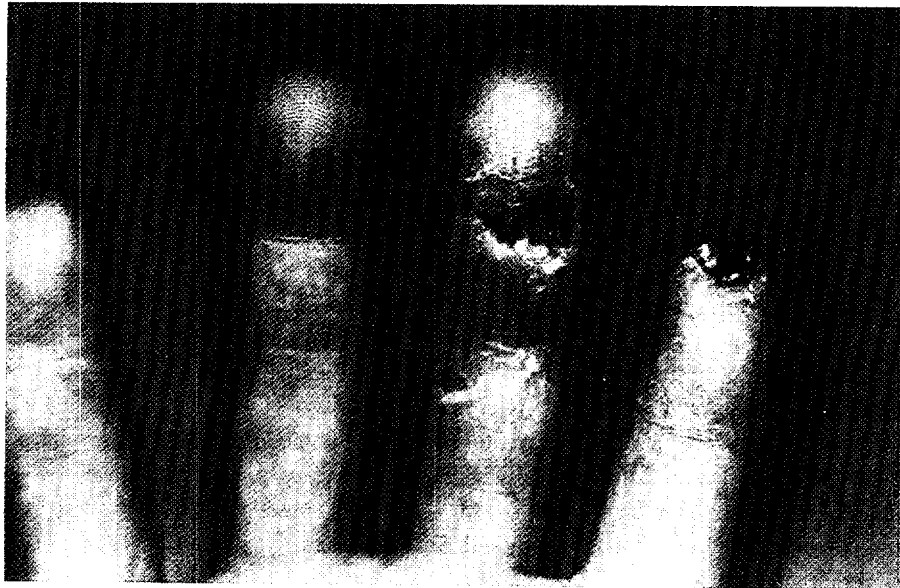
- In April 1999, an X ray examination of the right hand showed a slightly thinner bone tip of the first phalanx of the second finger, where the skin had also become thinner.
- In July 1999, the three phase bone scintigraphy showed slightly decreased perfusion and X rays revealed osteoporosis and soft tissue atrophy on the tip of the first phalanx of the second finger. Flexion limitation of the proximal interphalangeal joint was noticed. There was no sign of infection or pain.

*Photograph 17. Ulcerated third finger of patient 1 MI 14 months after an acute radiation exposure in Istanbul on 13 December 1998. The first phalanx of the second finger was amputated in November 1999. Since then some ulcerative–necrotic changes have developed.*

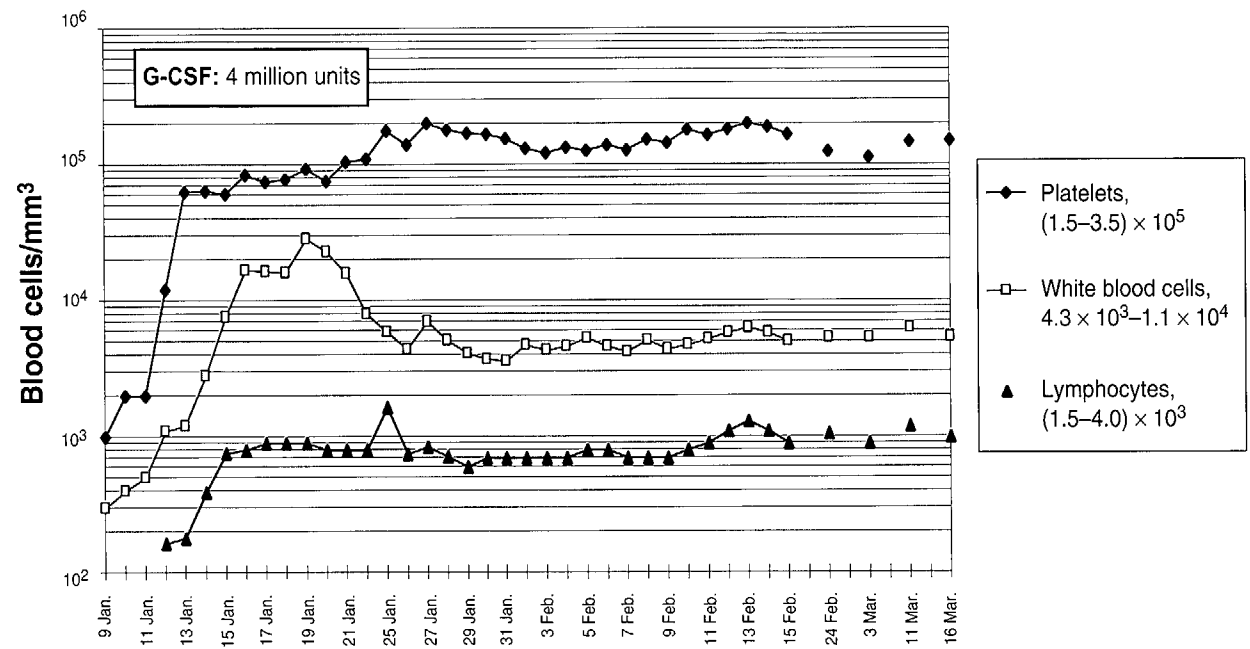
FIG. II-4. Haematological chart of patient 5 II, hospitalized from 9 January to 24 February 1999.

week of treatment, marked improvements were observed in the haematological parameters of all ARS patients. The white blood cell counts in most of the patients became normal within a few days. However, the lymphocyte levels remained just below the normal range for a long time. The platelet levels reached the lower end of the normal range in two weeks, on average (see Figs II-3 and II-4 in Annex II). The haematological evolution and hence the treatment scheme for patients 1-5, those most severely exposed, were very similar (see Figs II-3 and II-4 and Table II-V in Annex II).
