SERI
GRAND GULF NUCLEAR STATION SITE
EARLY SITE PERMIT APPLICATION
ENVIRONMENTAL REPORT

PLANT SITE
WELL PLAN
(UFSAR FIGURE 2.4-35c)

FIGURE 2.3-25

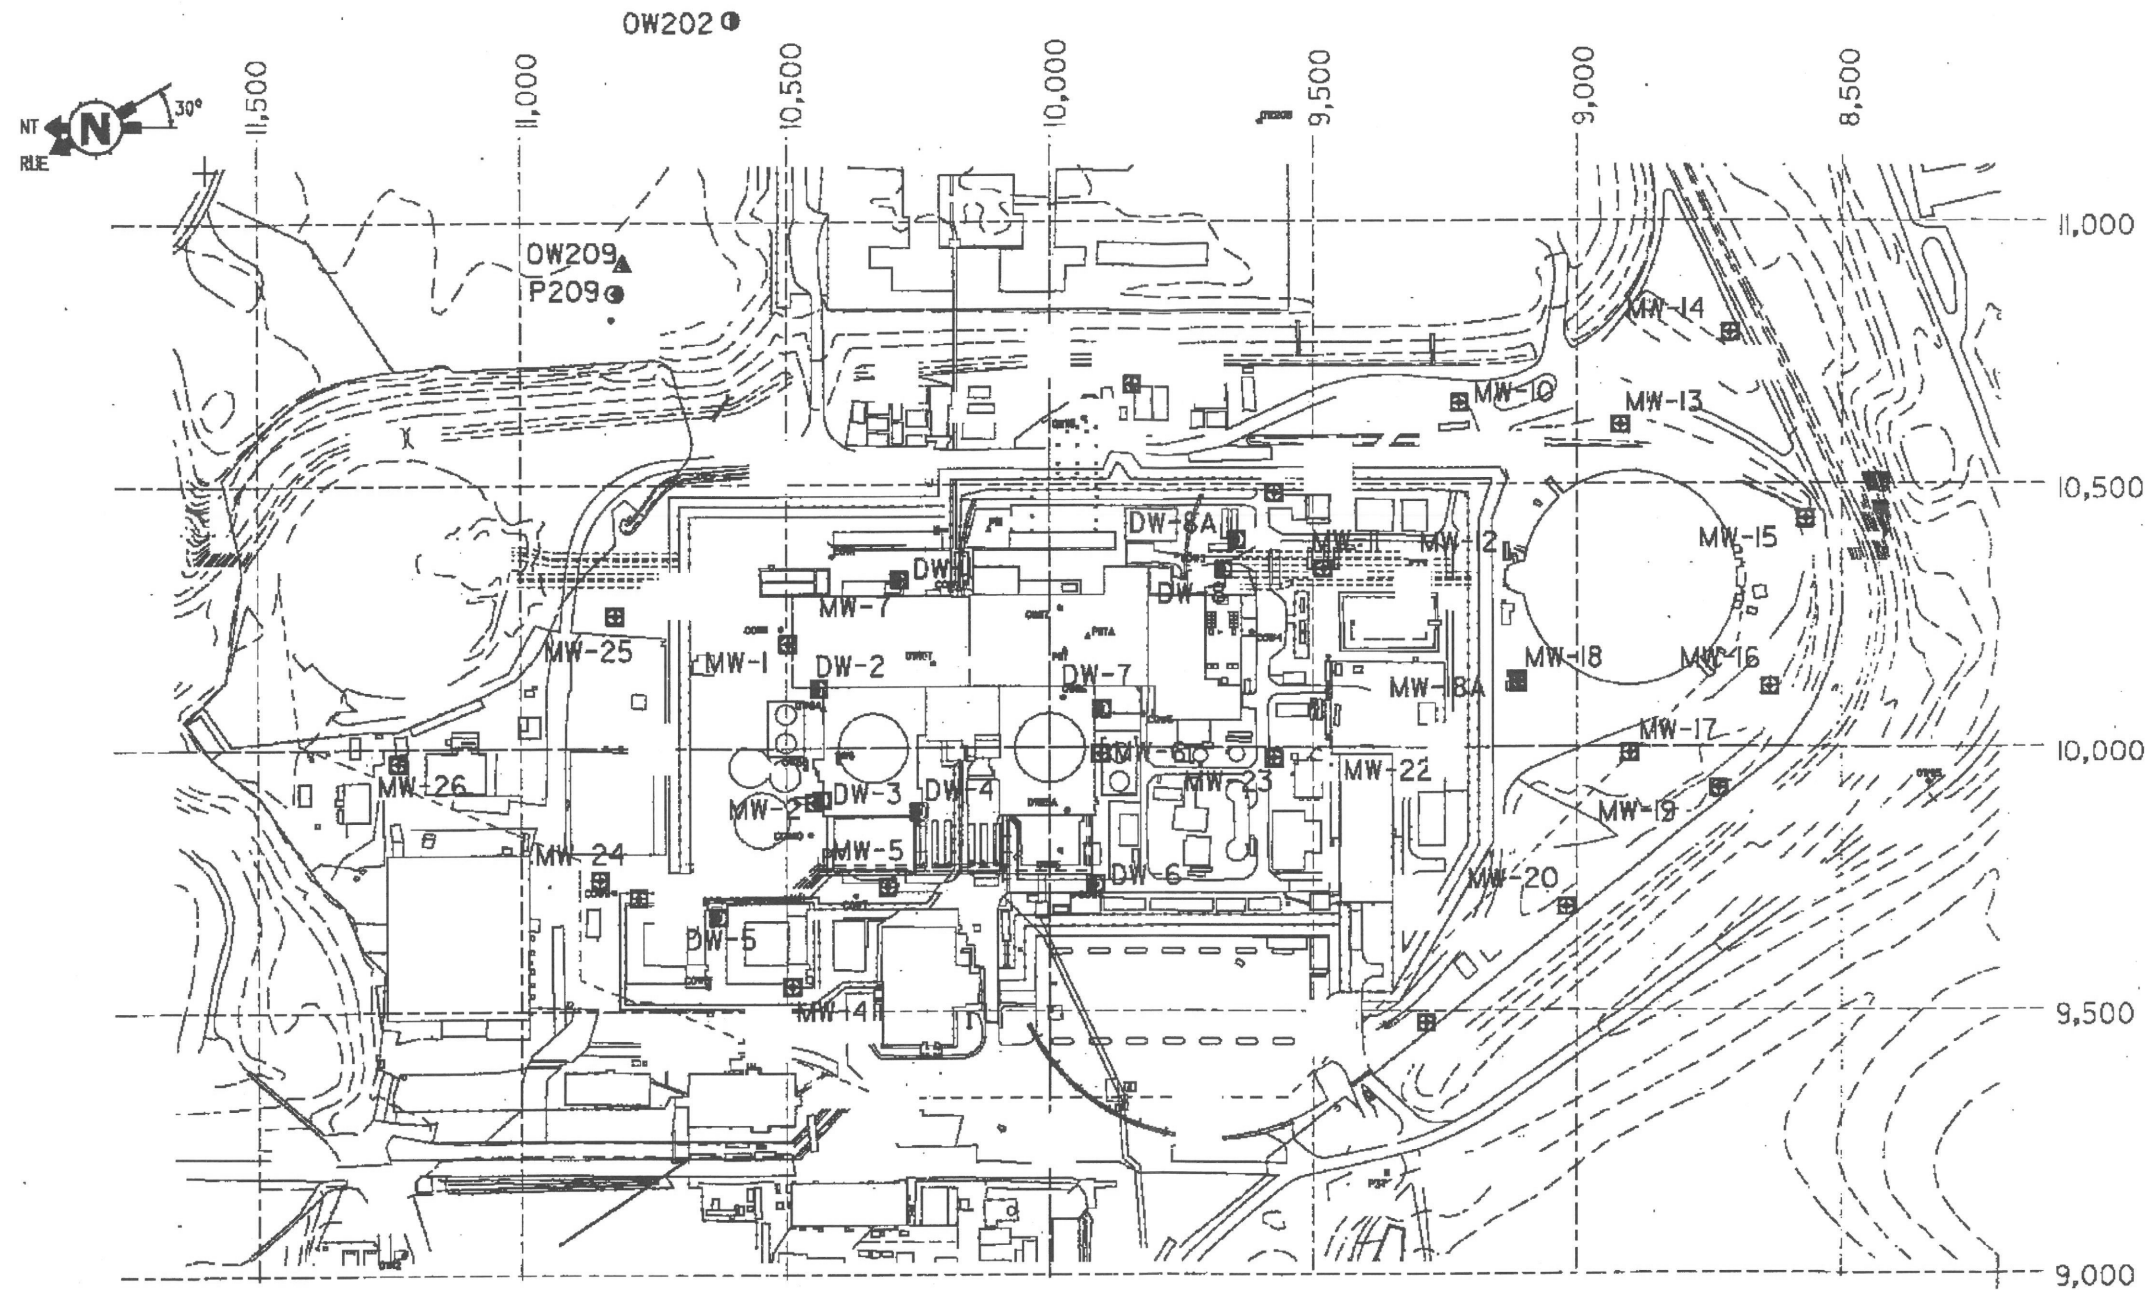
- ▲ HISTORICAL MONITORING WELL - CATAHOULA FORMATION
- HISTORICAL MONITORING WELL - TERRACE DEPOSITS
- ⊠ MONITORING WELL
- DEWATERING WELL
- TIE-BACK WALL PROJECTION

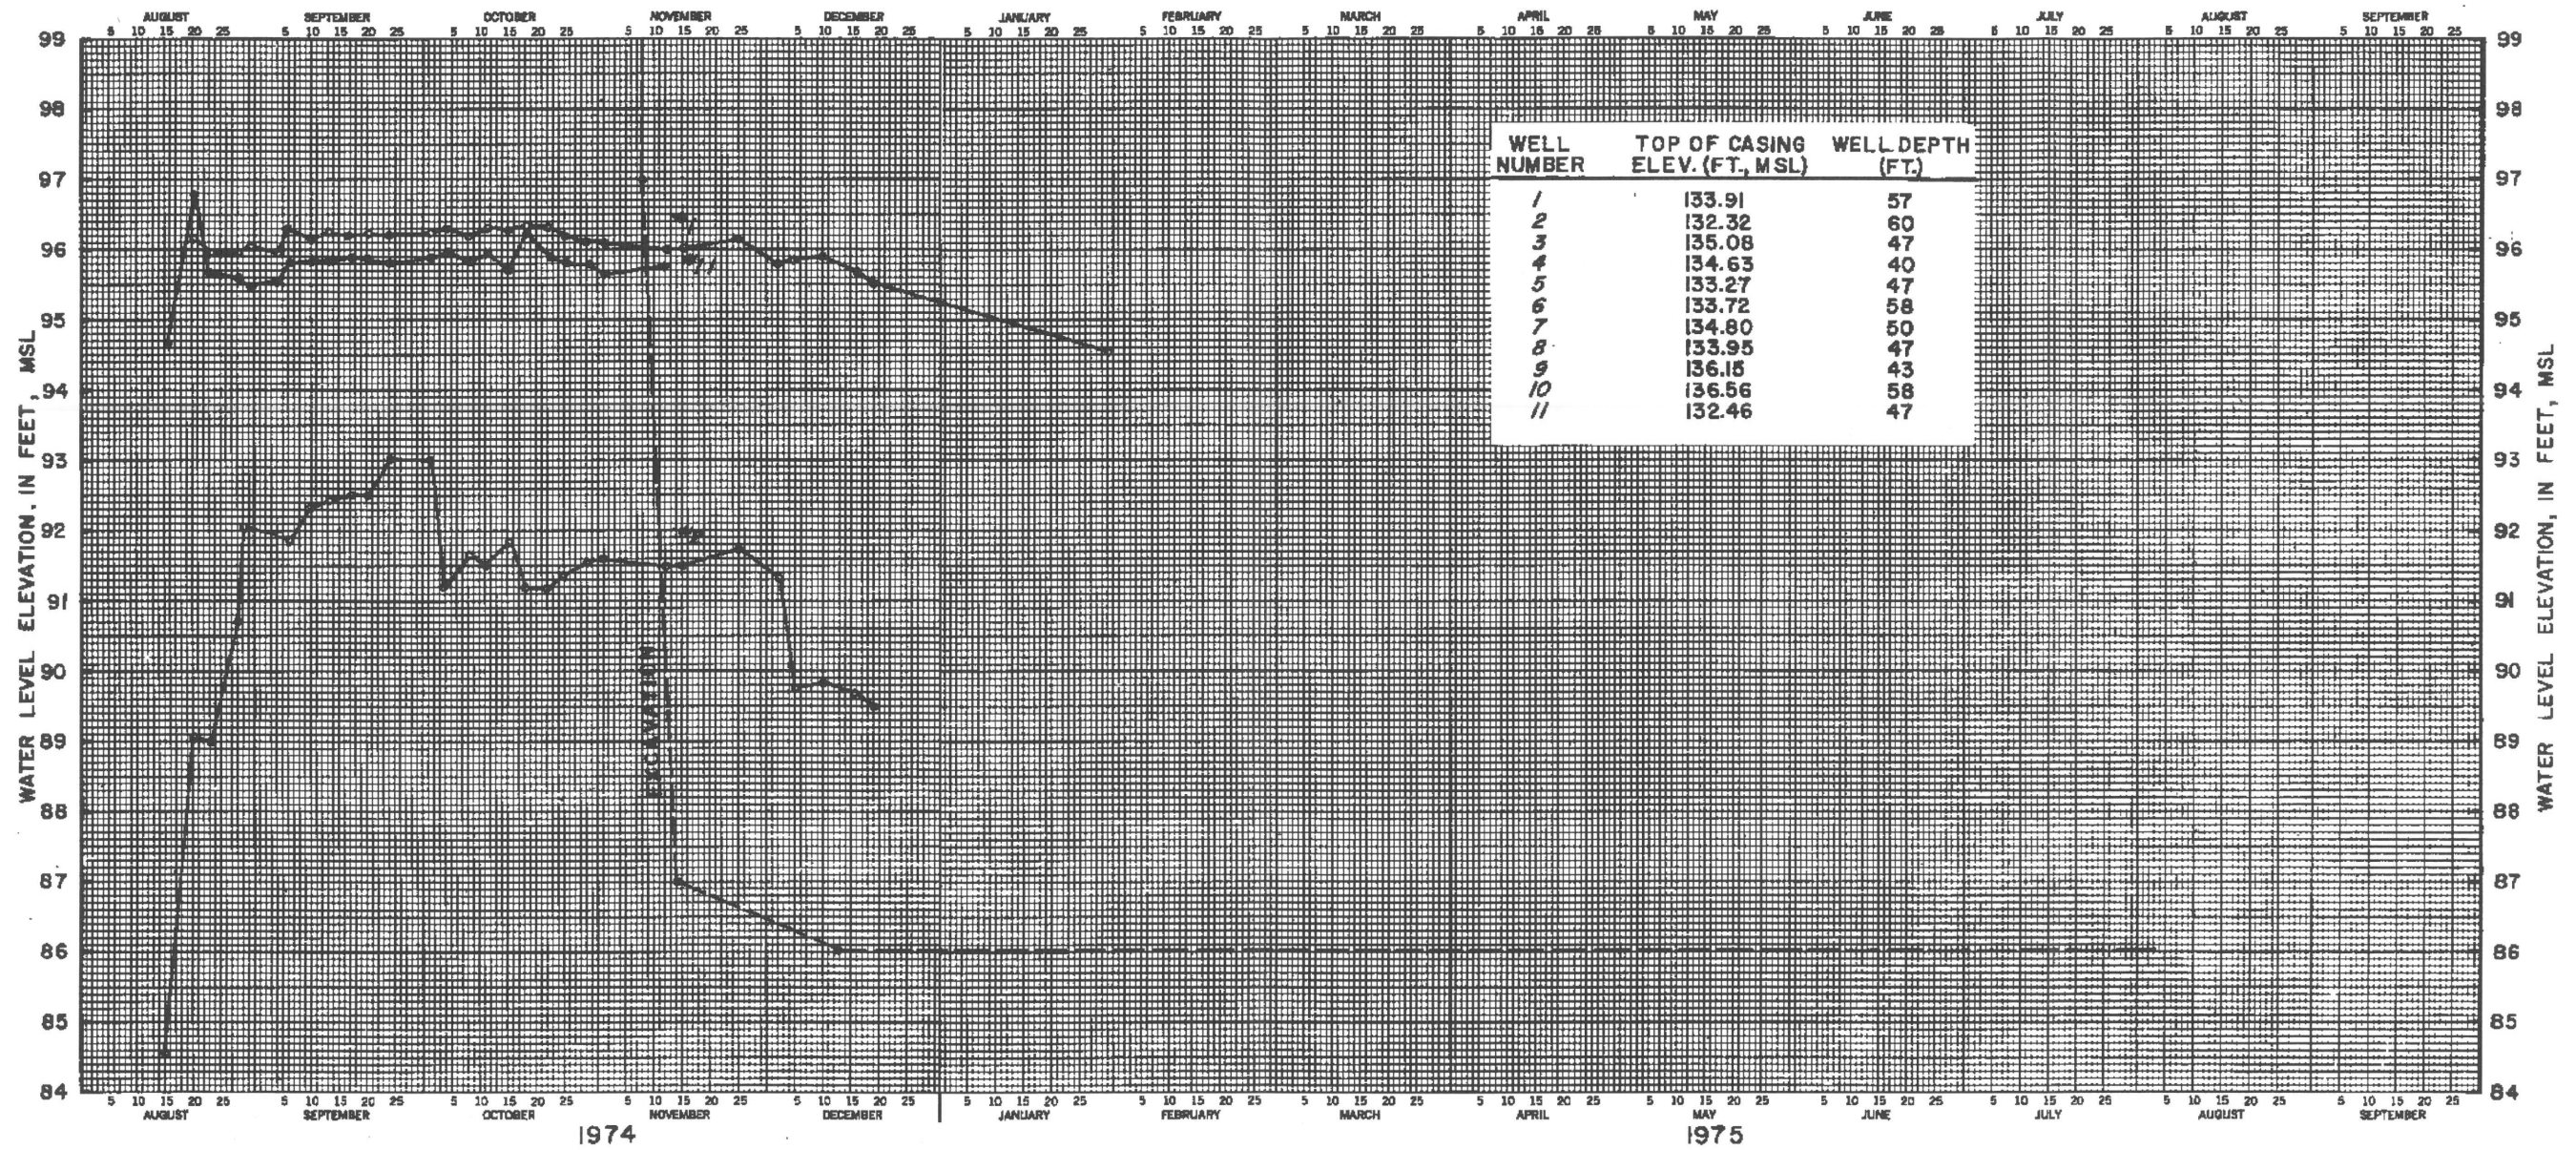
HYDROGRAPHS OF
 CONSTRUCTION OBSERVATION WELLS
 (UFSAR FIGURE 2.4-36, SH.1)

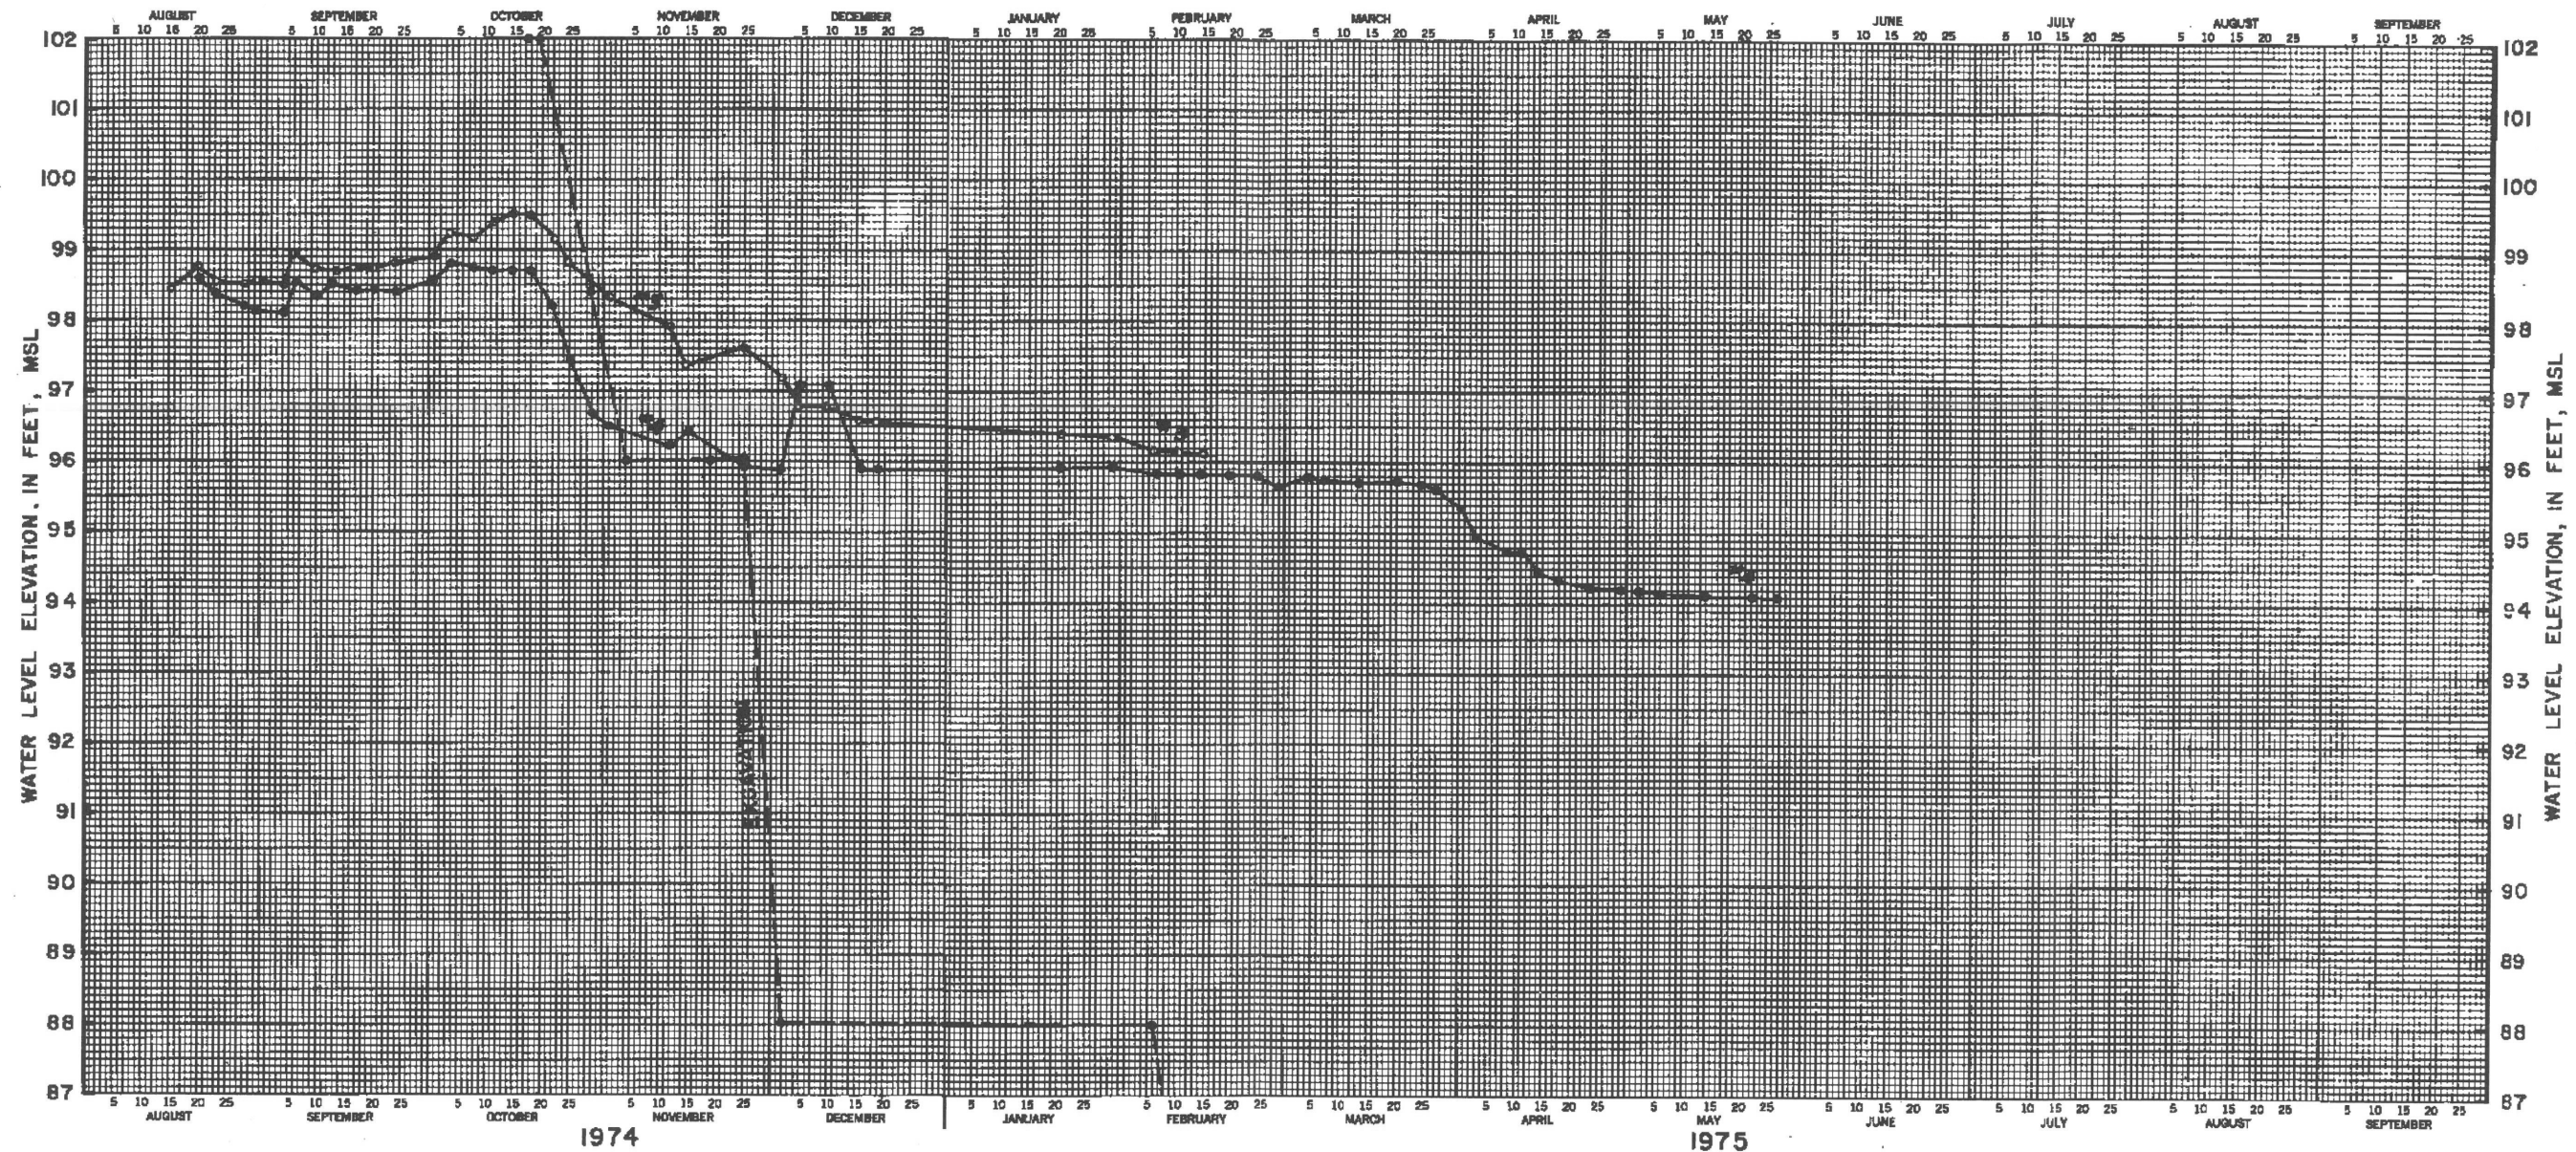
FIGURE 2.3-26 SHEET 2 OF 5 REV. 1

HYDROGRAPHS OF
 CONSTRUCTION OBSERVATION WELLS
 (UFSAR FIGURE 2.4-36, SH.2)

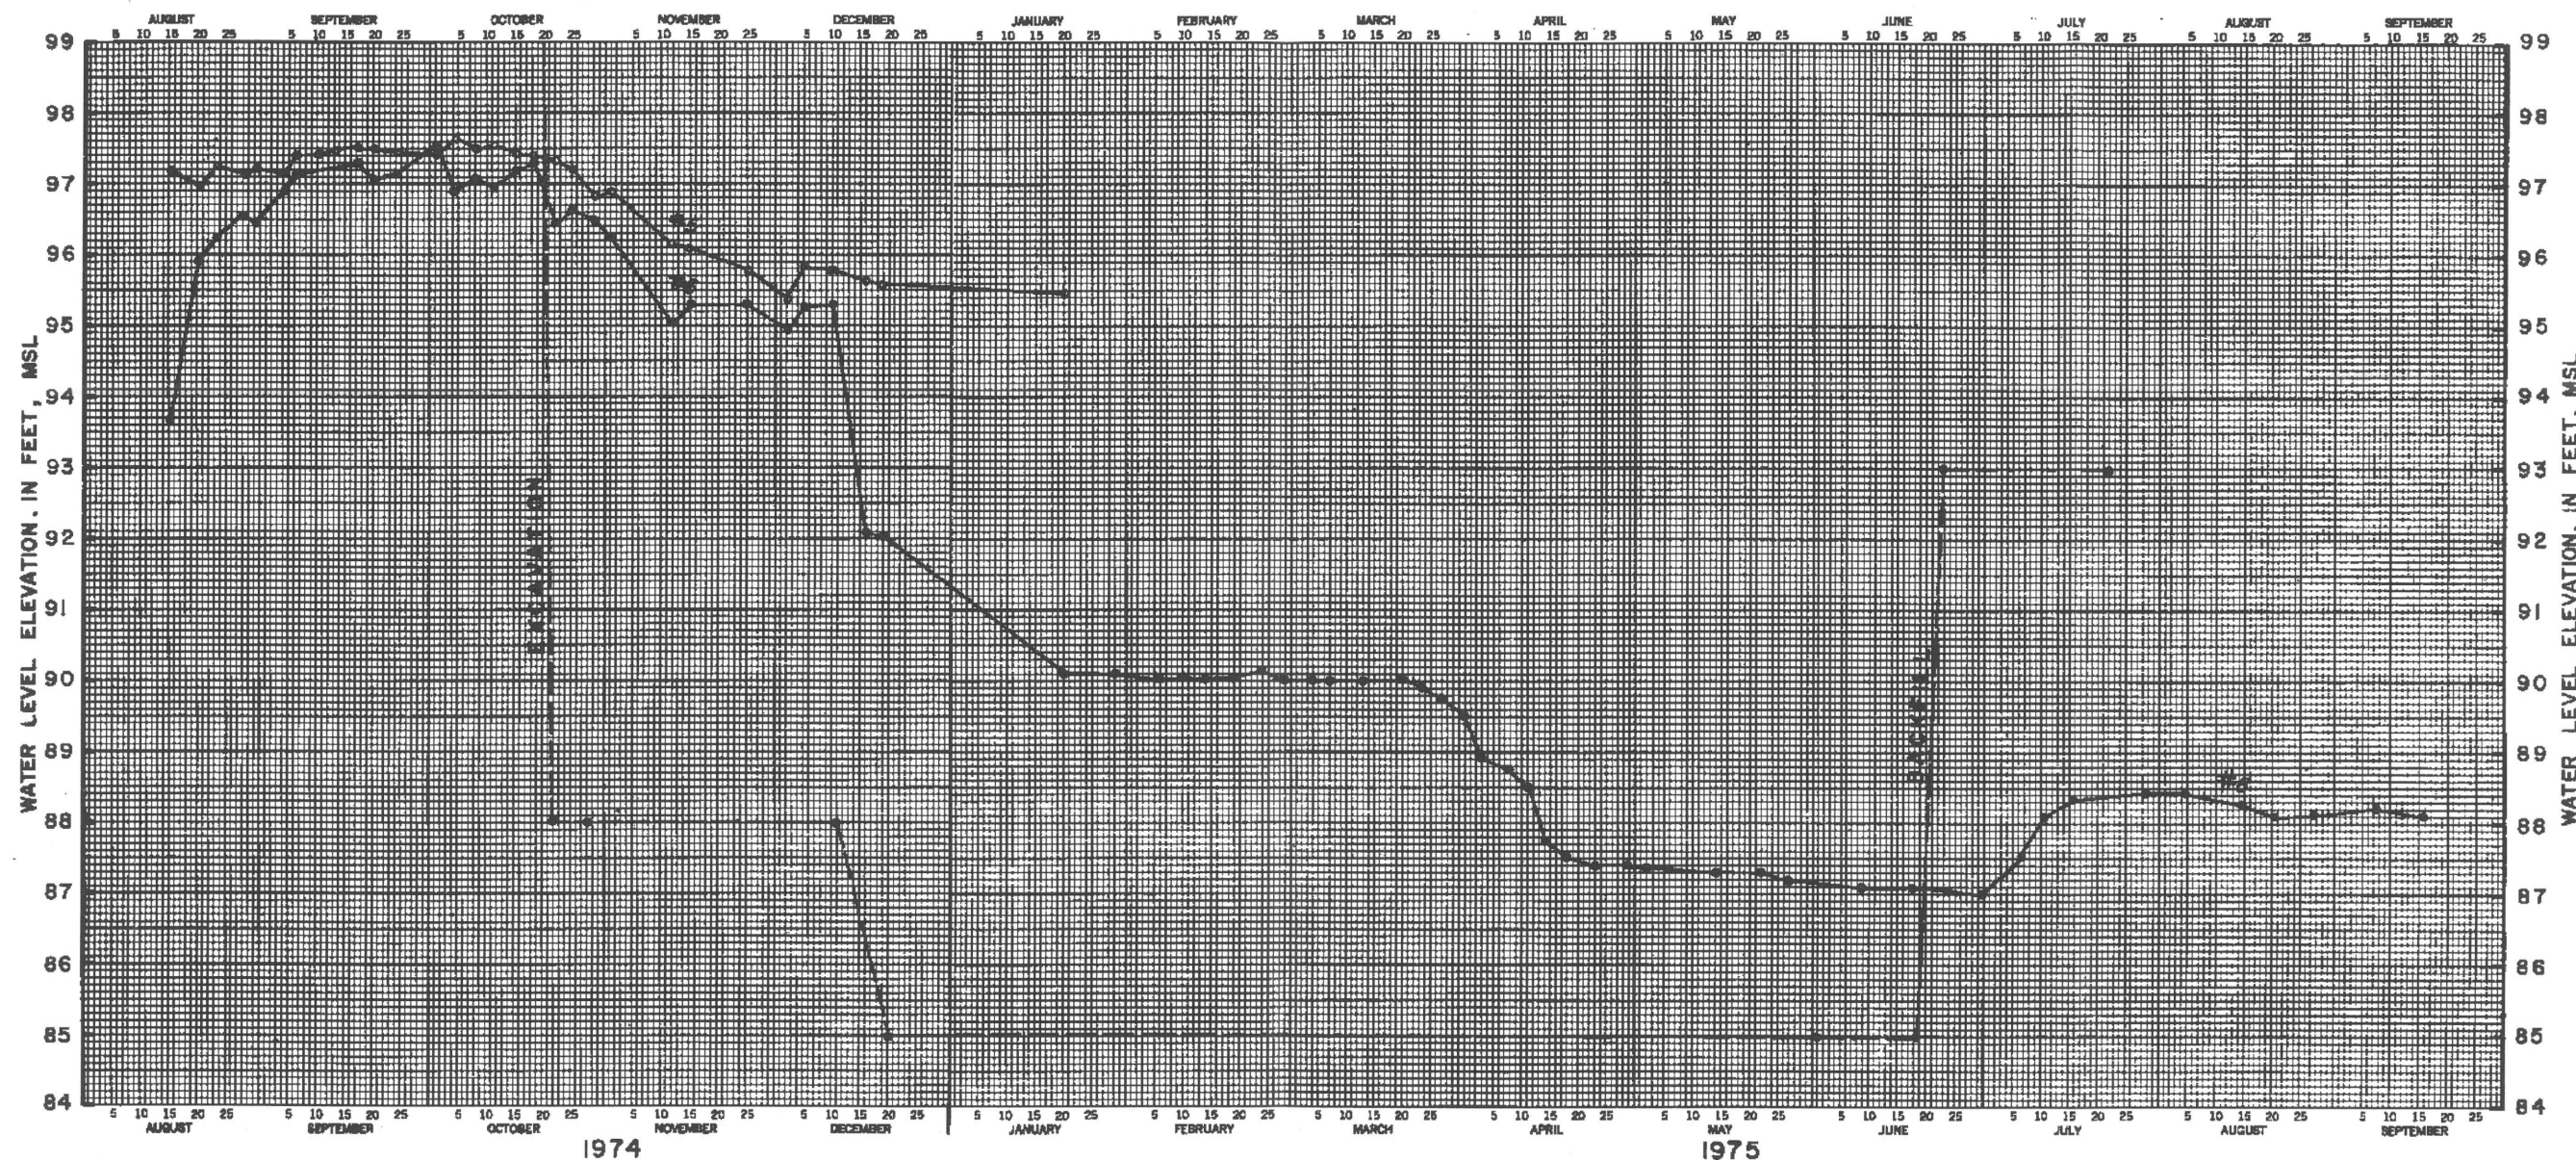
HYDROGRAPHS OF
 CONSTRUCTION OBSERVATION WELLS
 (UFSAR FIGURE 2.4-36, SH.3)

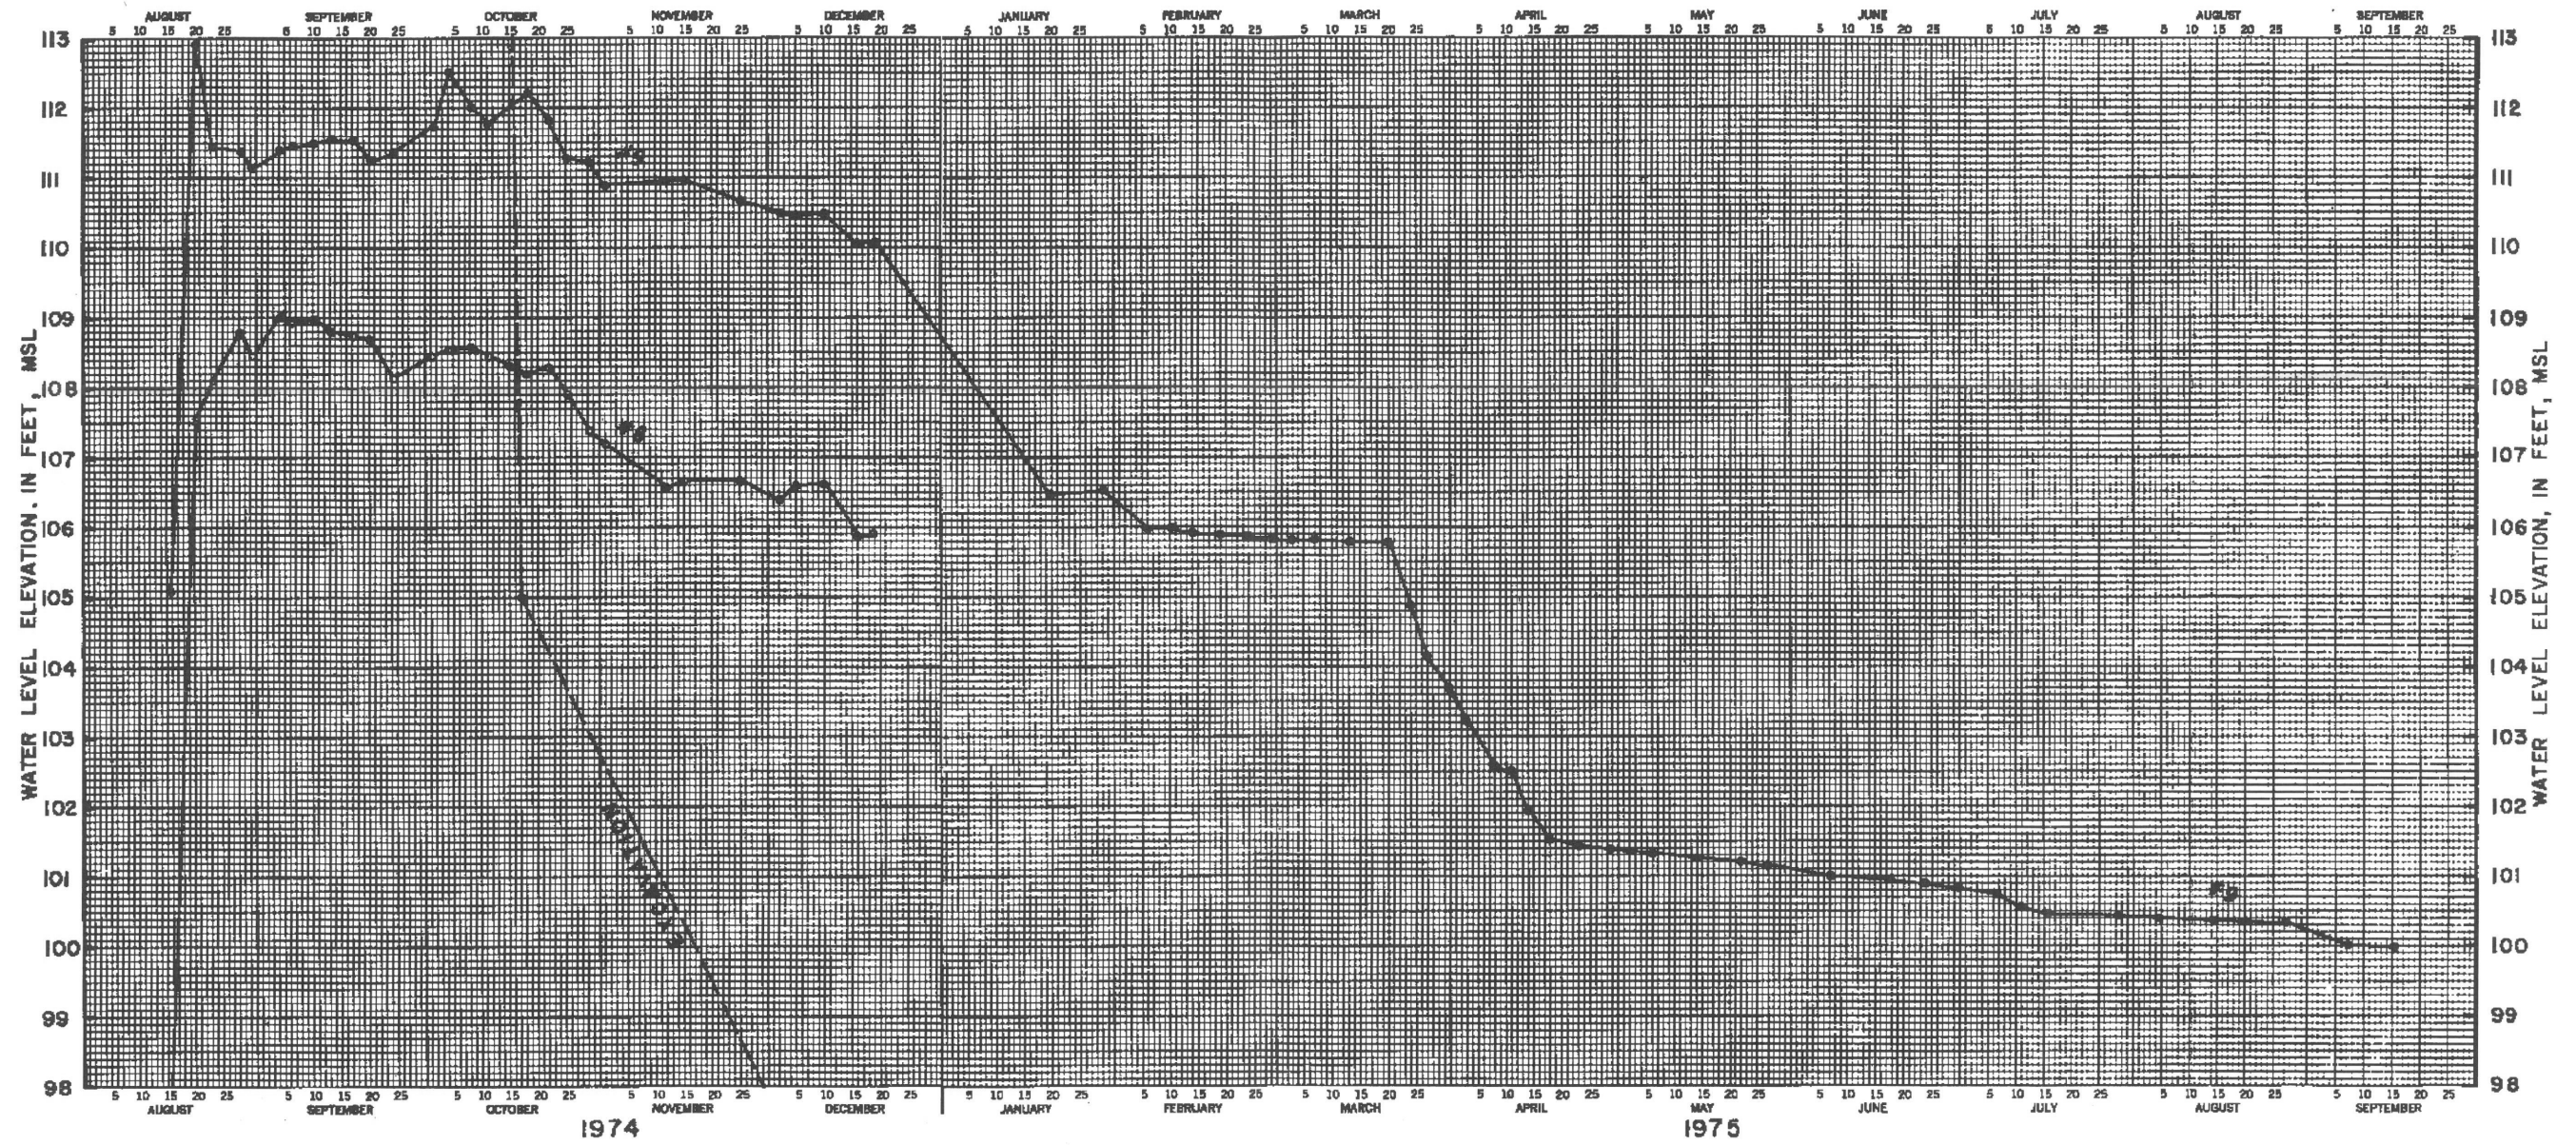
HYDROGRAPHS OF
 CONSTRUCTION OBSERVATION WELLS
 (UFSAR FIGURE 2.4-36, SH.4)

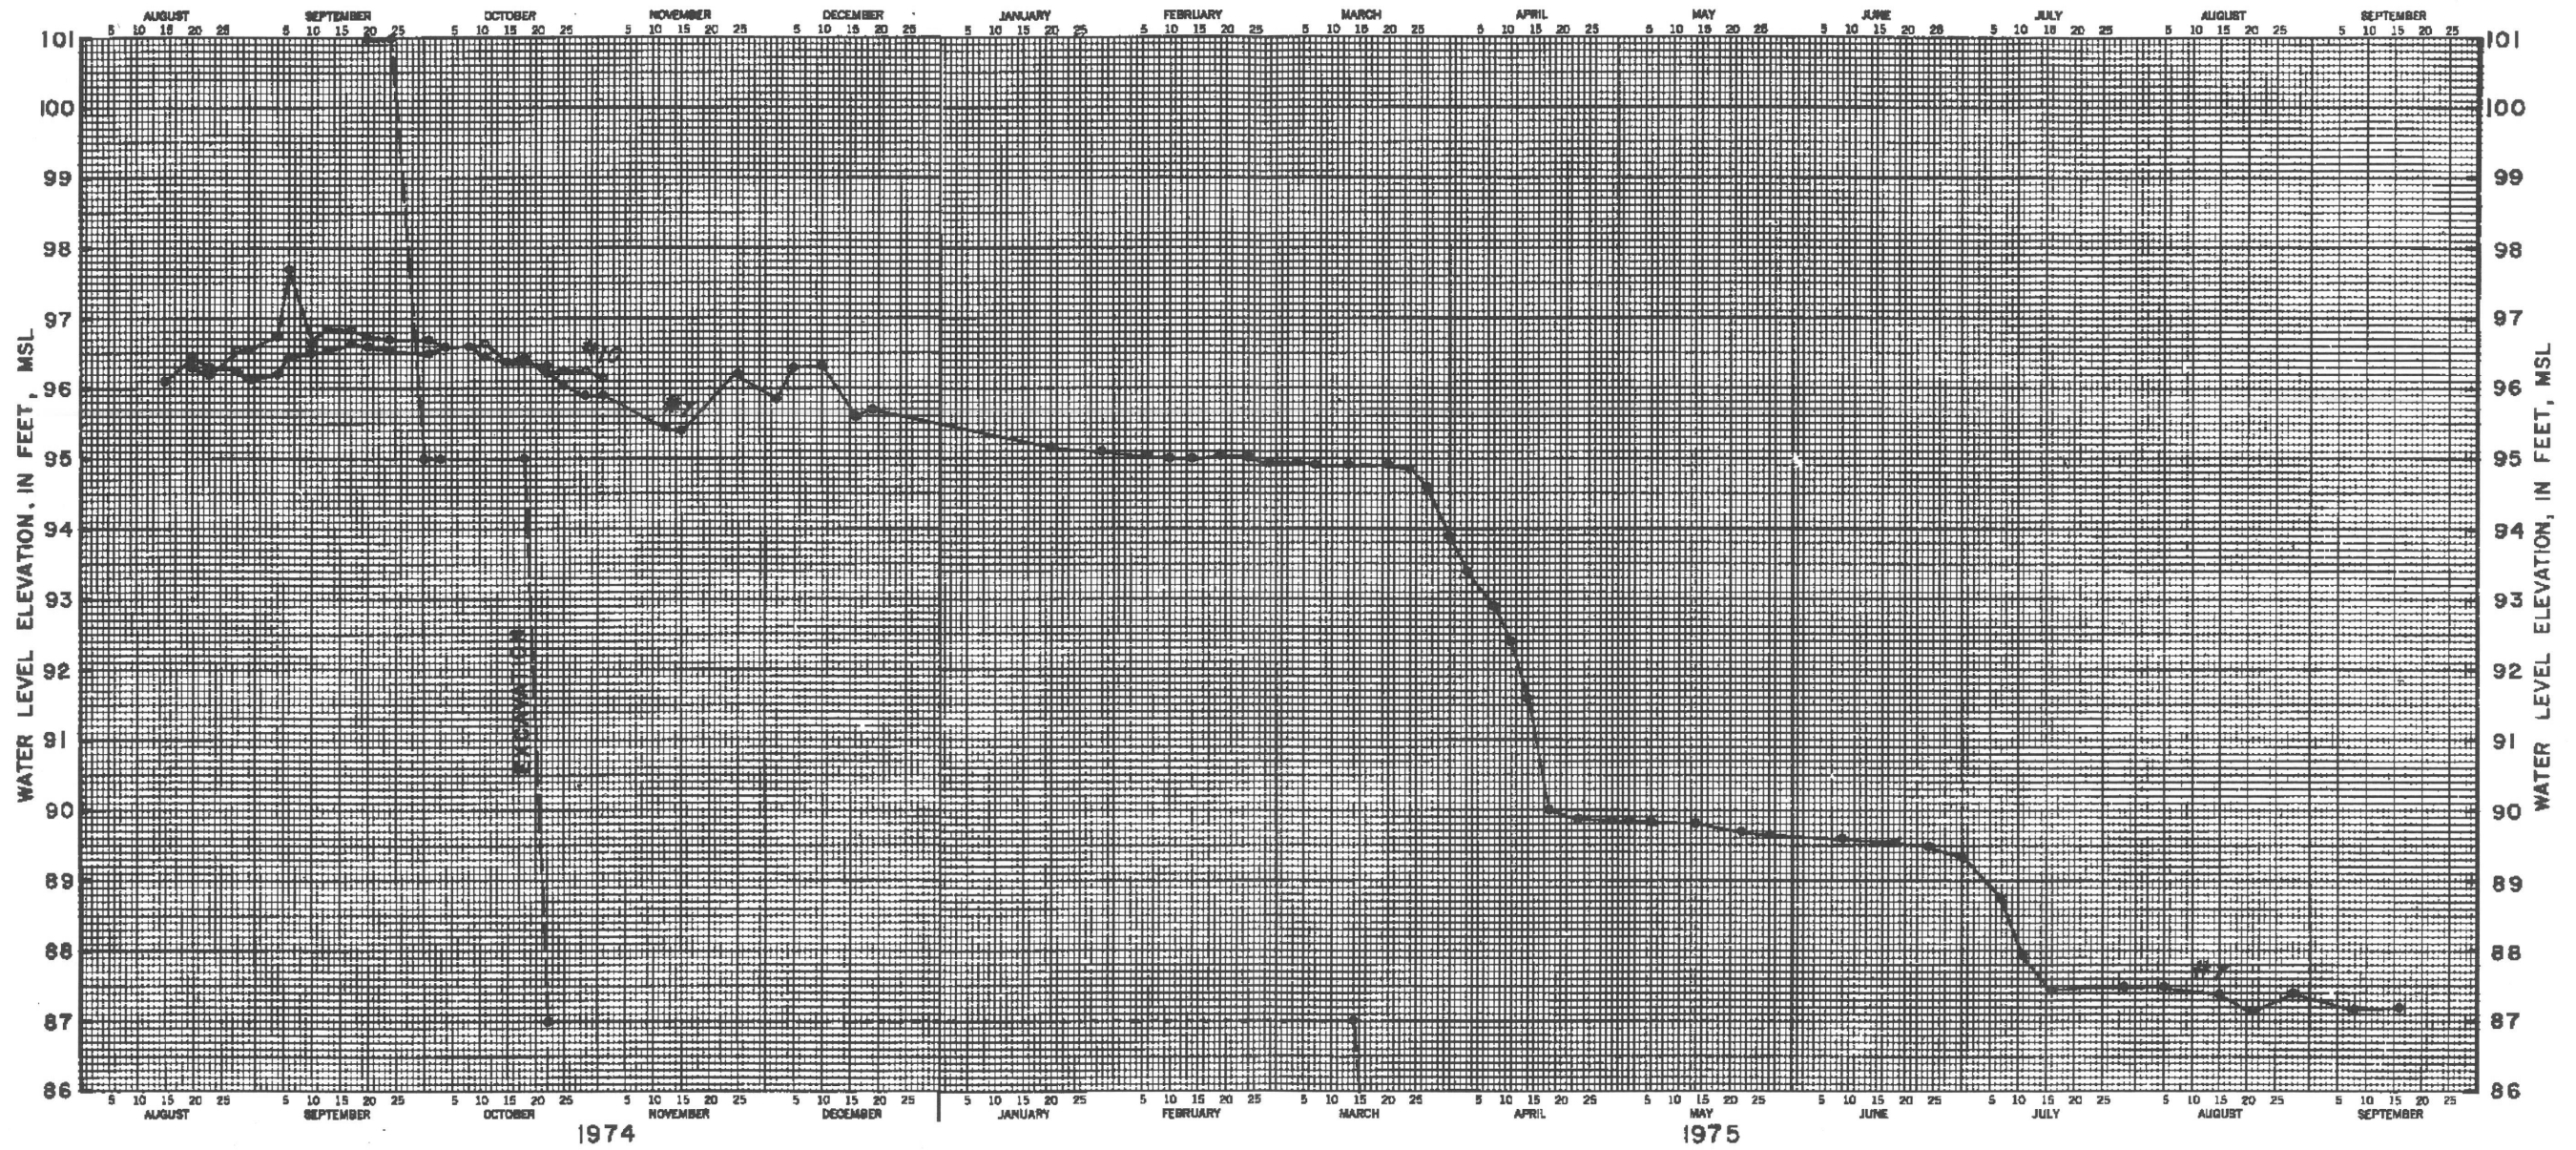
FIGURE 2.3-26 SHEET 5 OF 5 REV. 1

HYDROGRAPHS OF
 CONSTRUCTION OBSERVATION WELLS
 (UFSAR FIGURE 2.4-36, SH.5)

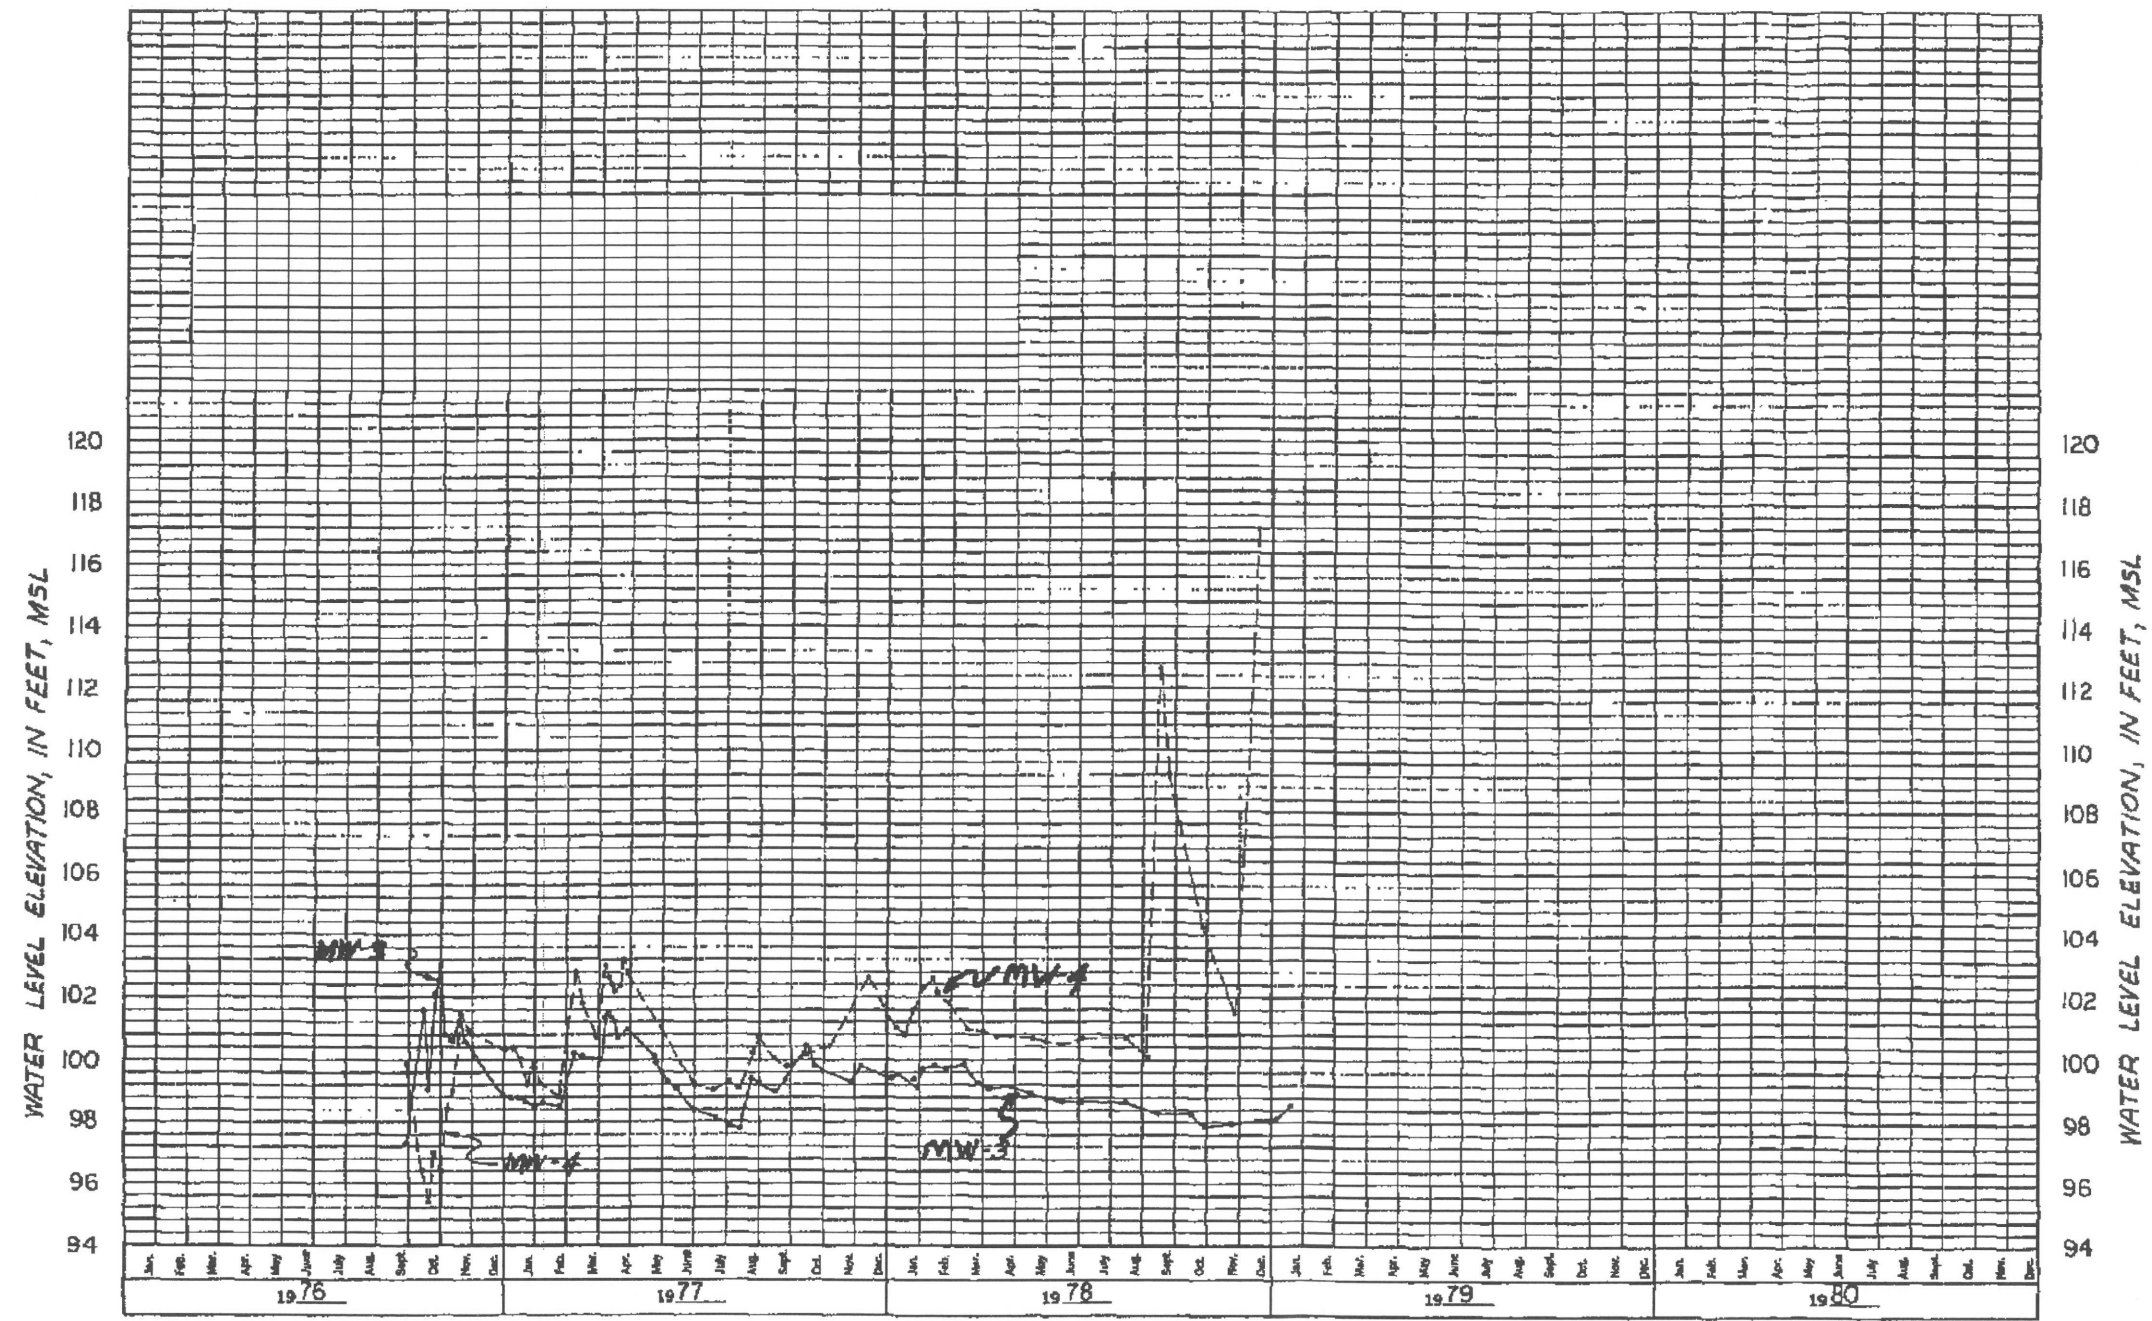
FIGURE 2.3-27 SHEET 1 OF 2 REV. 1

- NOTES:
1. OBSERVATION WELLS MW-1 AND MW-2 WERE DRY FROM SEPT., 1976 TO JAN., 1979.
 2. OBSERVATION WELL LOCATIONS SHOWN ON FIGURE 2.3-25 (UFSAR FIGURE 2.4-35c).
 3. TEMPORARY SITE DRAINAGE CAUSES RECHARGE INTO FILL NEAR MW-4. AREA TO BE REGRADED NEAR MW-4 FEB., 1979.

HYDROGRAPHS OF REPLACEMENT
 OBSERVATION WELLS
 MW-3 AND MW-4
 (UFSAR FIGURE 2.4-36a, SH.1)

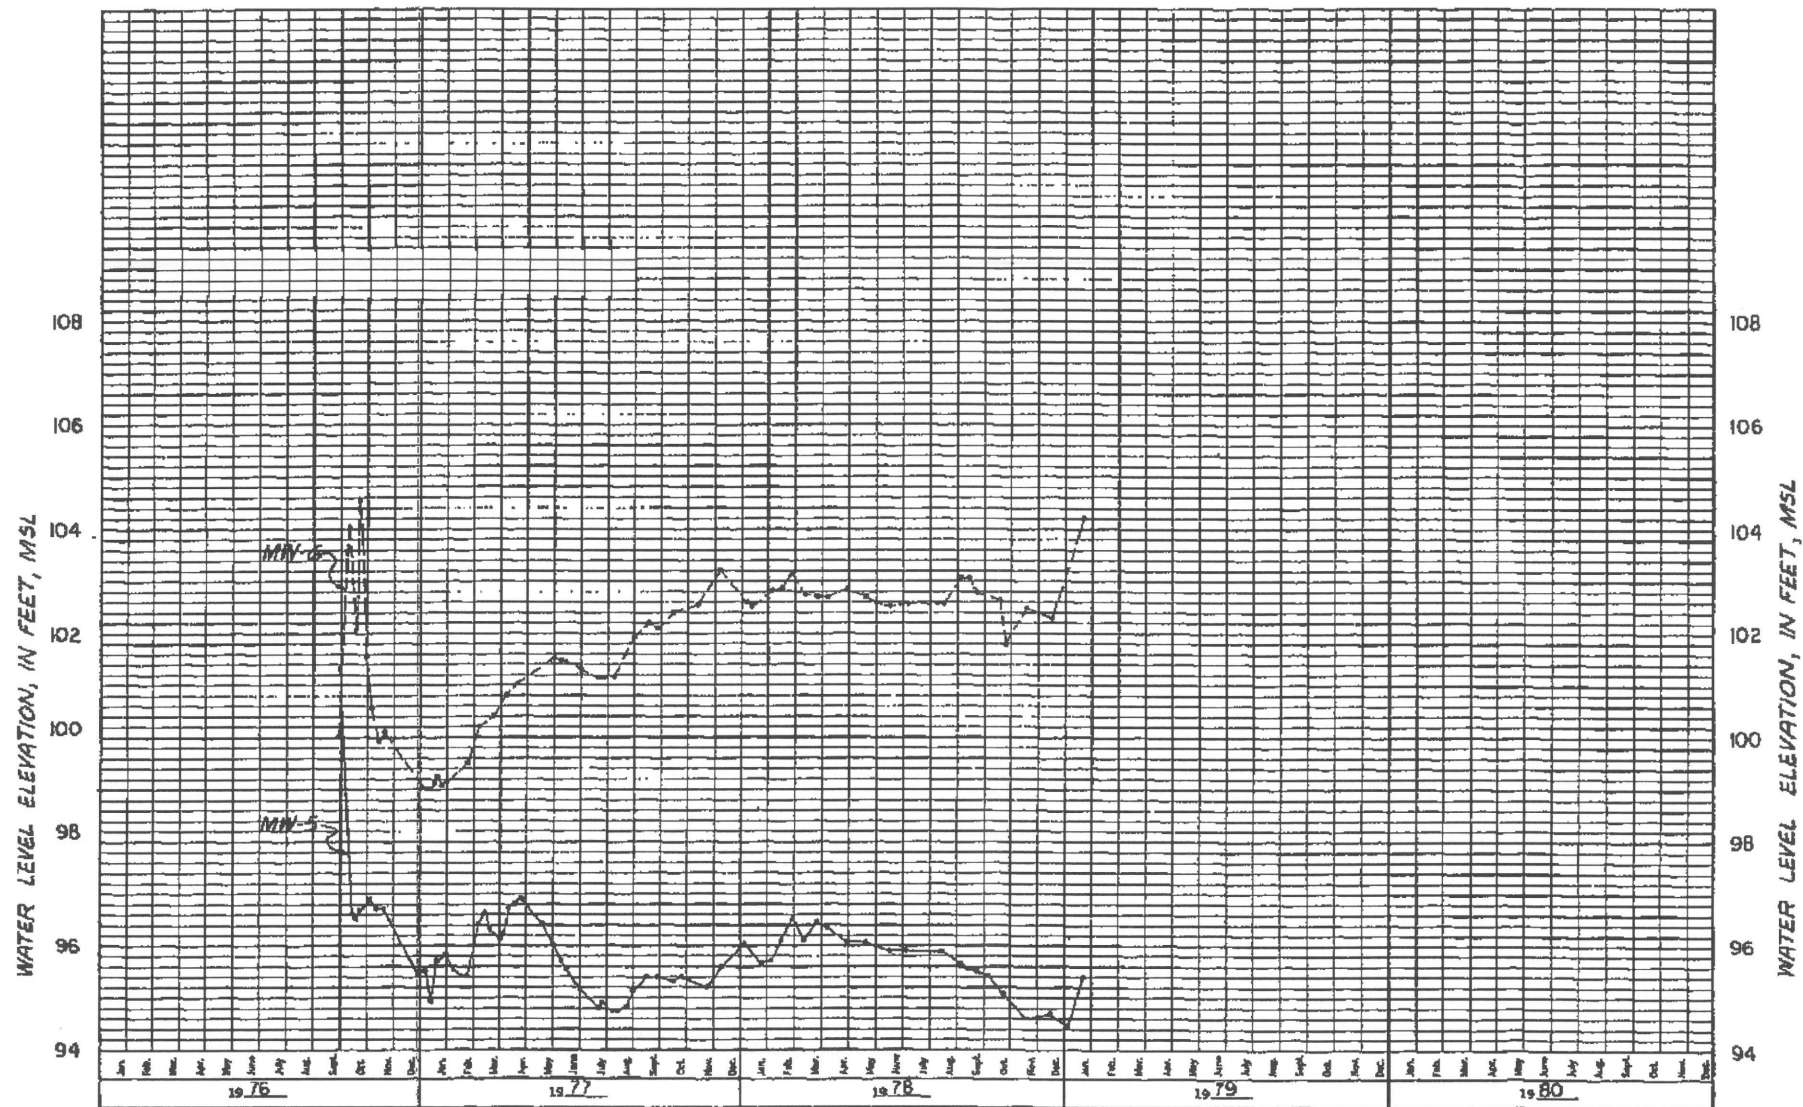
FIGURE 2.3-27 SHEET 2 OF 2 REV. 1

NOTES:
 1. OBSERVATION WELL LOCATIONS SHOWN
 ON FIGURE 2.3-25 (UFSAR FIGURE 2.4-35c).

HYDROGRAPHS OF REPLACEMENT
 OBSERVATION WELLS
 MW-5 AND MW-6
 (UFSAR FIGURE 2.4-36a, SH.2)
