SERI
GRAND GULF NUCLEAR STATION SITE
EARLY SITE PERMIT APPLICATION
ENVIRONMENTAL REPORT

PLANT SITE
WELL PLAN
(UFSAR FIGURE 2.4-35c)

FIGURE 2.3-25

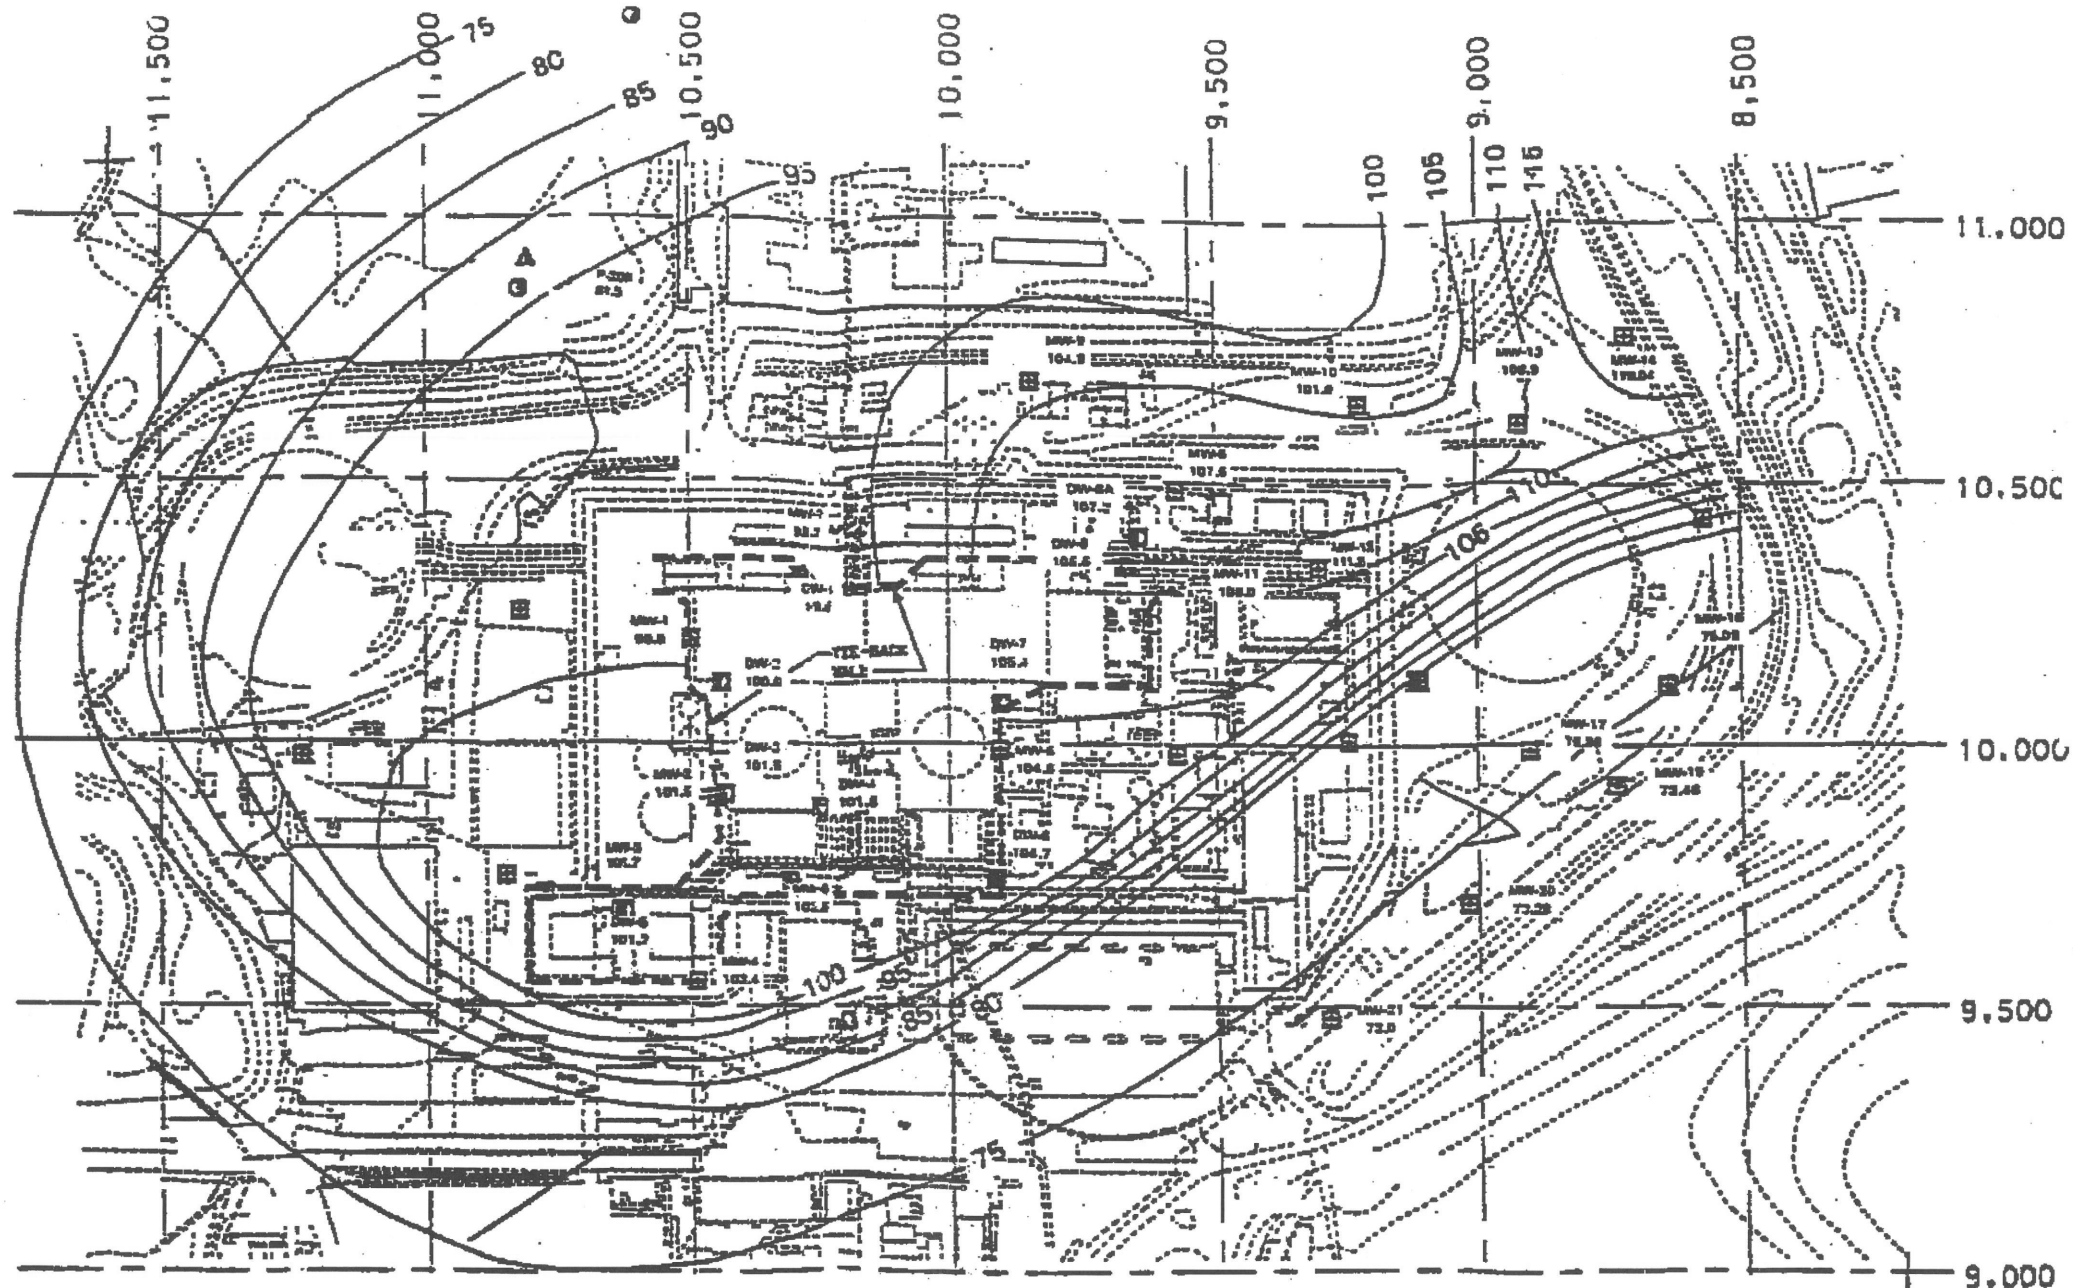
FIGURE 2.3-28

MW-1
101.6
Ground water dewatering wells, monitoring wells, observation wells and estimated average post-construction ground water
-

MW-2
101.7
elevations based on measurements taken on 11/08/90
-

MW-20
78.8
Ground water elevation contour, contour interval is 5 feet
-

AVERAGE
POST-CONSTRUCTION
GROUND WATER ELEVATIONS
(UFSAR FIGURE 2.4-48)

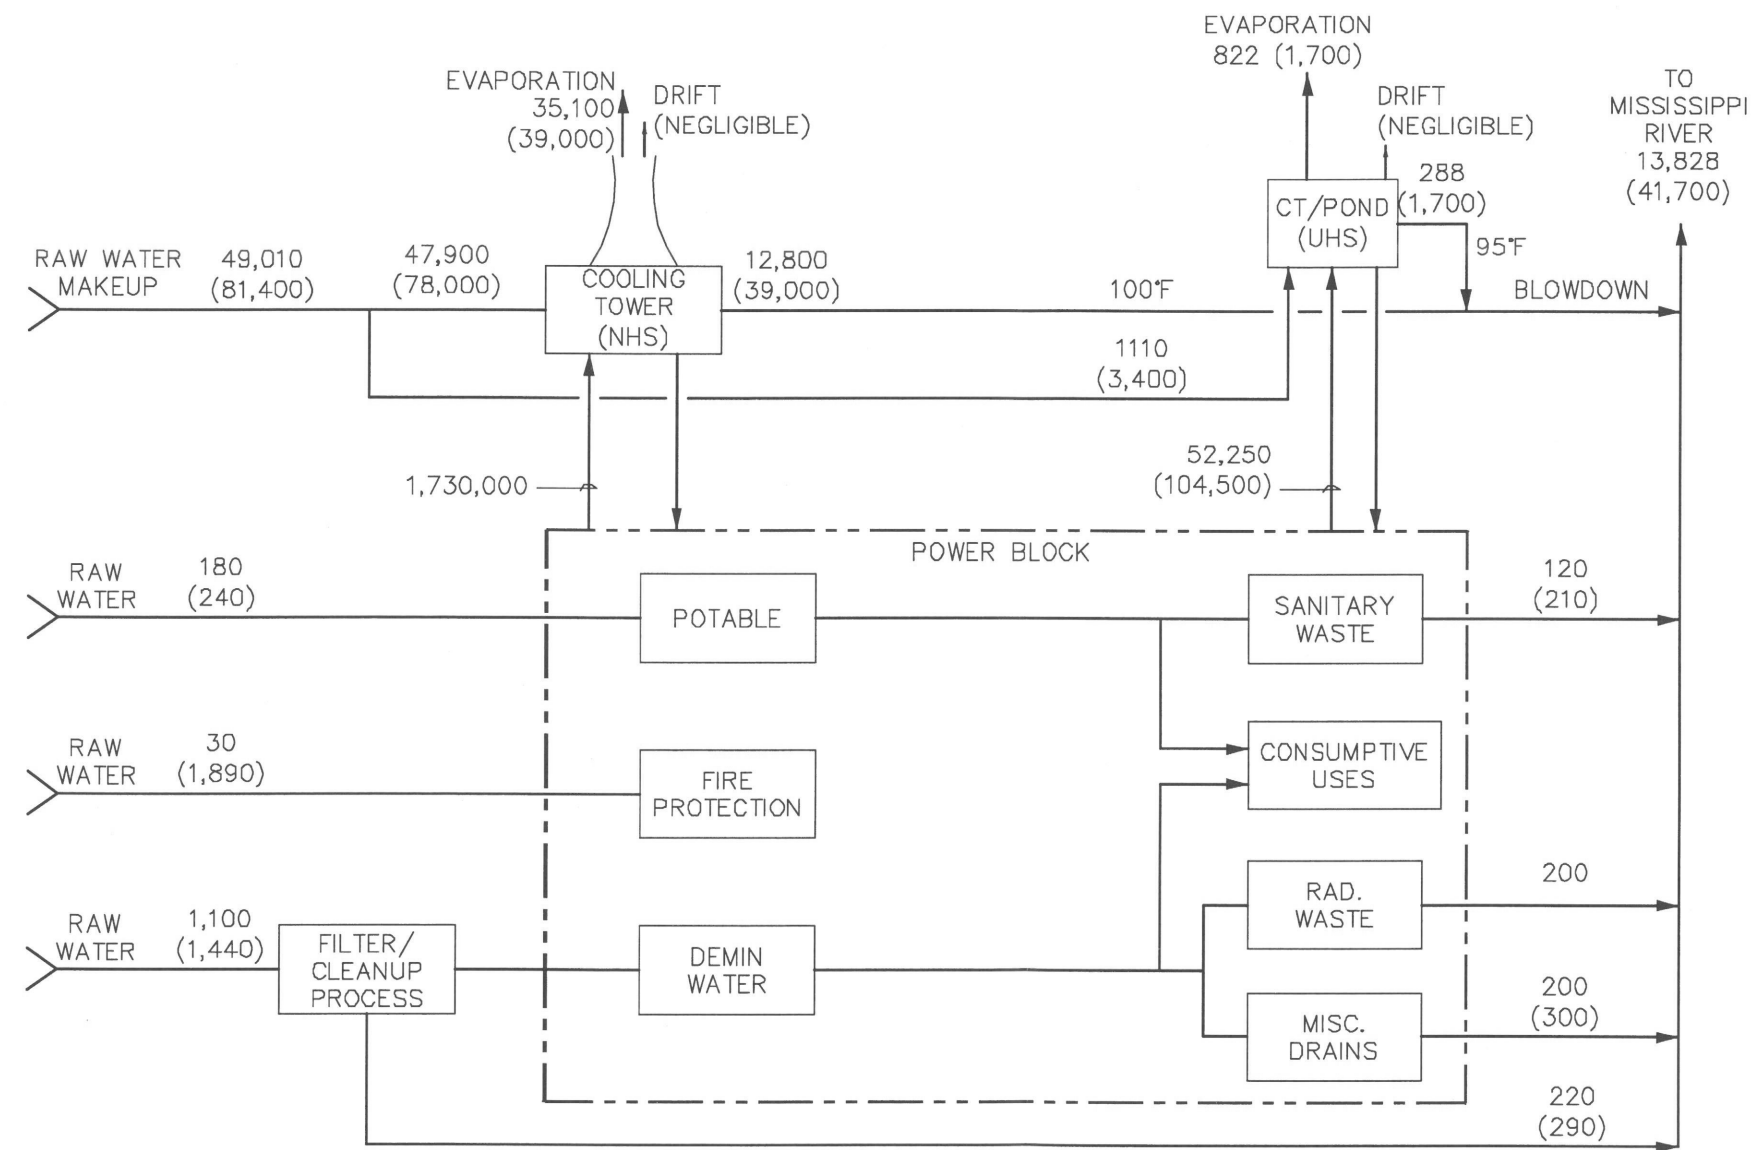
1. FLOW RATE VALUES SHOWN ARE EXPECTED OR MONTHLY AVERAGE. THE MAXIMUM VALUE IS SHOWN IN PARENTHESIS (). VALUES ARE IN GPM.

PLANT WATER USE DIAGRAM
