Subject: Docket No. 70-734; SNM-696: Request to Release a Certain Portion of General Atomics' Facility to Unrestricted Use and Delete it from License SNM-696: Namely, GA's "Section C of the Building 2 Service Corridor"

Building 2 is comprised of three arc-shaped sections which together form a "C"-shaped semi-circular building. The three sections are referred to as Sections A, B and C. Due to the large size and complexity of Building 2, the service corridor in each of the three sections is the subject of a separate release request. GA has previously requested the release of Sections A and B (References 1 and 2, respectively). This release request addresses the service corridor in **Section C**.

Figure 2A: GA's Building 2

Figure 2C: Section C of the Building 2 Service Corridor

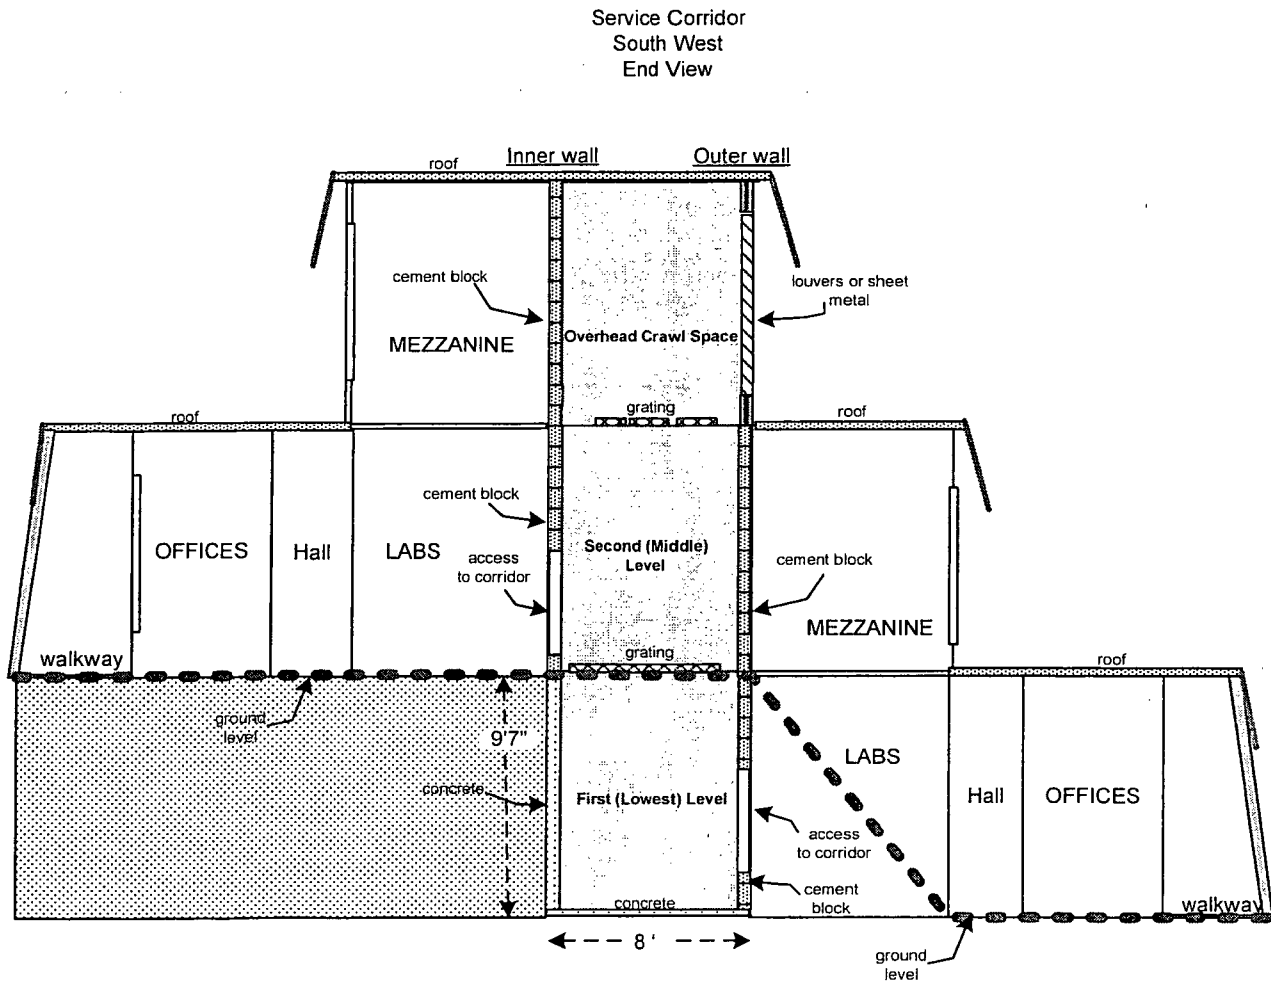
Figure 3: Building 2 End View

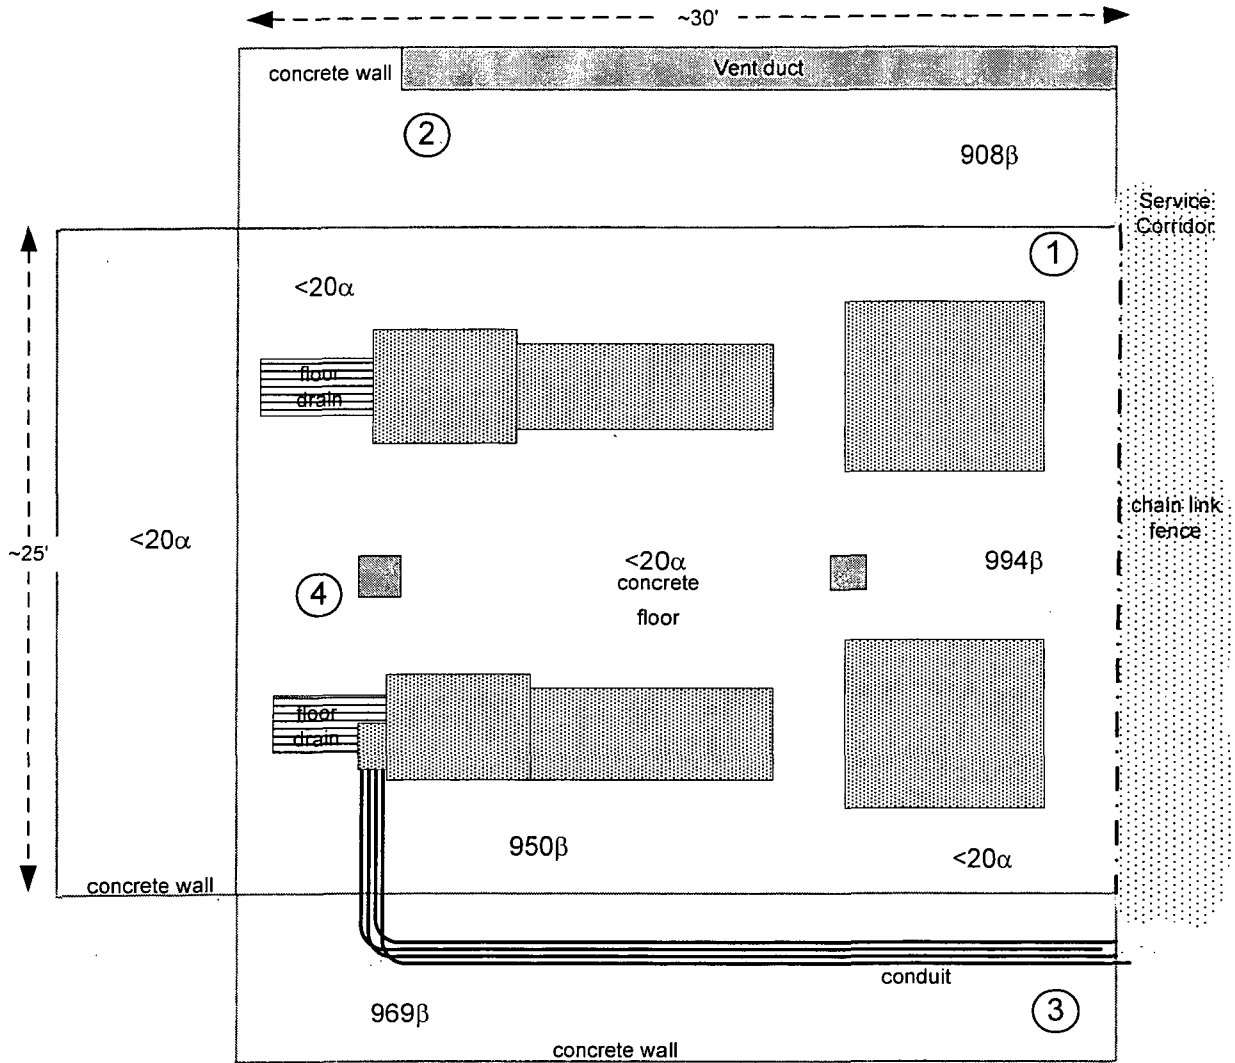
Figure 4: Building 2 Service Corridor Section C Electrical Room
 Alpha and Beta Fixed Measurement Locations and Results and Wipe Survey Locations

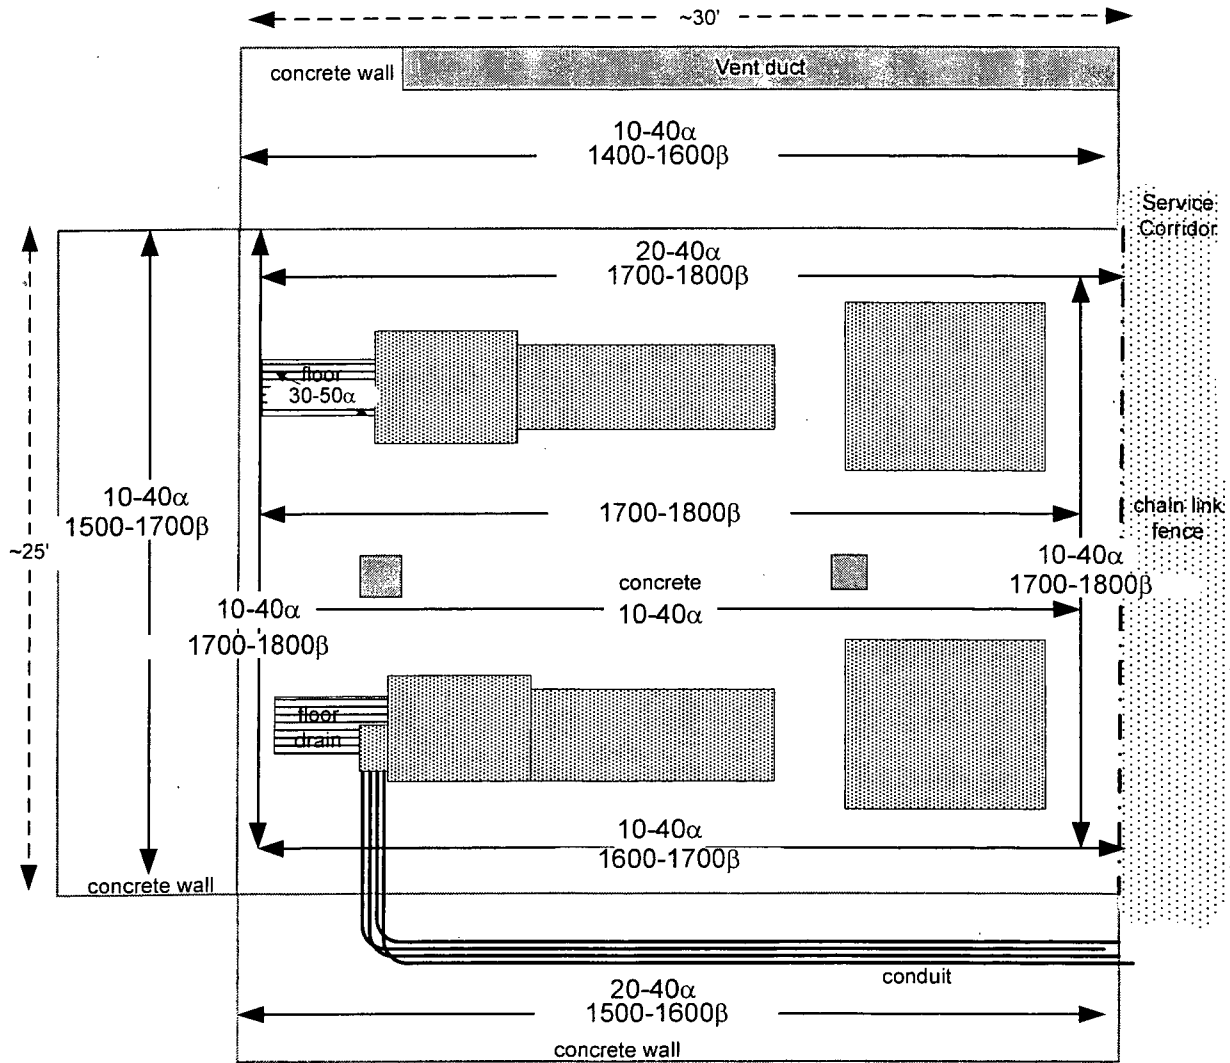
Figure 5: Building 2 Service Corridor Section C Electrical Room
Alpha and Beta Scan Measurement Locations and Results

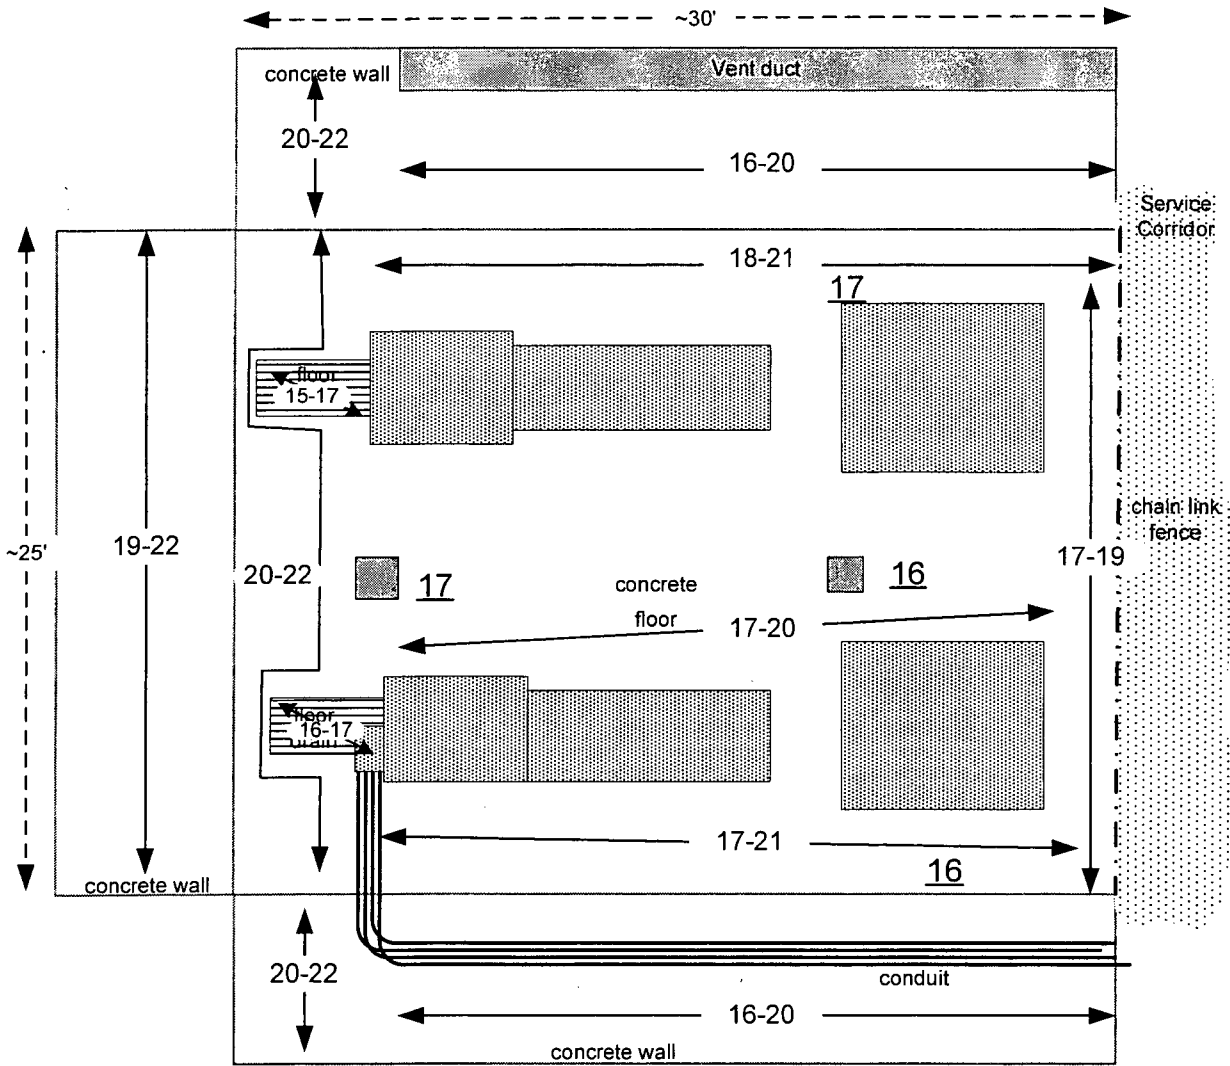
Figure 6: Building 2 Service Corridor Section C Electrical Room
 Fixed Exposure Rate and Exposure Rate Scan Measurement Locations and Results

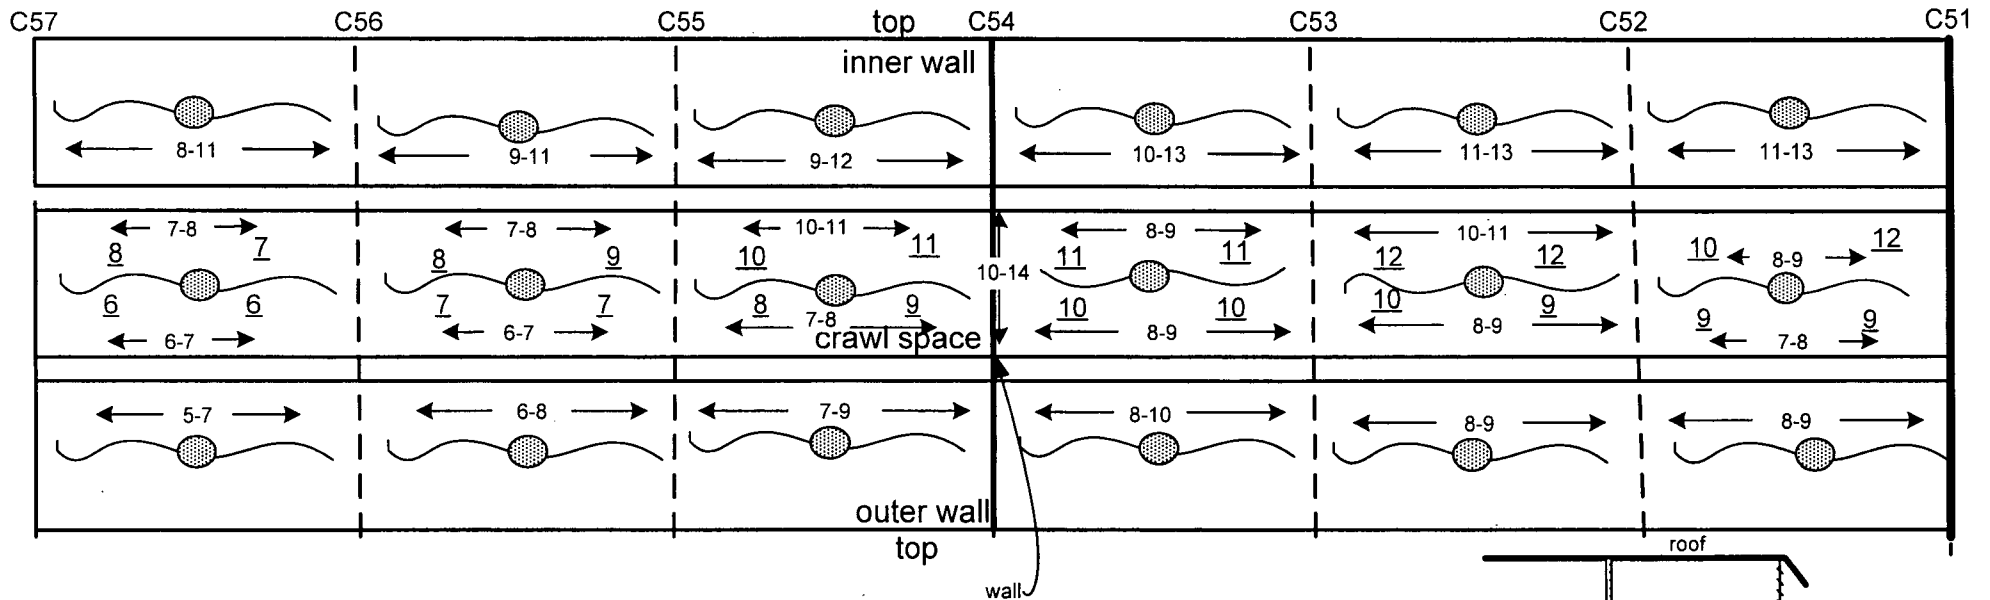
Figure 11: Building 2 Service Corridor Section C Overhead Crawl Space Column C51 to C57
 Fixed Exposure Rate and Exposure Rate Scan Measurement and Large Area Wipe Locations and Results

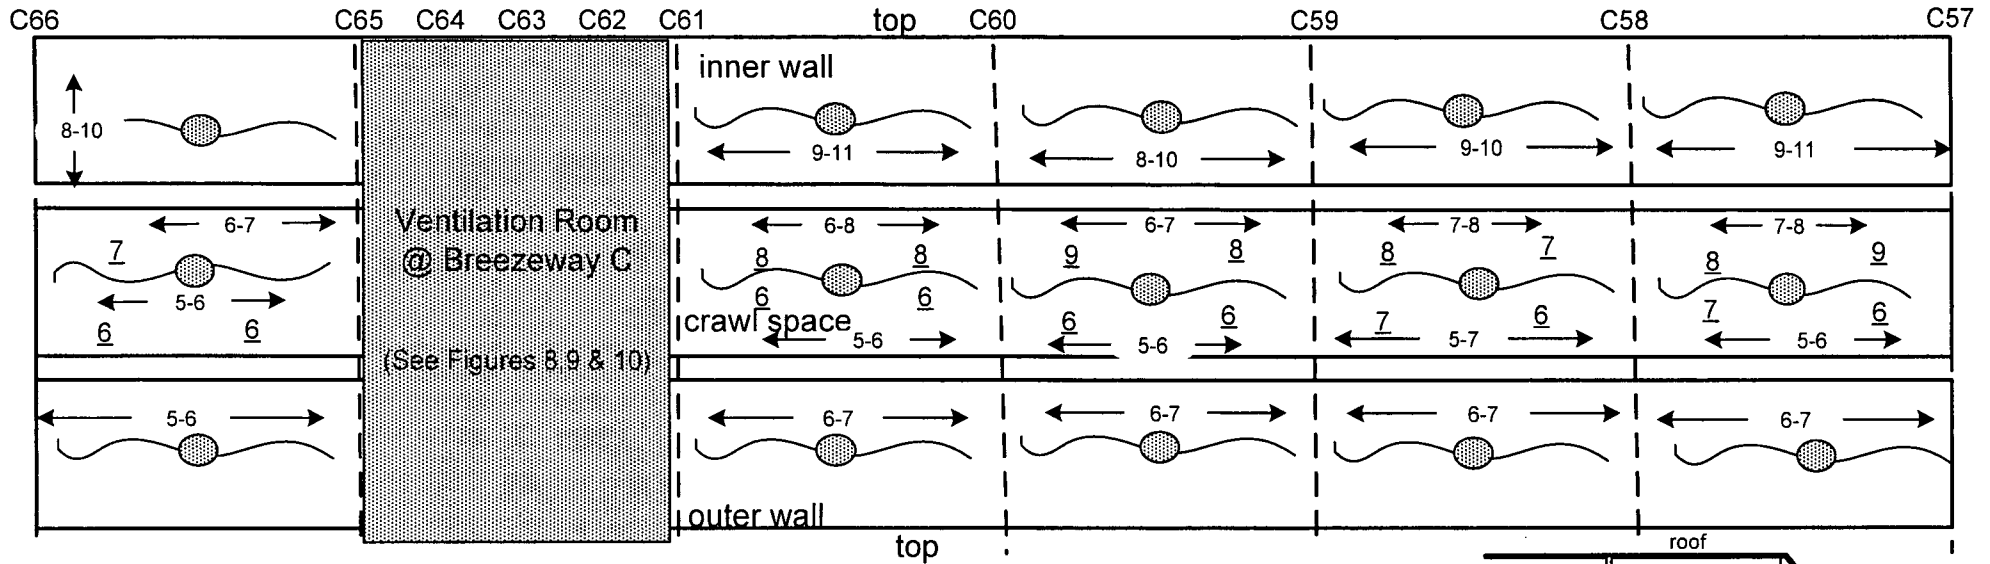
Figure 12: Building 2 Service Corridor Section C Overhead Crawl Space Column C57 to C66
 Fixed Exposure Rate and Exposure Rate Scan Measurement and Large Area Wipe Locations and Results

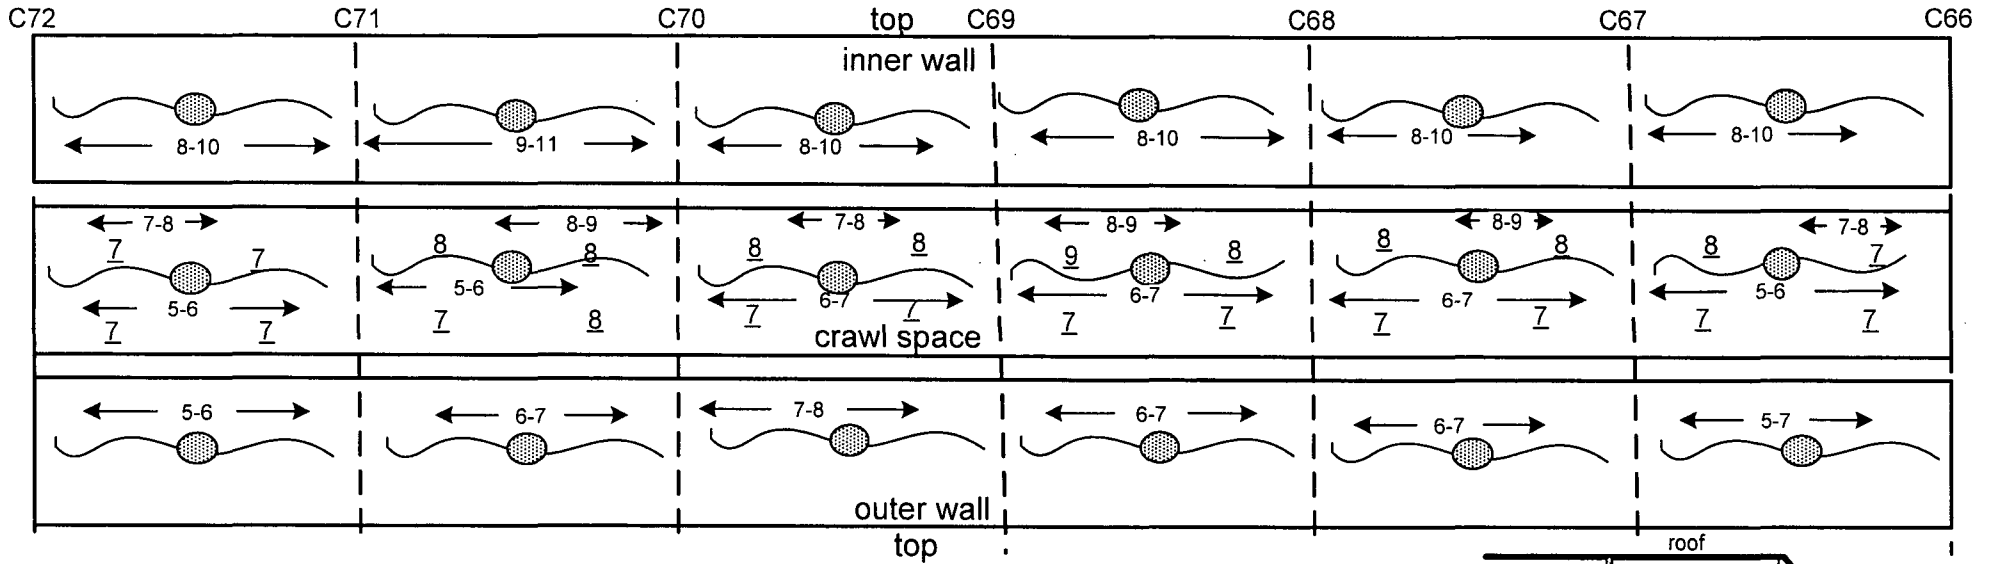
Figure 13: Building 2 Service Corridor Section C Overhead Crawl Space Column C66 to C72
 Fixed Exposure Rate and Exposure Rate Scan Measurement and Large Area Wipe Locations and Results

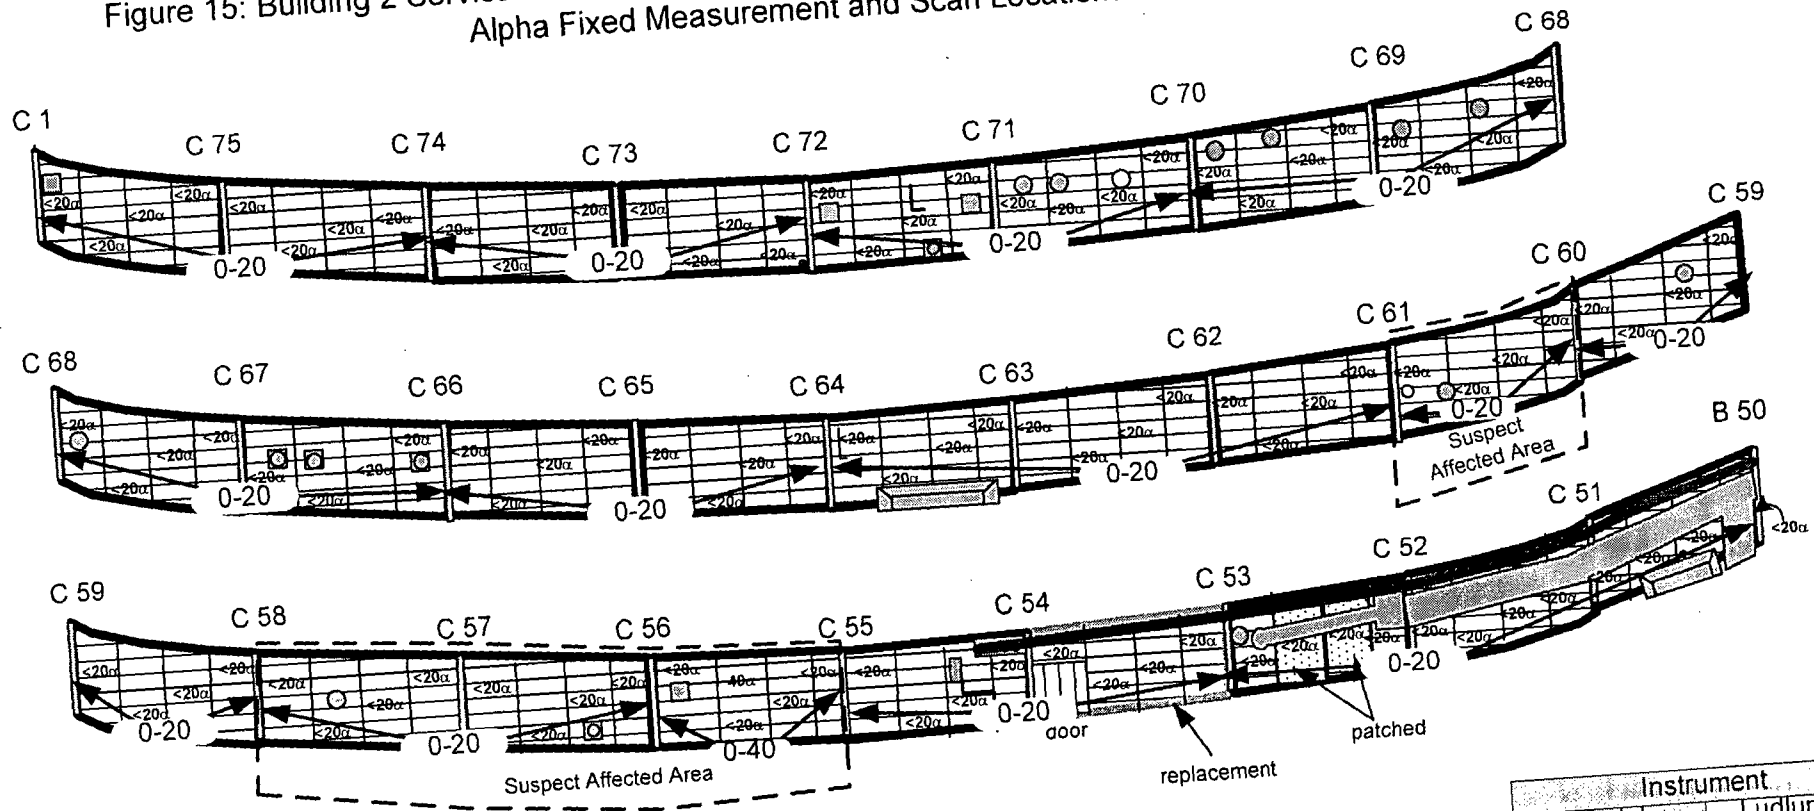
Figure 15: Building 2 Service Corridor Section C Overhead Crawl Space Outer Louvered Wall External Surface
Alpha Fixed Measurement and Scan Locations and Results

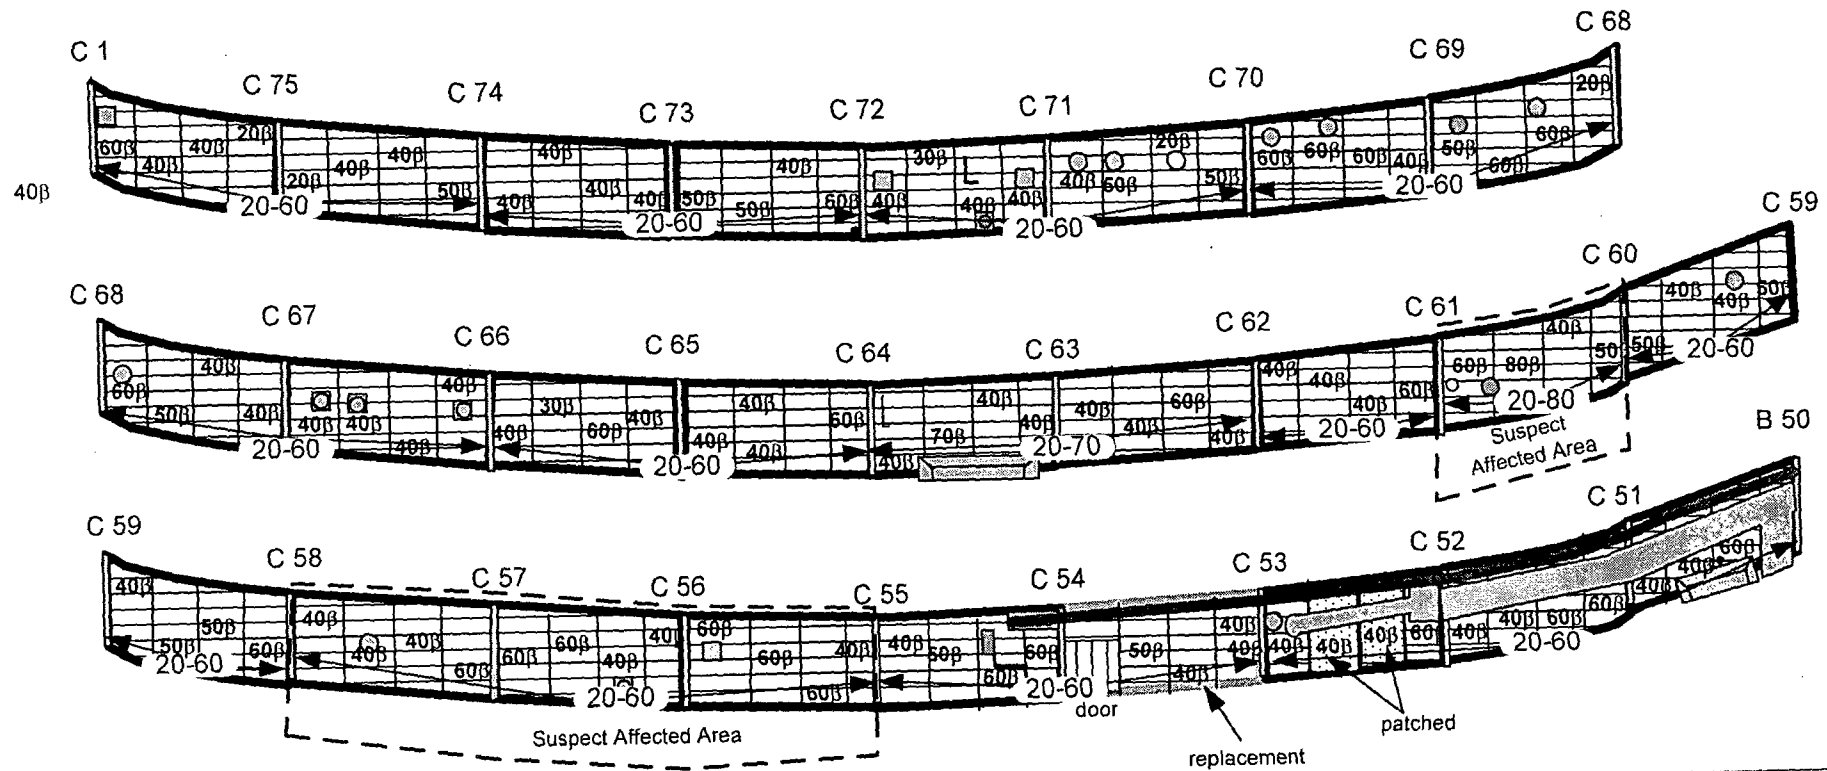
Figure 16: Building 2 Service Corridor Section C Overhead Crawl Space Outer Louvered Wall External Surface
Beta Fixed Measurement and Scan Locations and Results

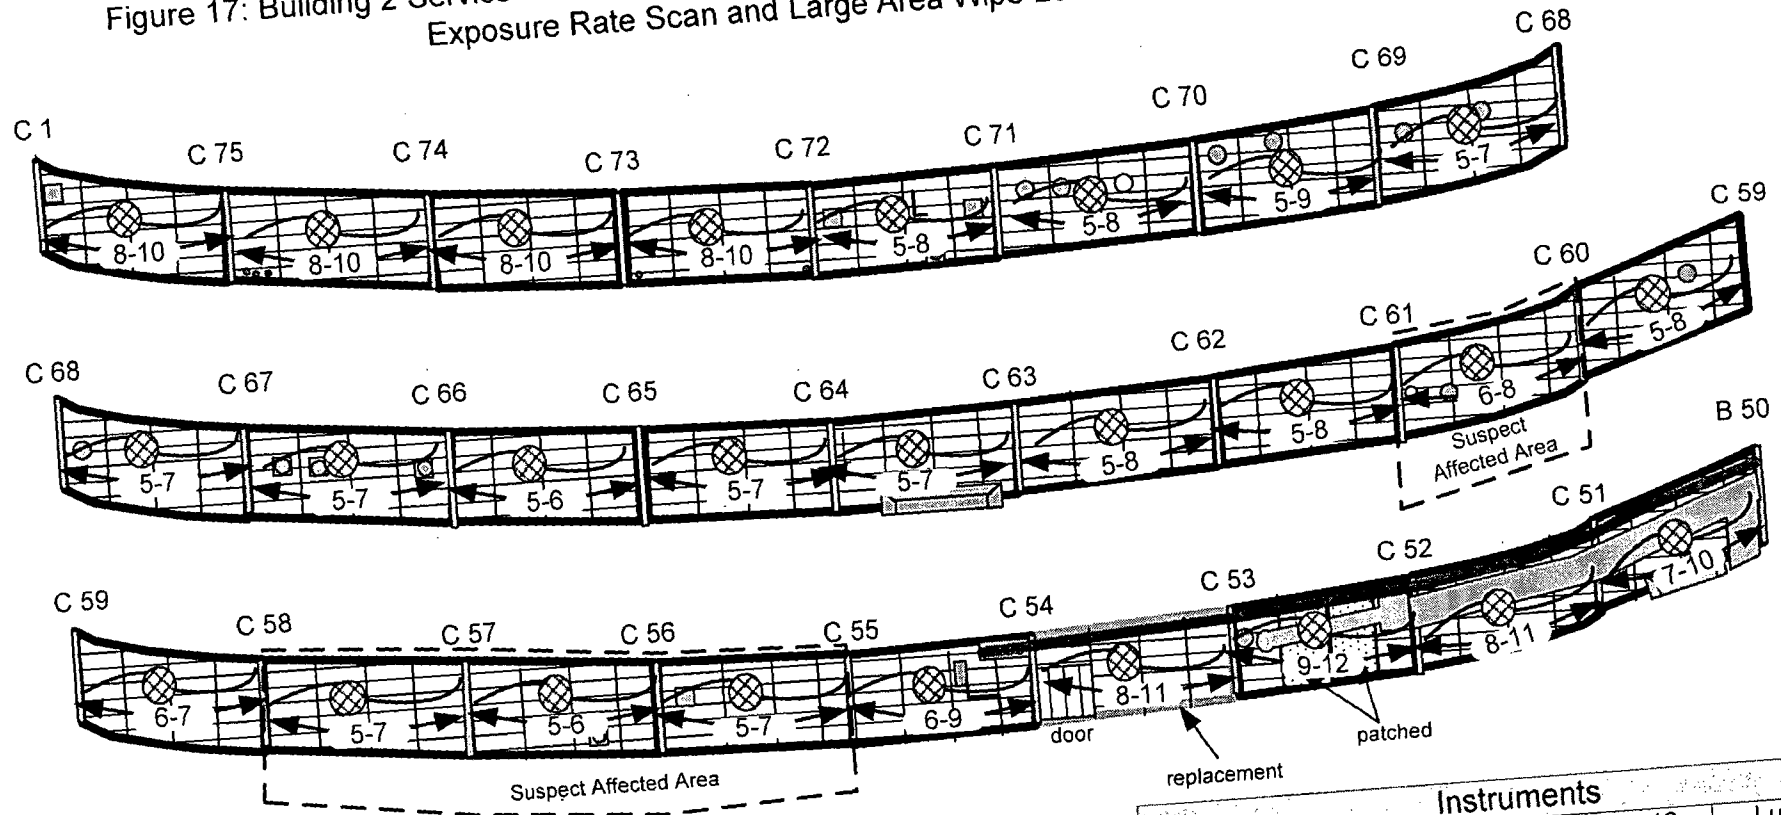
- Notes:
- Denotes exposure rate scan in $\mu\text{R/hr}$. 100% of the accessible louvered surface was scanned.
 - Denotes large area wipe. One large area wipe of the accessible surface per segment was taken as shown. All wipes were counted for alpha and beta contamination. All were \leq background for alpha or beta contamination.

Figure 18: Building 2 Service Corridor Section C Overhead Crawl Space Outer Louvered Wall External Surface Wipe Survey Locations

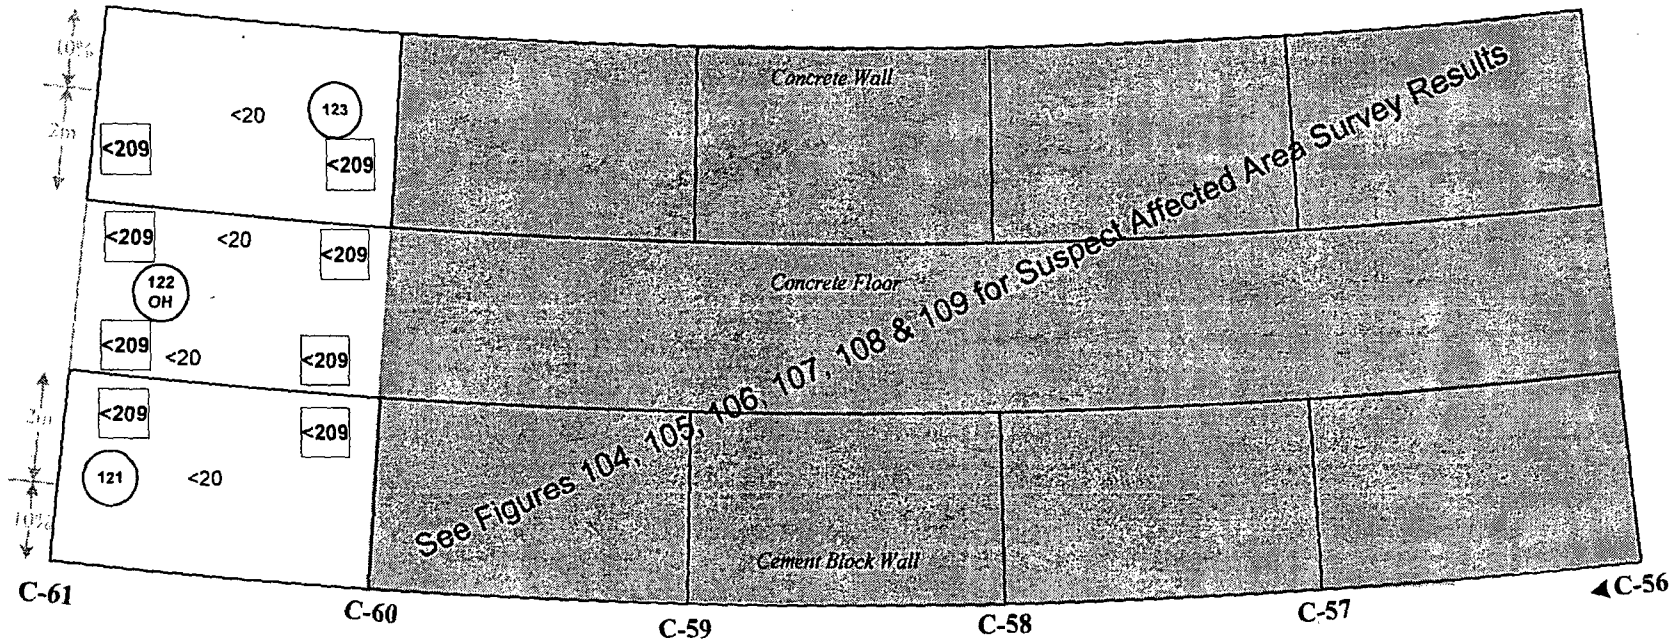
Figure 19: Building 2 Service Corridor, Section C, Level 1, Non-Suspect Affected Area, Columns C-56 to C-61 Fixed Alpha and Beta Measurement Locations and Results and Wipe Survey Locations

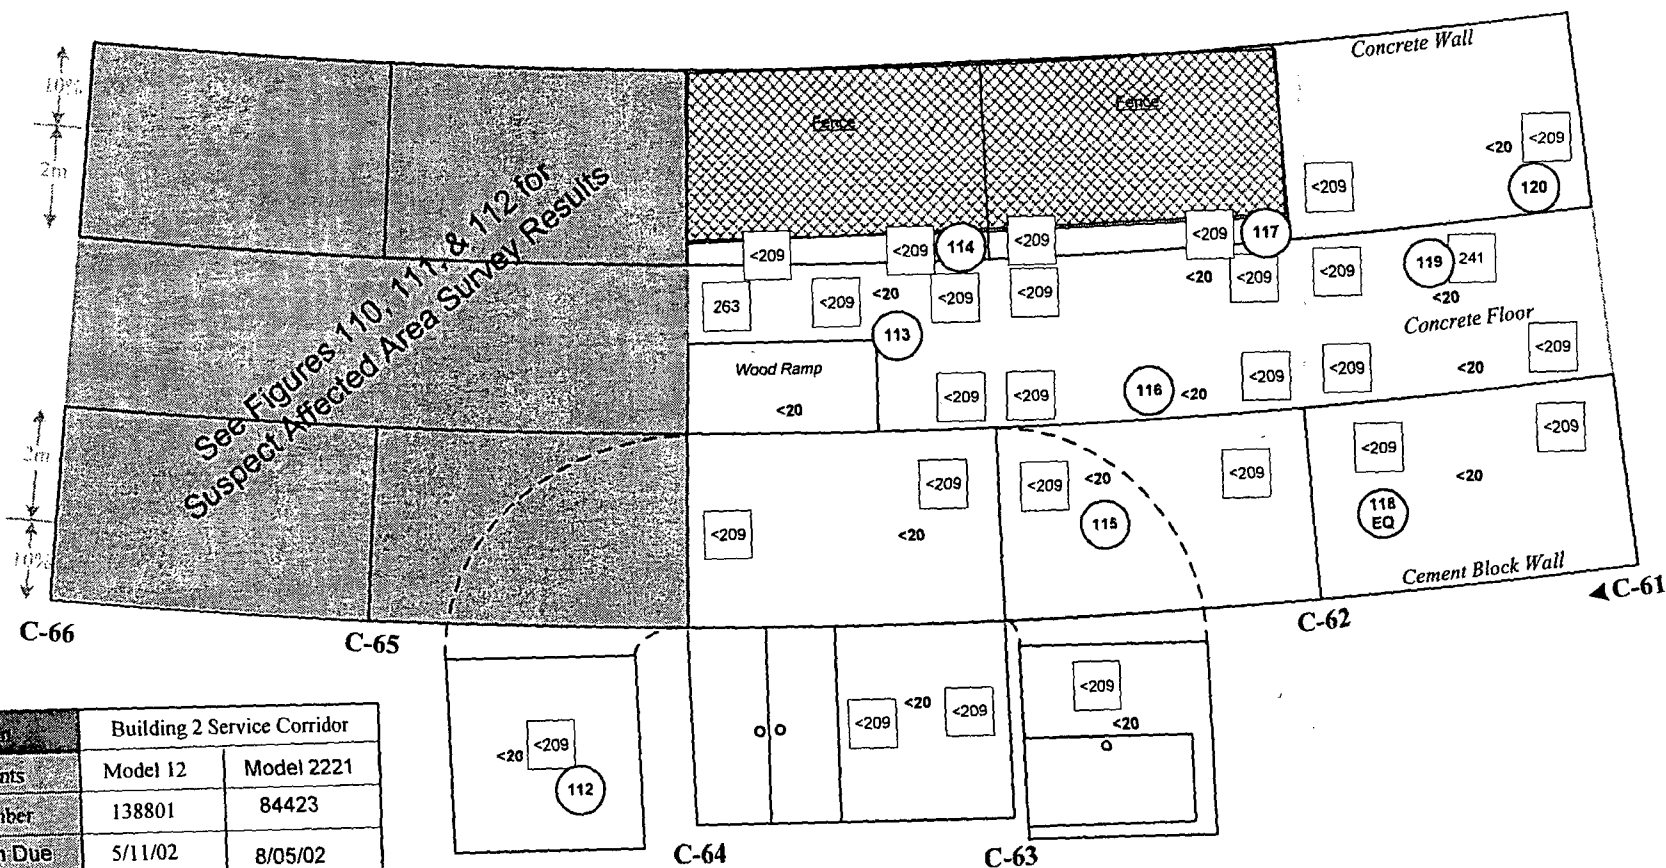
Figure 20: Building 2 Service Corridor, Section C, Level 1, Non-Suspect Affected Area, Columns C-61 to C-66 Fixed Alpha and Beta Measurement Locations and Results and Wipe Survey Locations

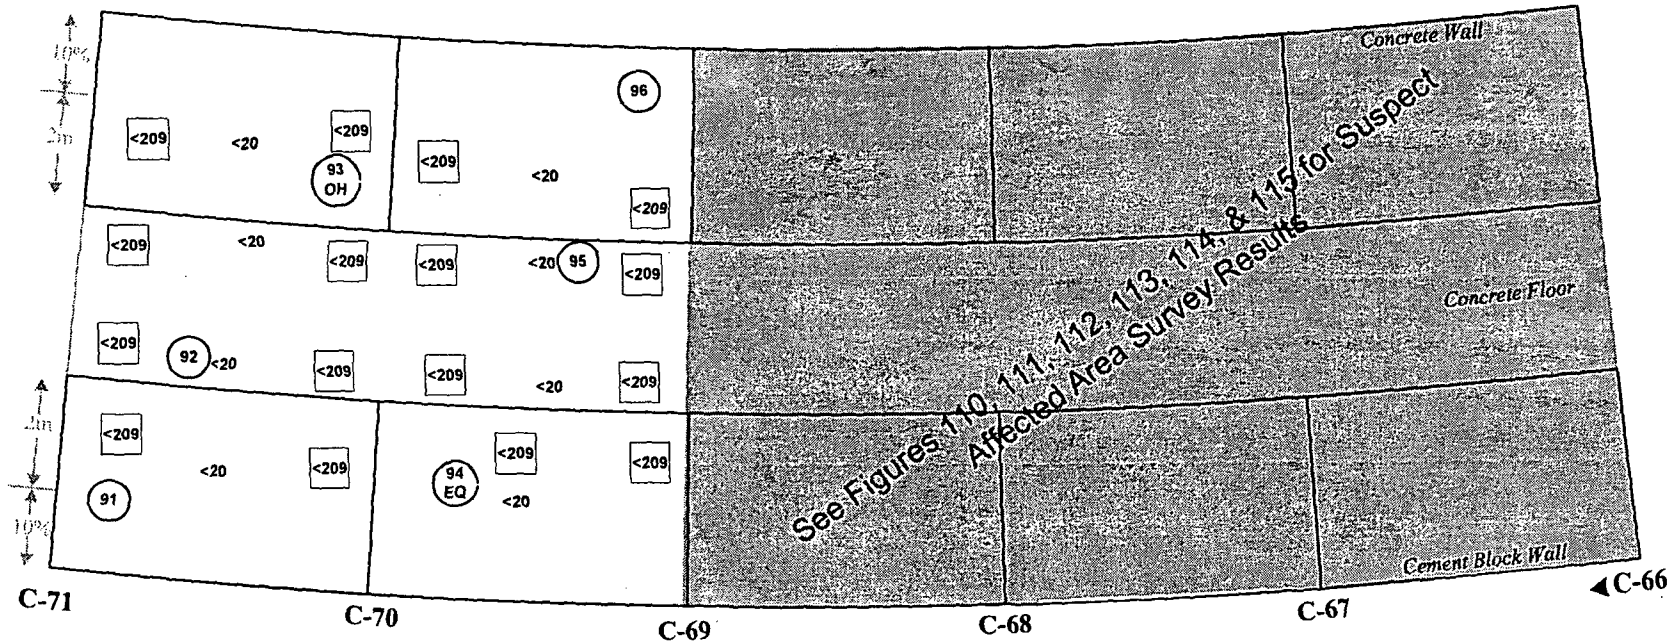
**Figure 21: Building 2 Service Corridor, Section C, Level 1, Non-Suspect Affected Area, Columns C-66 to C-71
Fixed Alpha and Beta Measurement Locations and Results and Wipe Survey Locations**

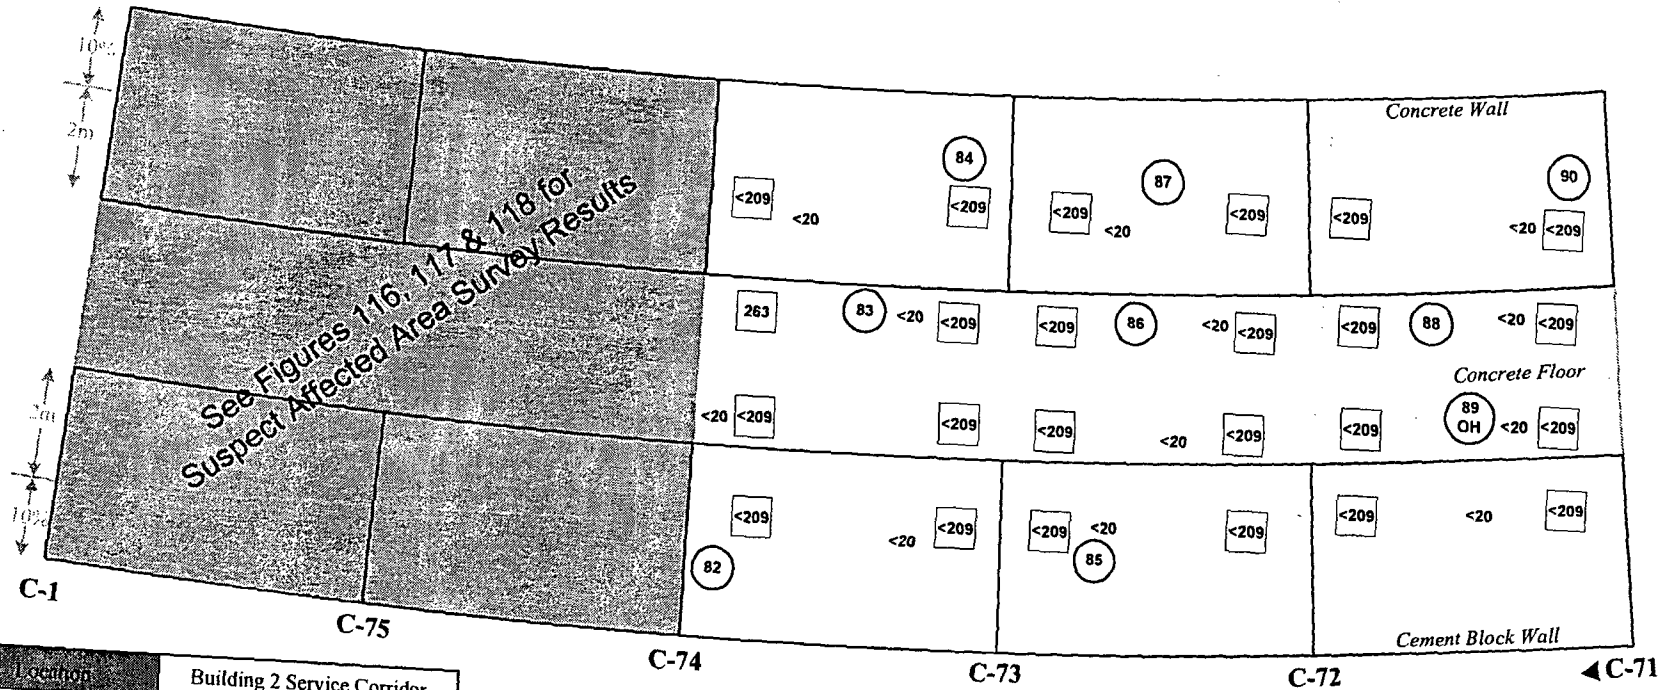
Figure 22: Building 2 Service Corridor, Section C, Level 1, Non-Suspect Affected Area, Columns C-71 to C-1 Fixed Alpha and Beta Measurement Locations and Results and Wipe Survey Locations

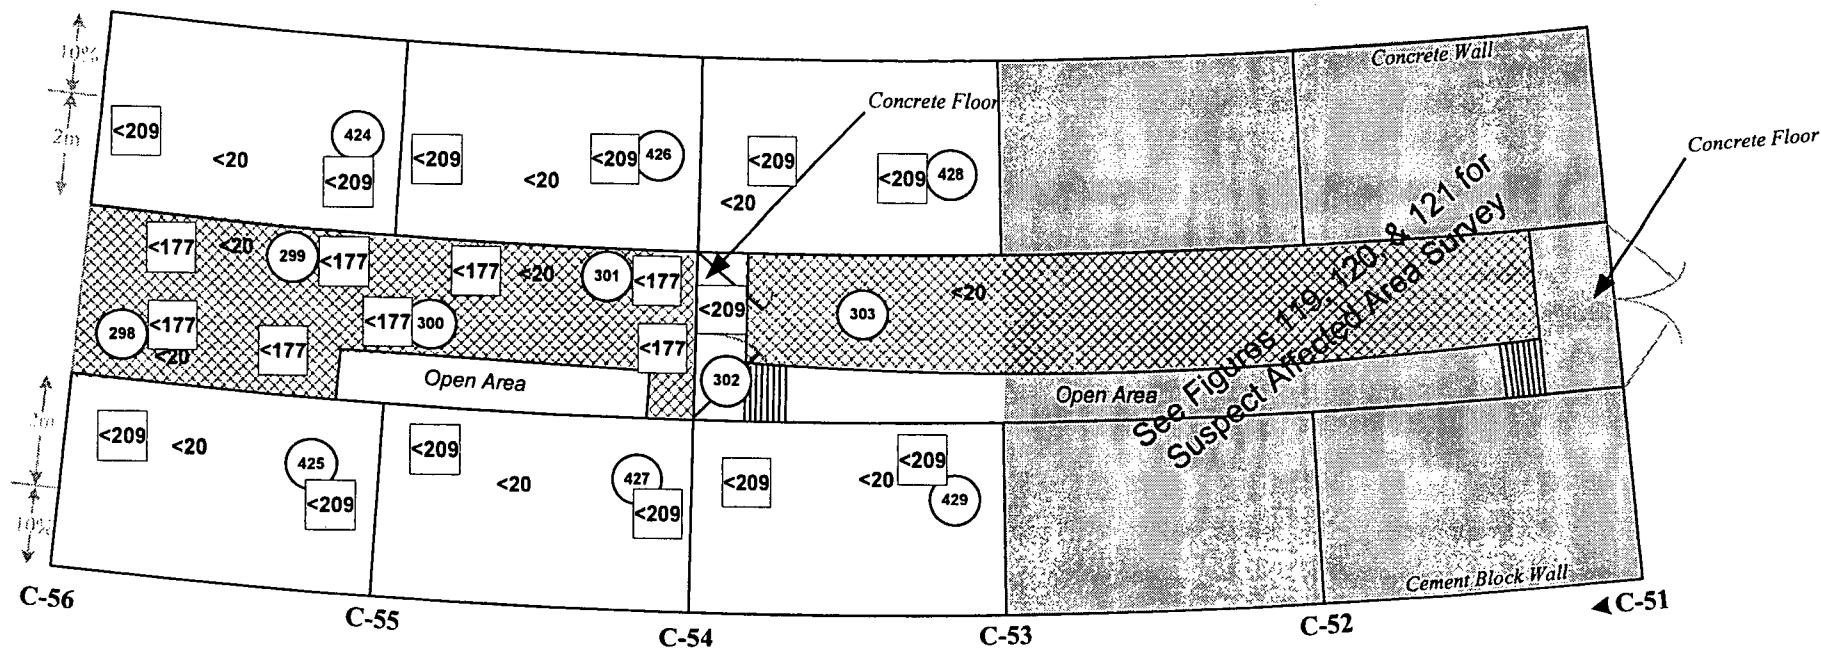
Figure 23: Building 2 Service Corridor, Section C, Level 2, Non-Suspect Affected Area, Columns C-51 to C-56 Fixed Alpha and Beta Measurement Locations and Results, and Wipe Survey Locations

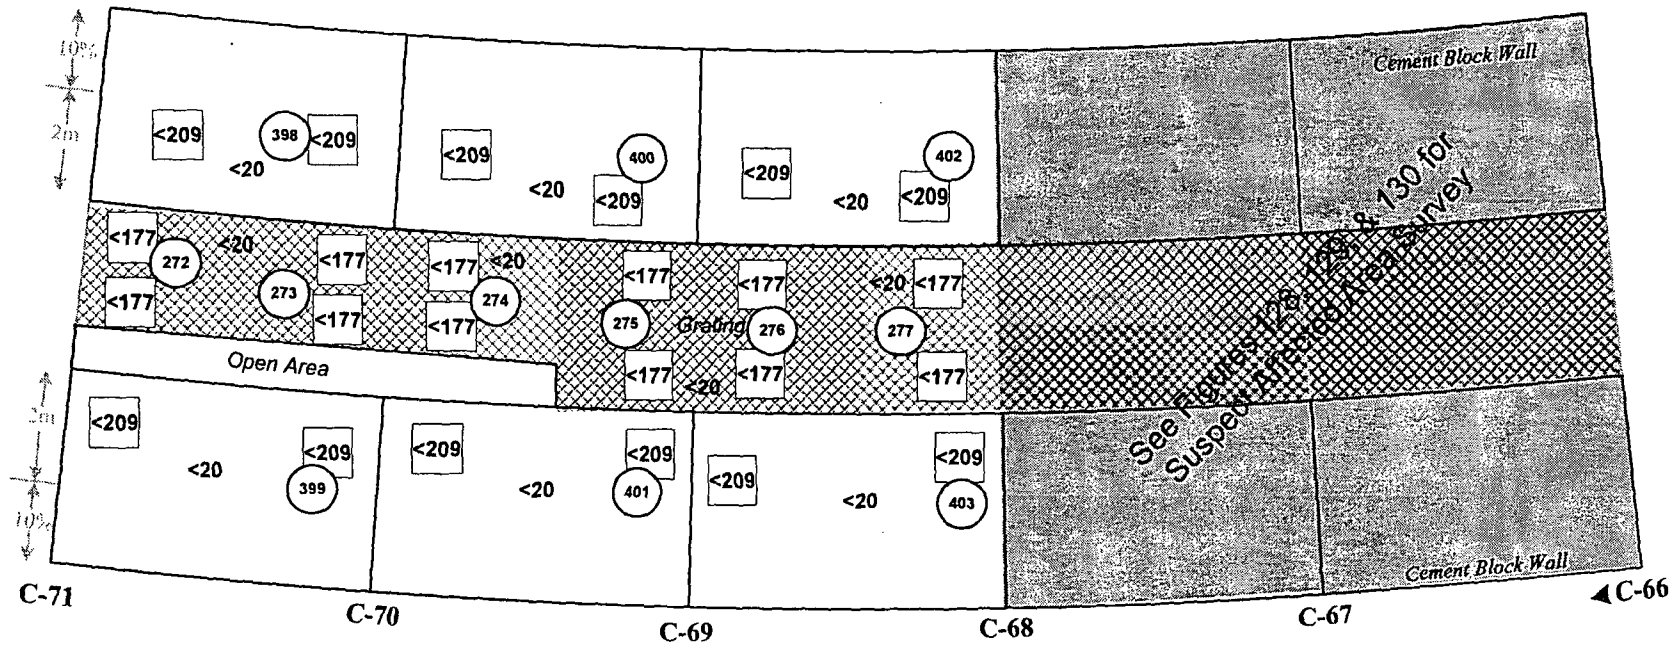
Figure 26: Building 2 Service Corridor, Section C, Level 2, Non-Suspect Affected Area, Columns C-66 to C-71 Fixed Alpha and Beta Measurement Locations and Results, and Wipe Survey Locations

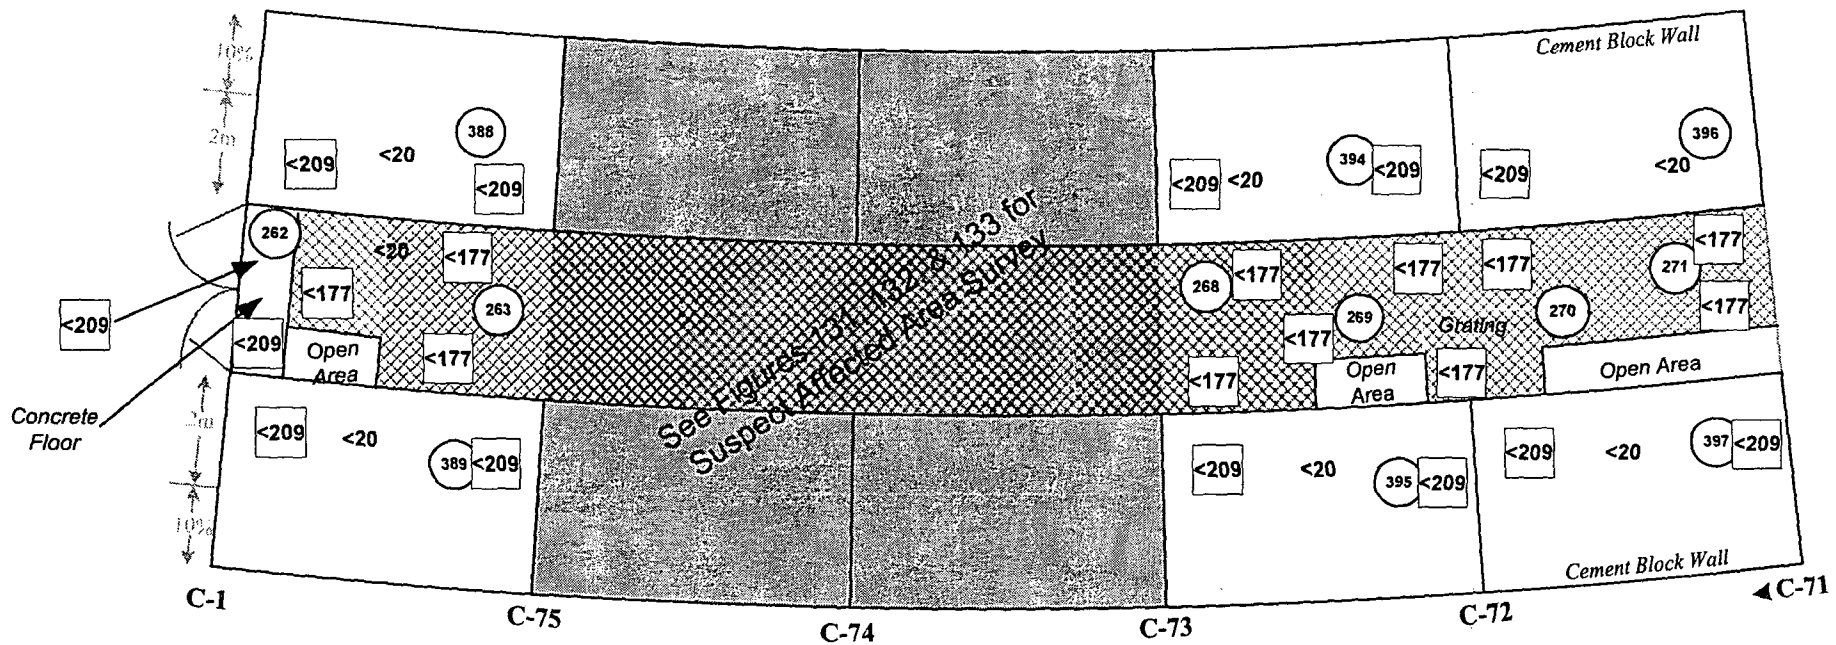
Figure 27: Building 2 Service Corridor, Section C, Level 2, Non-Suspect Affected Area, Columns C-71 to C-1 Fixed Alpha and Beta Measurement Locations and Results, and Wipe Survey Locations
