Subject: Docket No. 70-734; SNM-696: Request to Release a Certain Portion of General Atomics' Facility to Unrestricted Use and Delete it from License SNM-696: Namely, GA's "Section C of the Building 2 Service Corridor"

Building 2 is comprised of three arc-shaped sections which together form a "C"-shaped semi-circular building. The three sections are referred to as Sections A, B and C. Due to the large size and complexity of Building 2, the service corridor in each of the three sections is the subject of a separate release request. GA has previously requested the release of Sections A and B (References 1 and 2, respectively). This release request addresses the service corridor in **Section C**.

Figure 2A: GA's Building 2

Figure 2C: Section C of the Building 2 Service Corridor

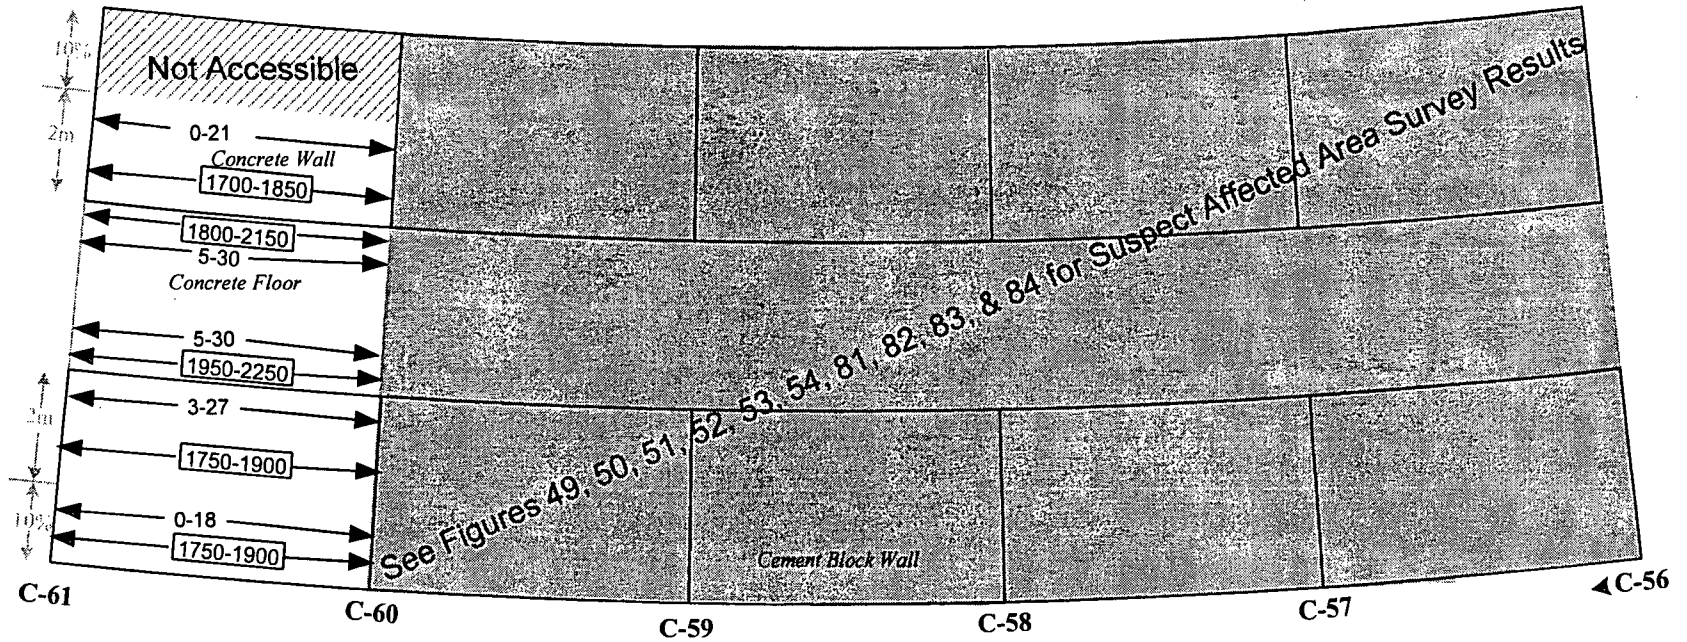
Figure 28: Building 2 Service Corridor, Section C, Level 1, Non-Suspect Affected Area, Columns C-56 to C-61 Alpha and Beta Surface Scan Measurement Locations and Results

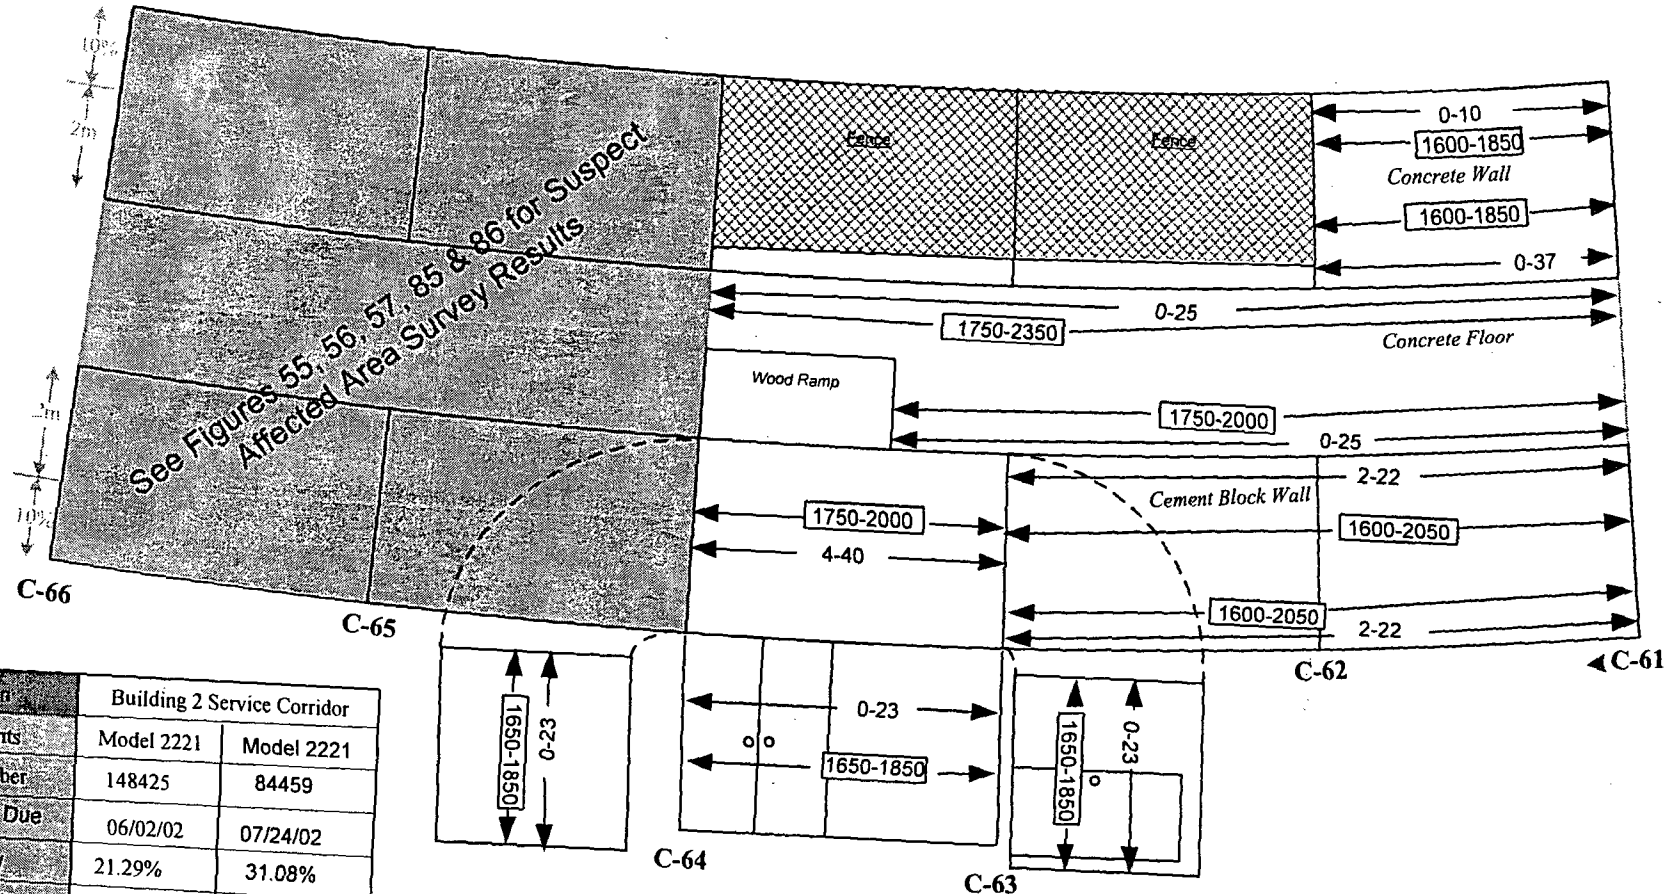
Figure 29: Building 2 Service Corridor, Section C, Level 1, Non-Suspect Affected Area, Columns C-61 to C-66
Alpha and Beta Scan Measurement Locations and Results.

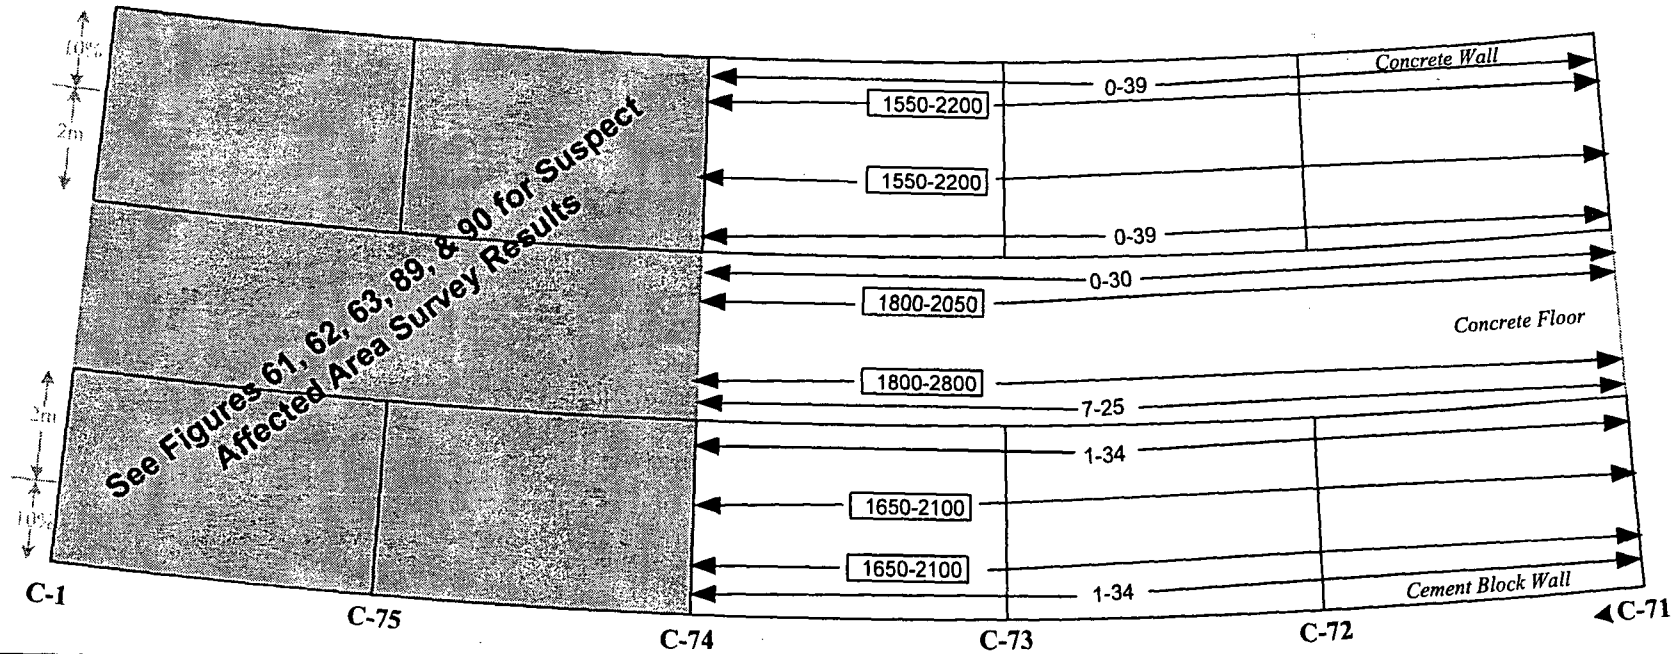
Figure 31: Building 2 Service Corridor, Section C, Level 1, Non-Suspect Affected Area, Columns C-71 to C-1 Alpha and Beta Scan Measurement Locations and Results.

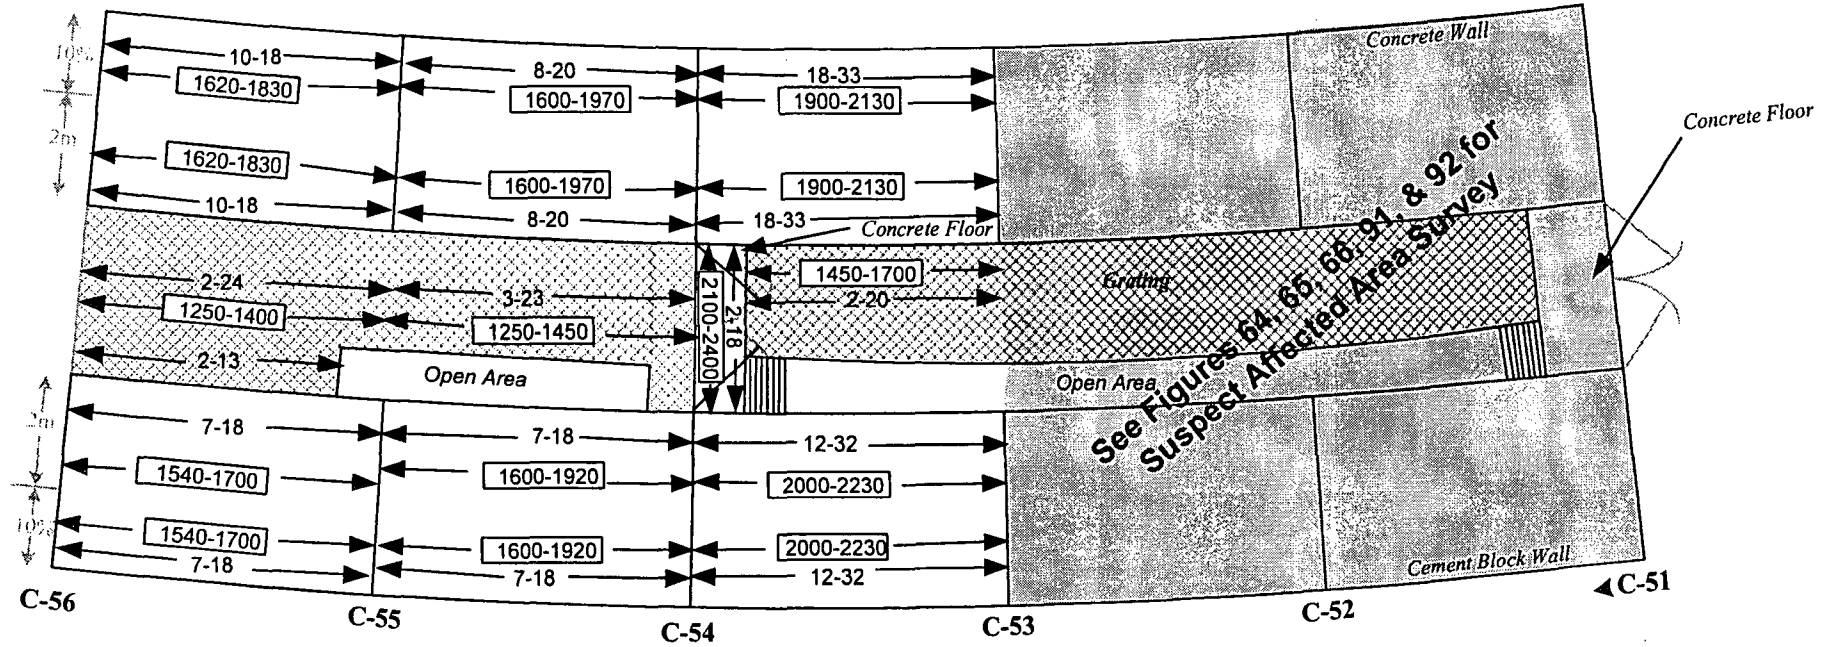
Figure 32: Building 2 Service Corridor, Section C, Level 2, Non-Suspect Affected Area, Columns C-51 to C-56 Alpha and Beta Scan Measurement Locations and Results.

100% of the accessible floor and wall surfaces below 2m, with the exception of the middle three (3) feet of new floor material, and, 10% of the accessible walls above 2m, was scanned for β activity. The highest activity level found was 2,800 cpm on the 2nd level between columns C71 and C74 (see Figure 31). This activity level is equivalent to 615 dpm/100 cm², which is far below the NRC- and State- approved release criteria identified in the GA Site Decommissioning Plan. See Figures 28, 29, 30, and 31 for the 1st level survey locations and results, and, Figures 32, 33, 34, 35, and 36 for the 2nd level survey locations and results.

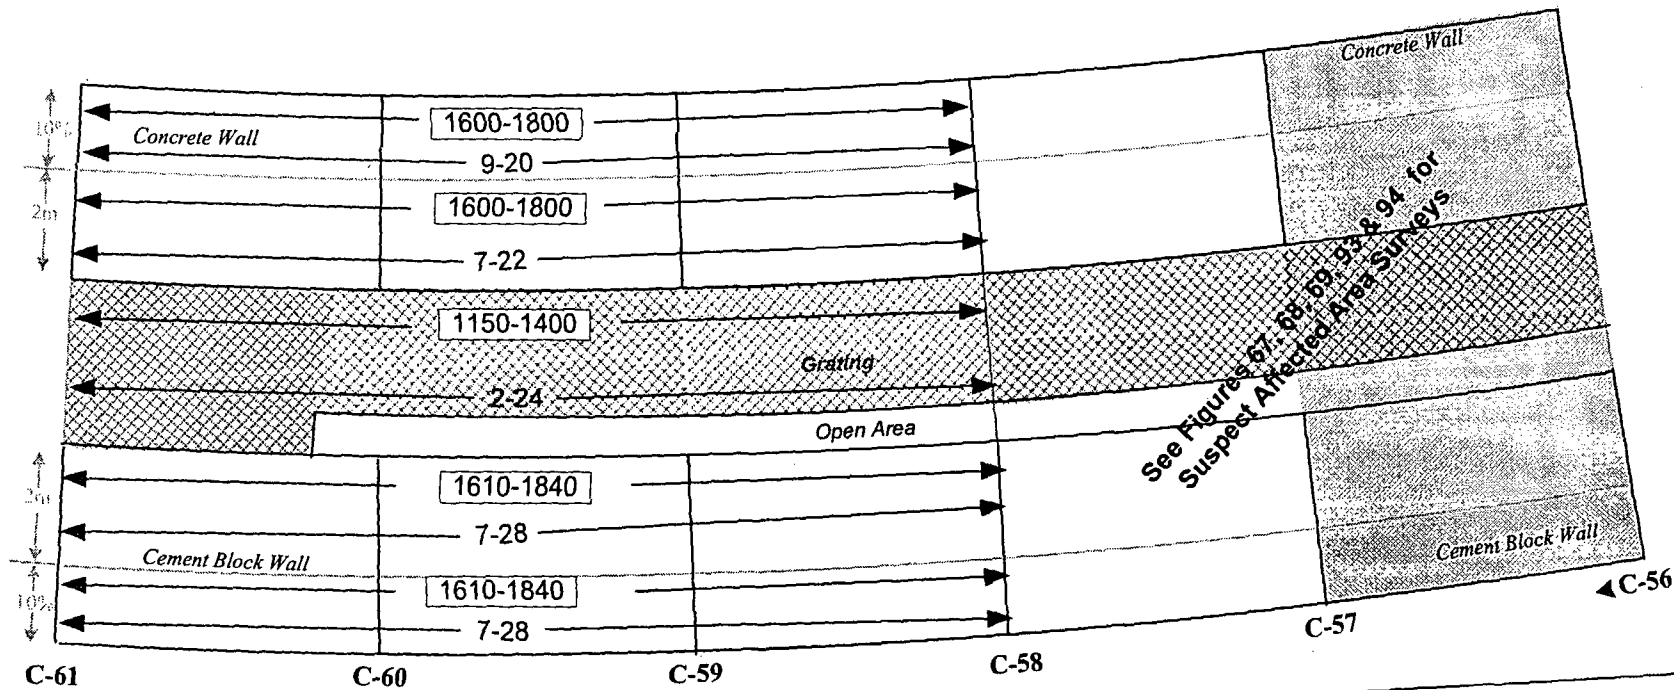
Figure 33: Building 2 Service Corridor, Section C, Level 2, Non-Suspect Affected Area, Column C-56 to C-61, Alpha and Beta Scan Survey Locations and Results.

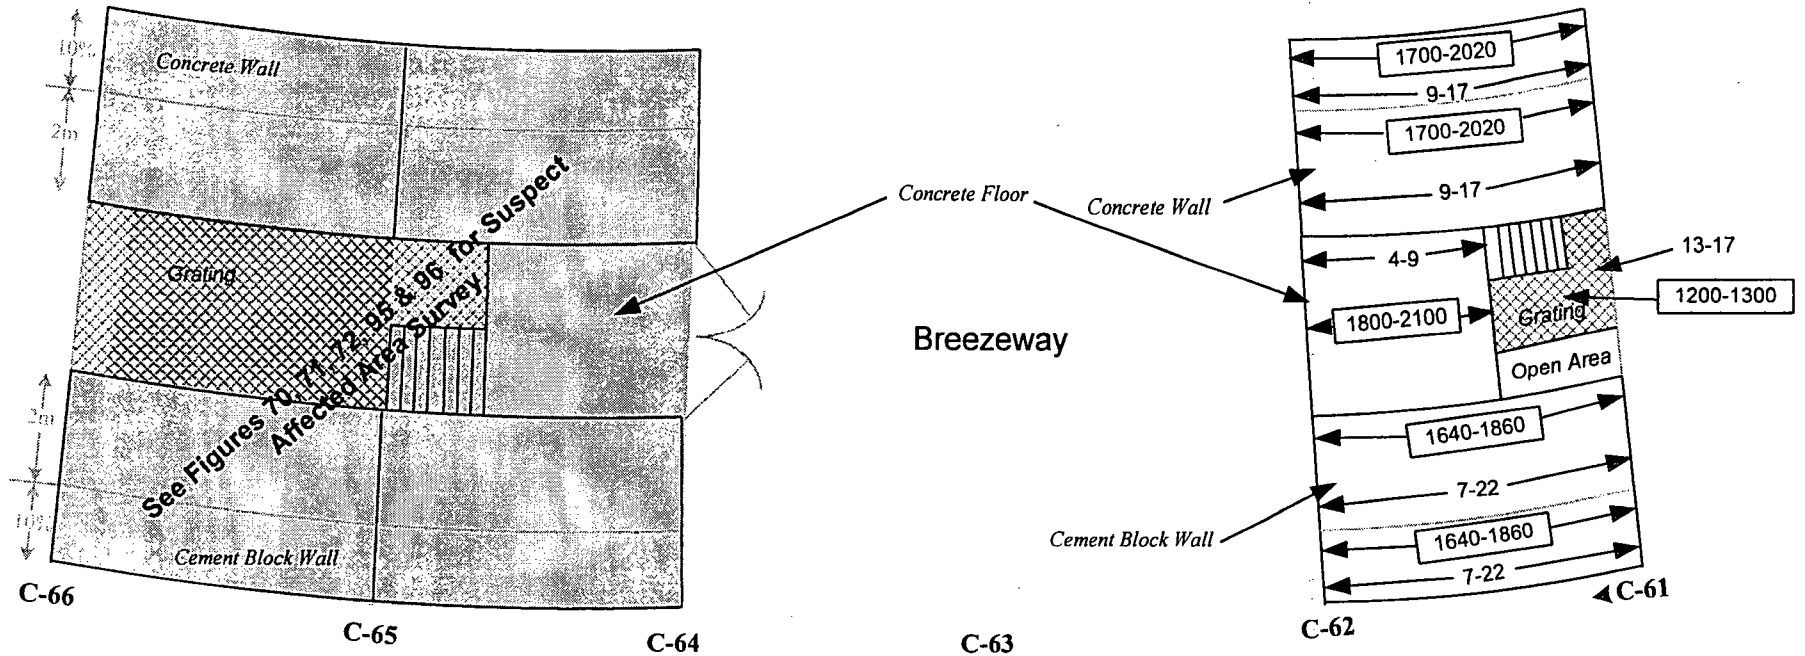
Figure 34: Building 2 Service Corridor, Section C, Level 2, Non-Suspect Affected Area, Column C-61 to C-68, Alpha and Beta Scan Survey Locations and Results.

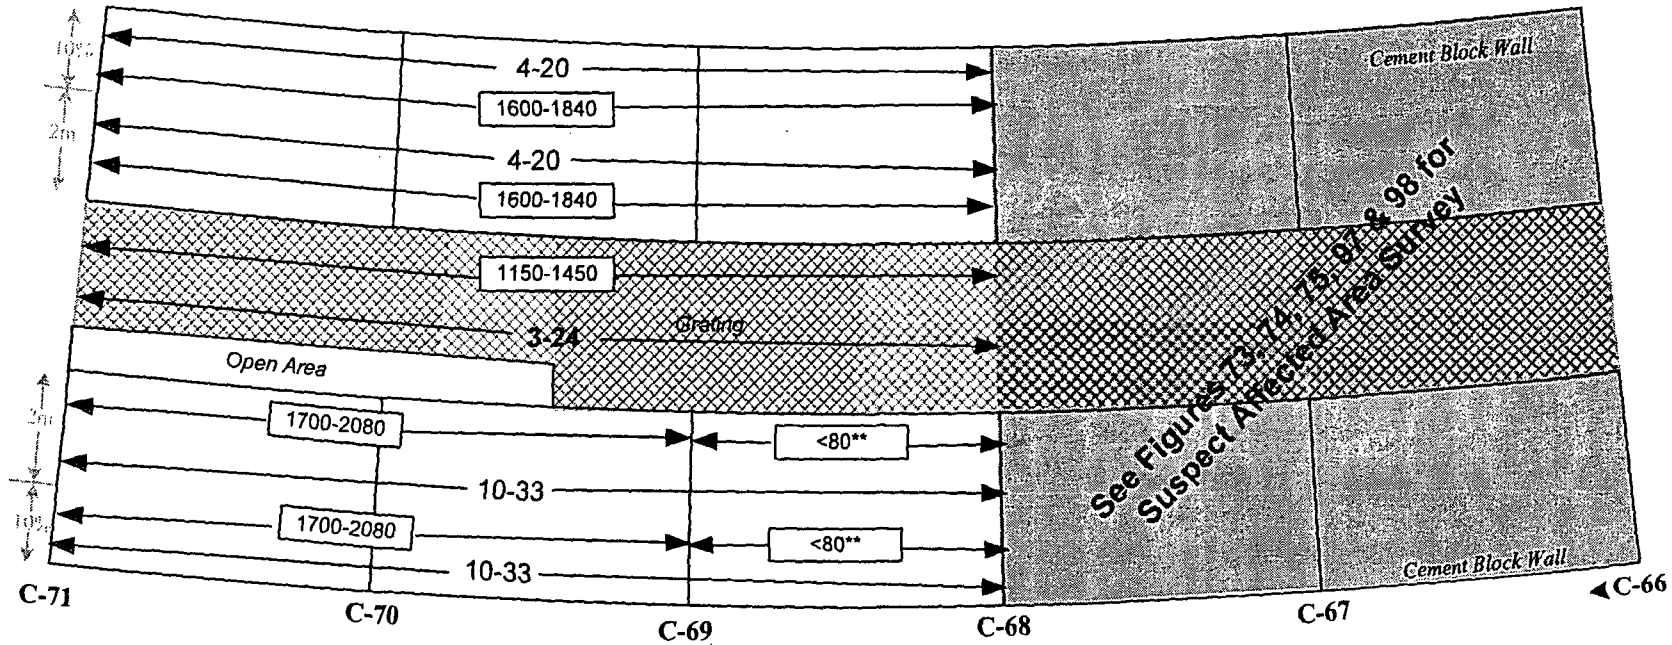
**Figure 35: Building 2 Service Corridor, Section C, Level 2, Non-Suspect Affected Area, Columns C-66 to C-71
Alpha and Beta Scan Measurement Locations and Results**

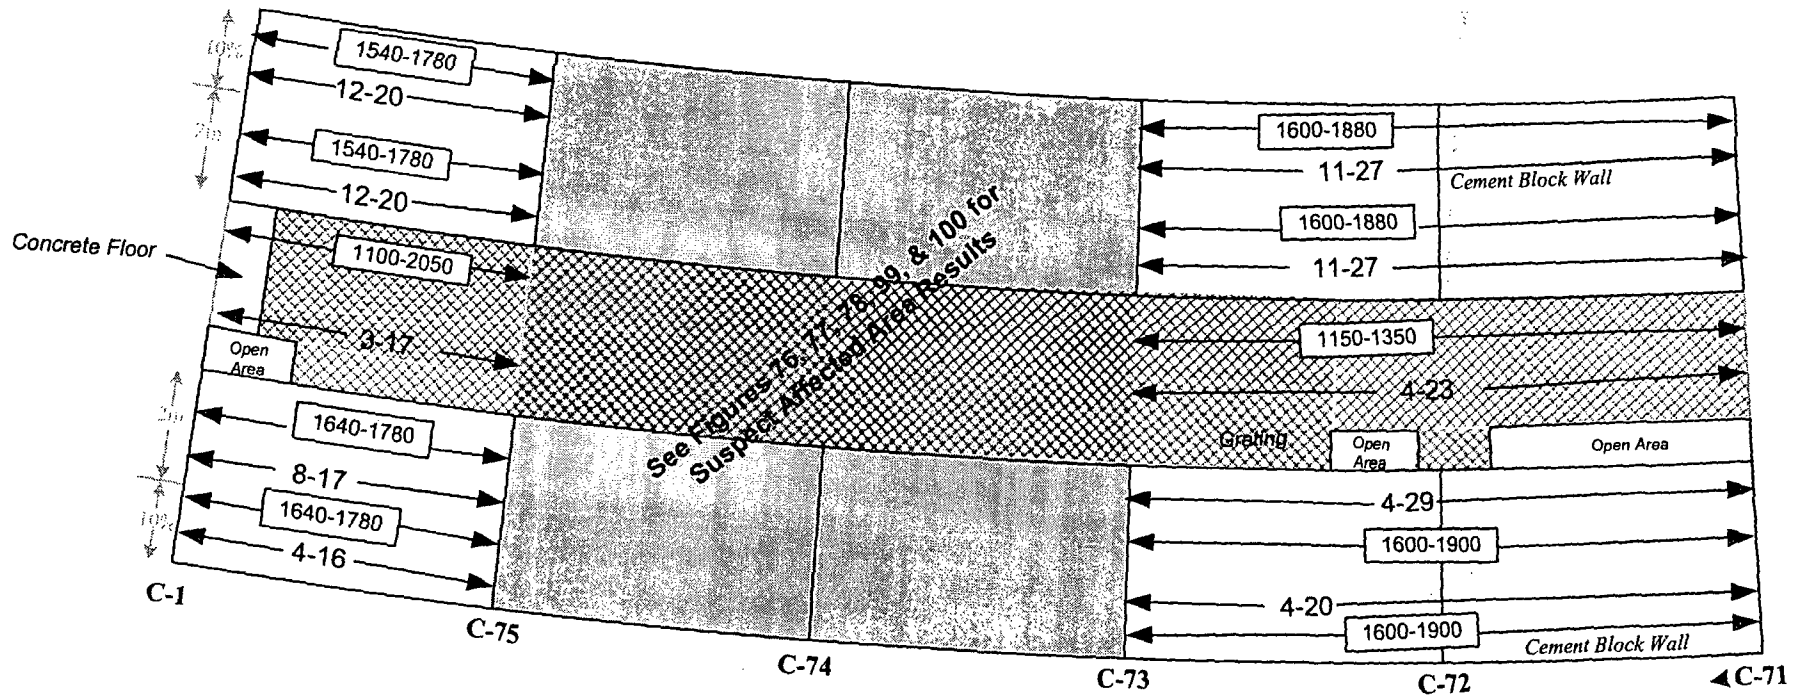
Figure 36: Building 2 Service Corridor, Section C, Level 2, Non-Suspect Affected Area, Columns C-71 to C-1
Alpha and Beta Scan Measurement Locations and Results

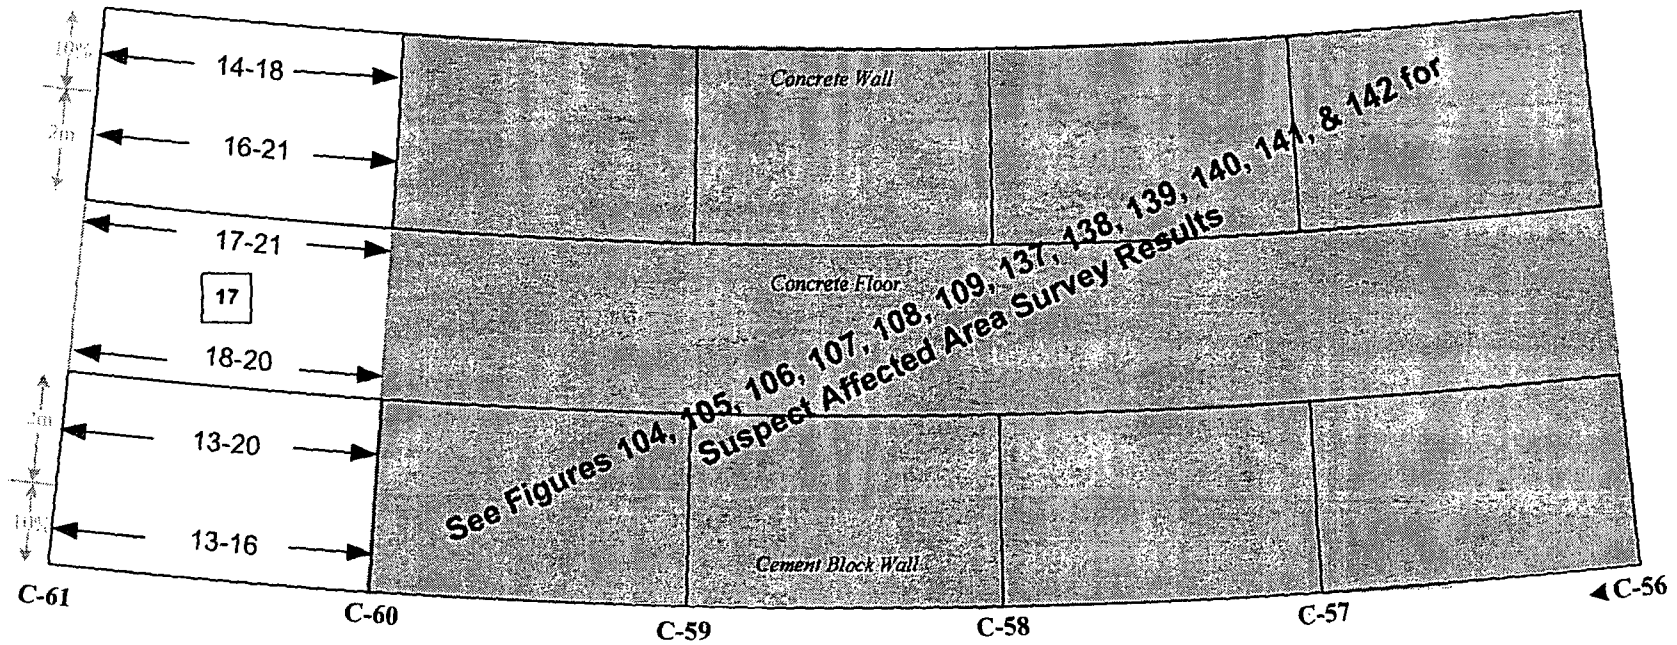
**Figure 37: Building 2 Service Corridor, Section C, Level 1, Non-Suspect Affected Area, Columns C-56 to C-61
Exposure Rate Fixed and Scan Measurement Locations and Results**

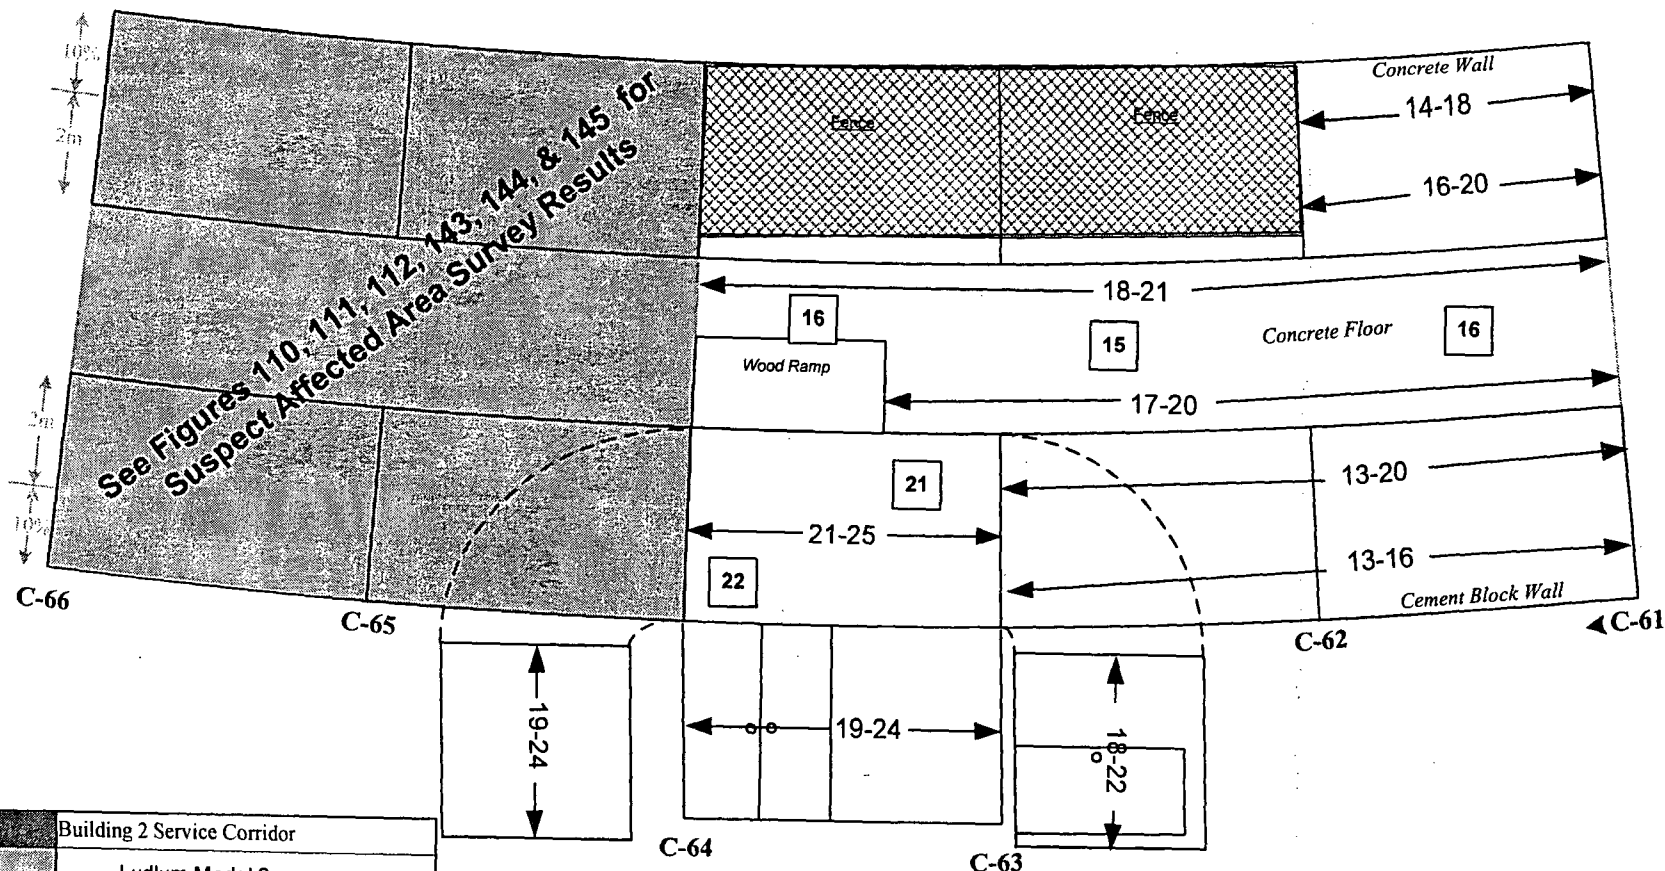
**Figure 38: Building 2 Service Corridor, Section C, Level 1, Non-Suspect Affected Area, Columns C-61 to C-66
Exposure Rate Fixed and Scan Measurement Locations and Results**

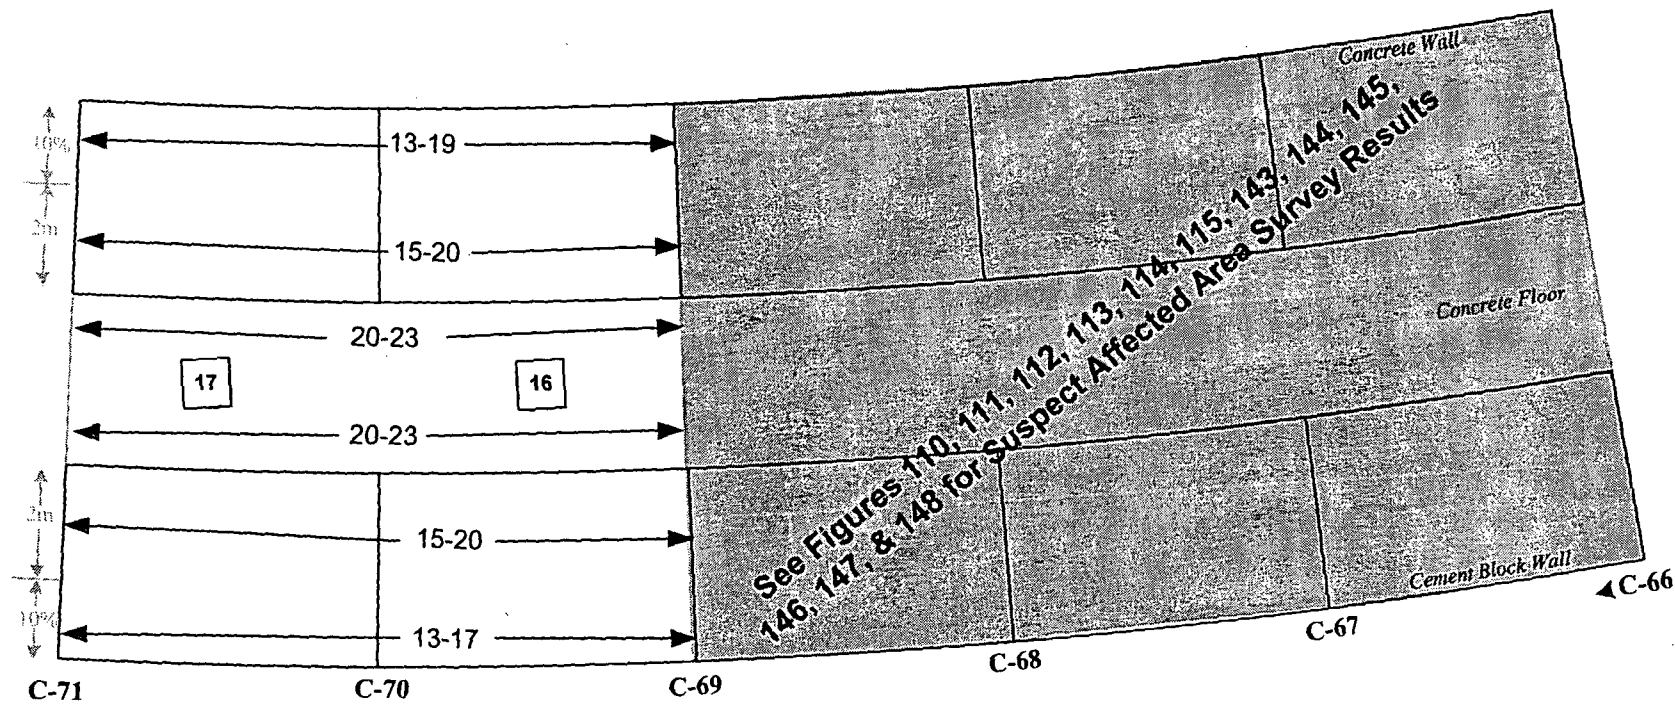
Figure 39: Building 2 Service Corridor, Section C, Level 1, Non-Suspect Affected Area, Columns C-66 to C-71
 Exposure Rate Fixed and Scan Measurement Locations and Results

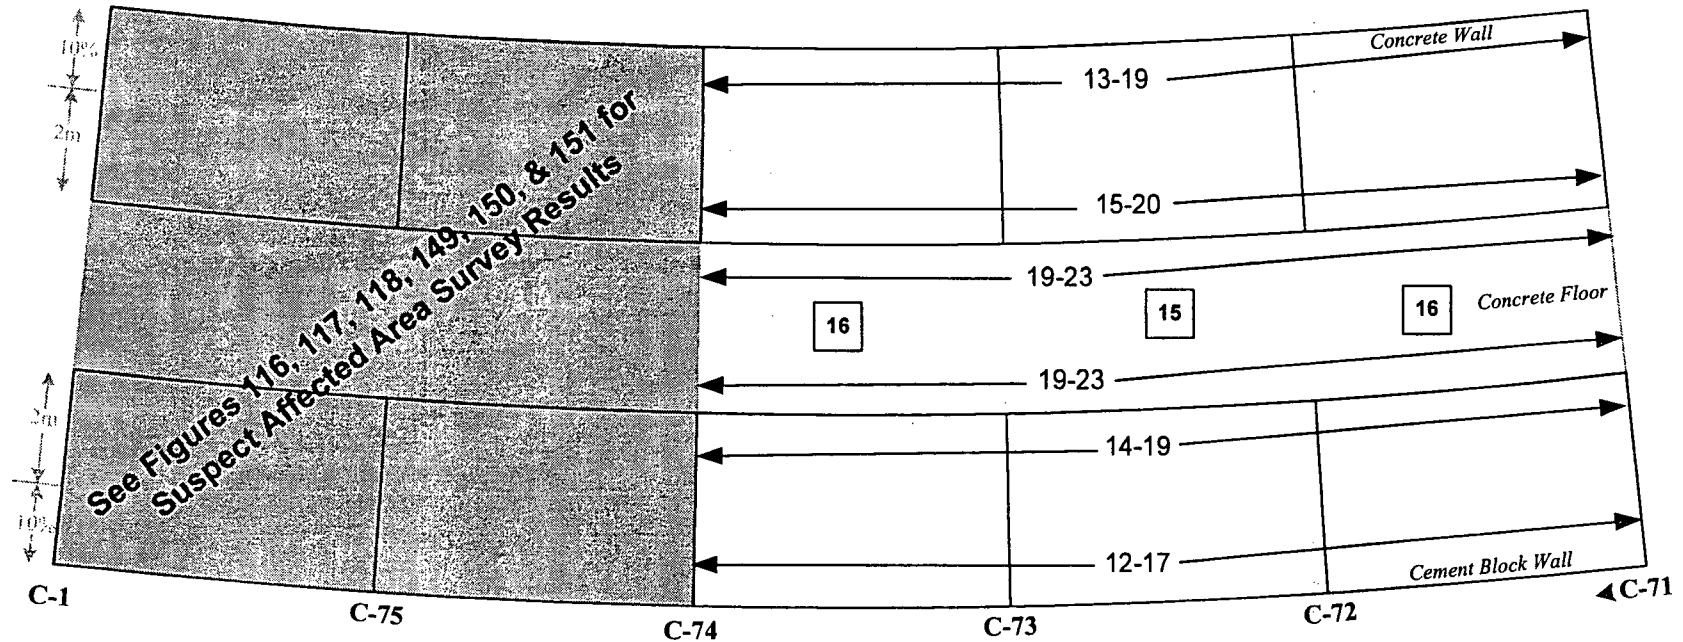
Figure 40: Building 2 Service Corridor, Section C, Level 1, Non-Suspect Affected Area, Columns C-71 to C-1 Exposure Rate Fixed and Scan Measurement Locations and Results

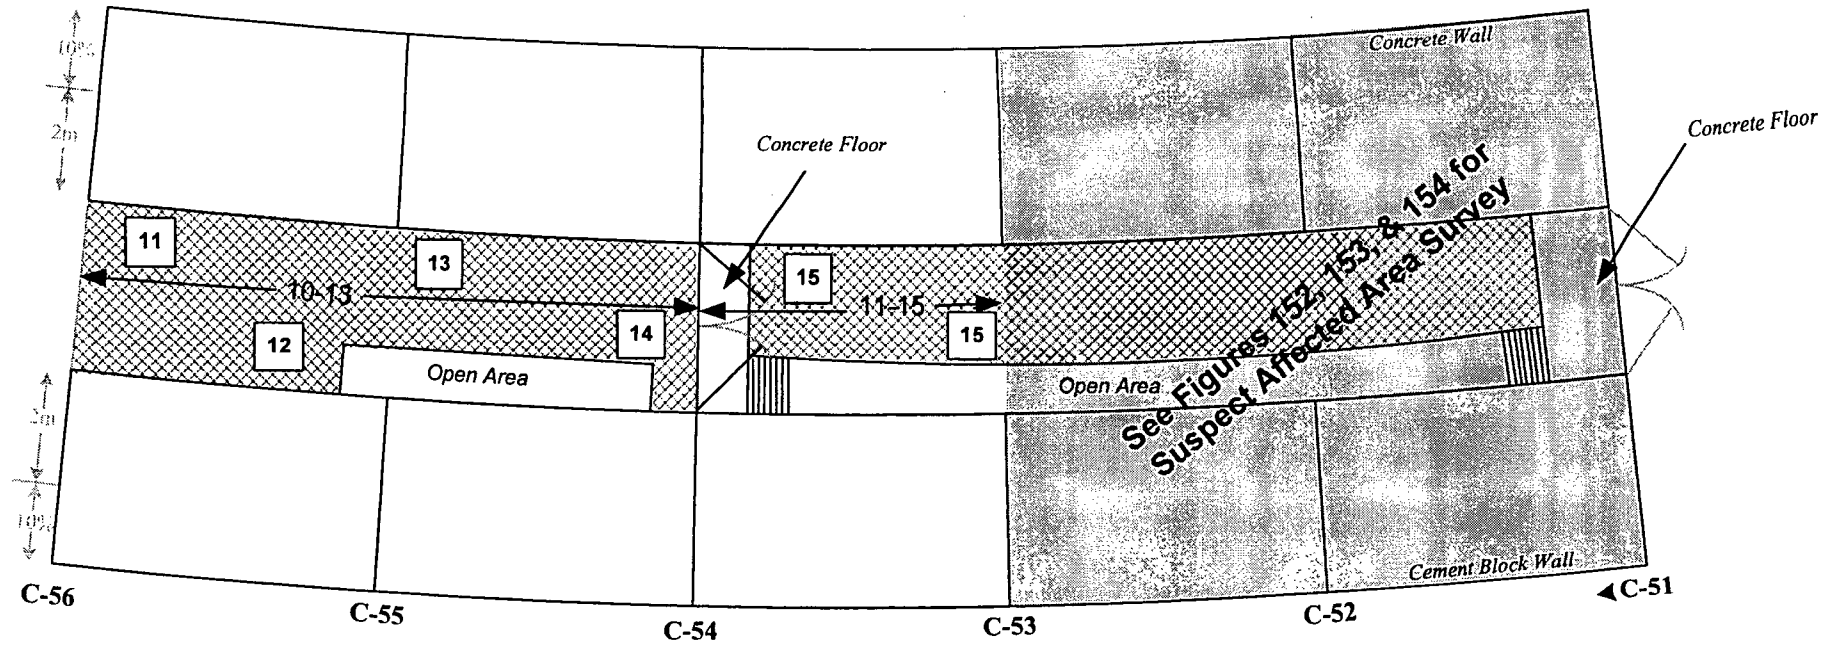
**Figure 41: Building 2 Service Corridor, Section C, Level 2, Non-Suspect Affected Area, Columns C-51 to C-56
Exposure Rate Fixed and Scan Measurement Locations and Results**

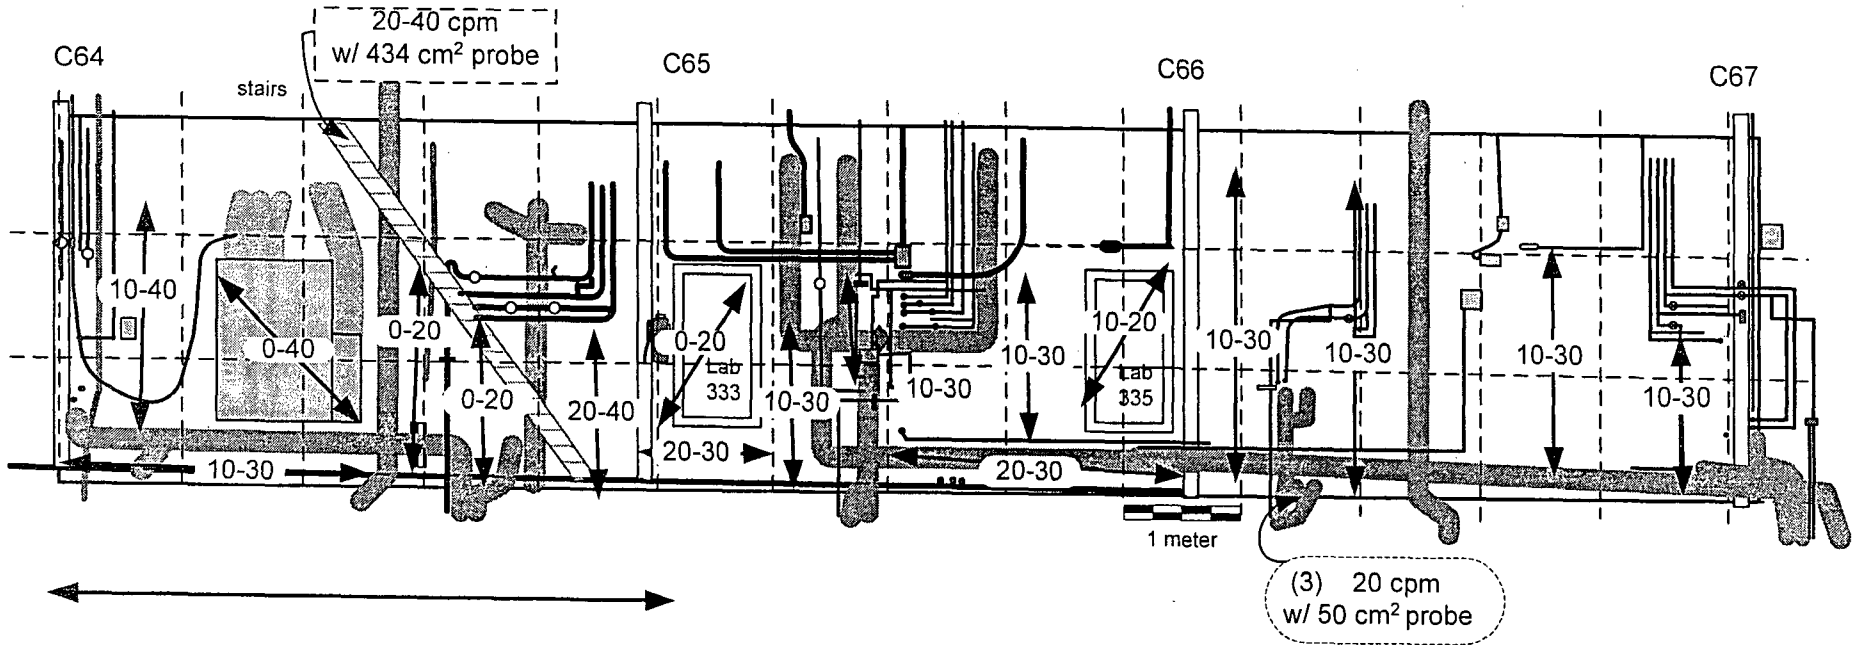
1. 100% of accessible area, 2 meters and below, 10% above 2 meters was scanned for alpha.
2. ← ## → Denotes alpha scan range in cpm as measured with the 434 cm² probe.
3. Areas not accessible with 434 cm² probe were scanned with the 50 cm² probe. All readings <20 cpm except as noted.

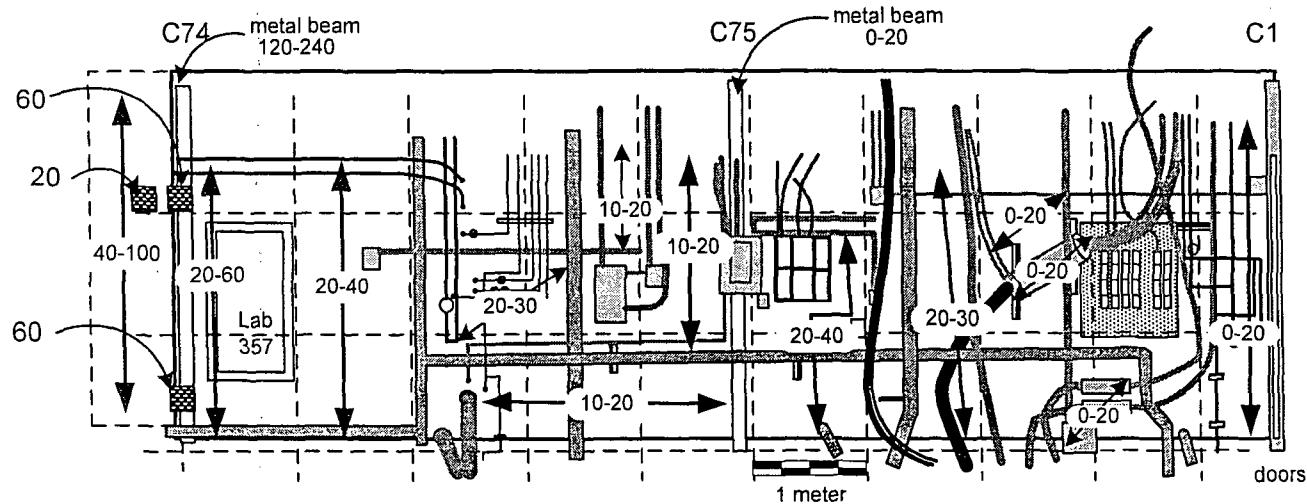
1. 100% of accessible area, 2 meters and below, 10% above 2 meters was scanned for alpha.
2. $\leftarrow \#\# \rightarrow$ Denotes alpha scan range in cpm as measured with the 434 cm² probe.
3. Areas not accessible with 434 cm² probe were scanned with the 50 cm² probe.
All readings <20 cpm except as noted.
4. $\#\#$

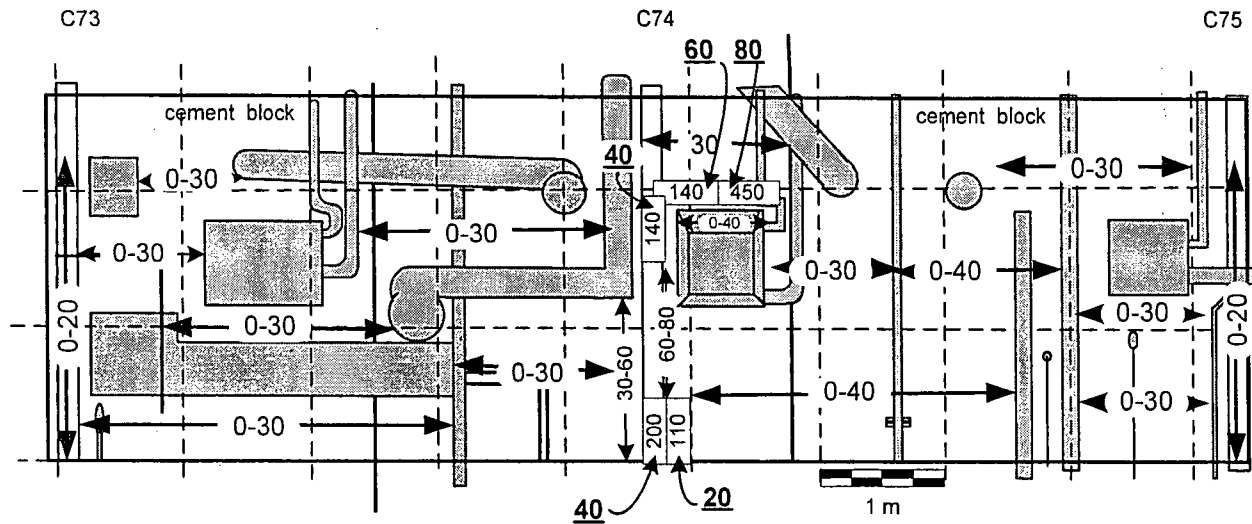
- 100% of accessible area, 2 meters and below, 10% above 2 meters was scanned for alpha.
- ← ## → Denotes alpha scan in cpm as measured with the 434 cm² probe.
- Areas not accessible with 434 cm² probe were scanned with the 50 cm² probe. All readings <20 cpm except as noted below.
- ### Denotes elevated scan location, >100 cpm, with 434 cm² probe shown in cpm..
- ## Denotes fixed alpha measurement, in cpm, taken with 50 cm² probe in elevated scan locations. Maximum measurement was 80 cpm, 533 dpm/100 cm². MDA = 209 dpm/100 cm².

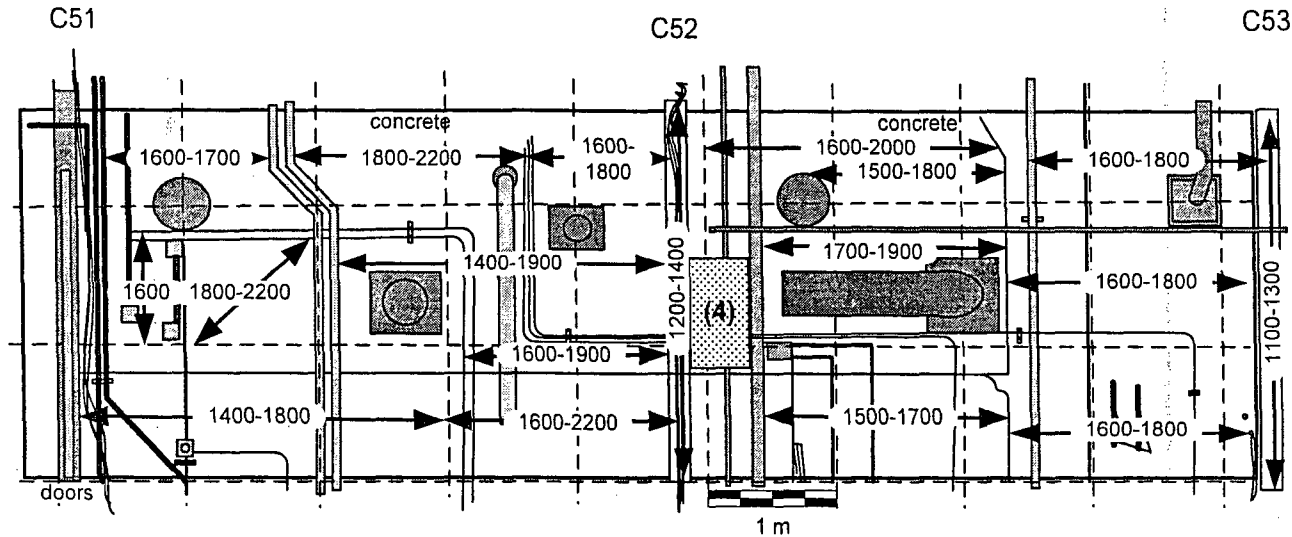
1. 100% of accessible surface scanned 2 meters and below, 10% above 2 meters.
2. $\leftarrow \#\# \rightarrow$ Denotes beta scan in cpm as measured with the 434 cm² probe.
3. Surfaces not accessible with 434 cm² probe were scanned with 100 cm² probe. All readings < background except as noted below.
4.
