3.12 Comparison of Test vs Analysis

Physical testing of the ES-3100 shipping container to the 4-foot, 30-foot, 30-foot crush and 40-inch punch impacts were carried out in late May, 2004 at the Oak Ridge National Lab (ORNL), National Transportation Research Center (NTRC) facility in Oak Ridge.

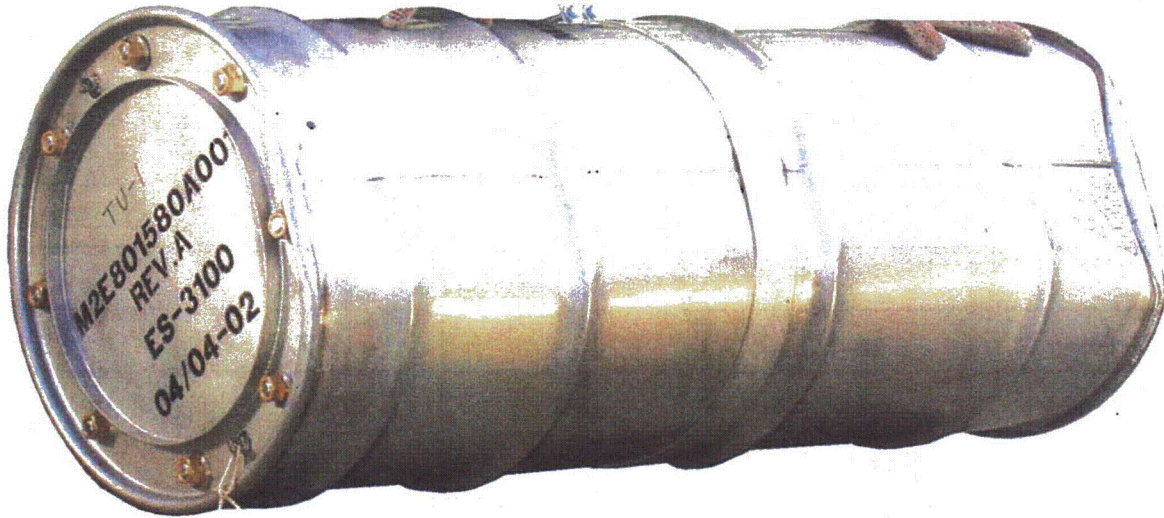
Figure 3.12.1.1 - TU1, Results of 30-Foot Impact

Figure 3.12.1.1 shows the final configuration of the test specimen after the 4 and 30-foot impacts. Figure 3.12.1.2 shows the analytical model configuration after the 30-foot impact.

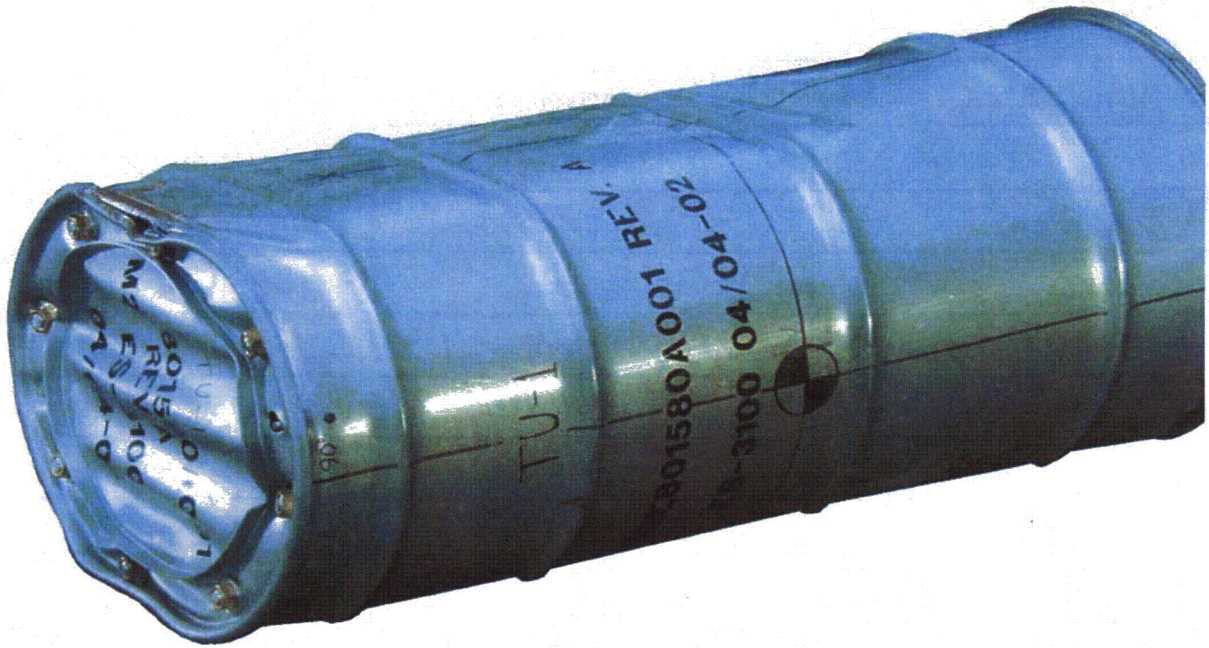
Figure 3.12.1.3 - TU1, View of Crush Damage with the Crush Side Up

Figure 3.12.1.3 shows an isometric view of the test specimen with the crush side up. Figure 3.12.1.4 shows a similar view for the analysis results.

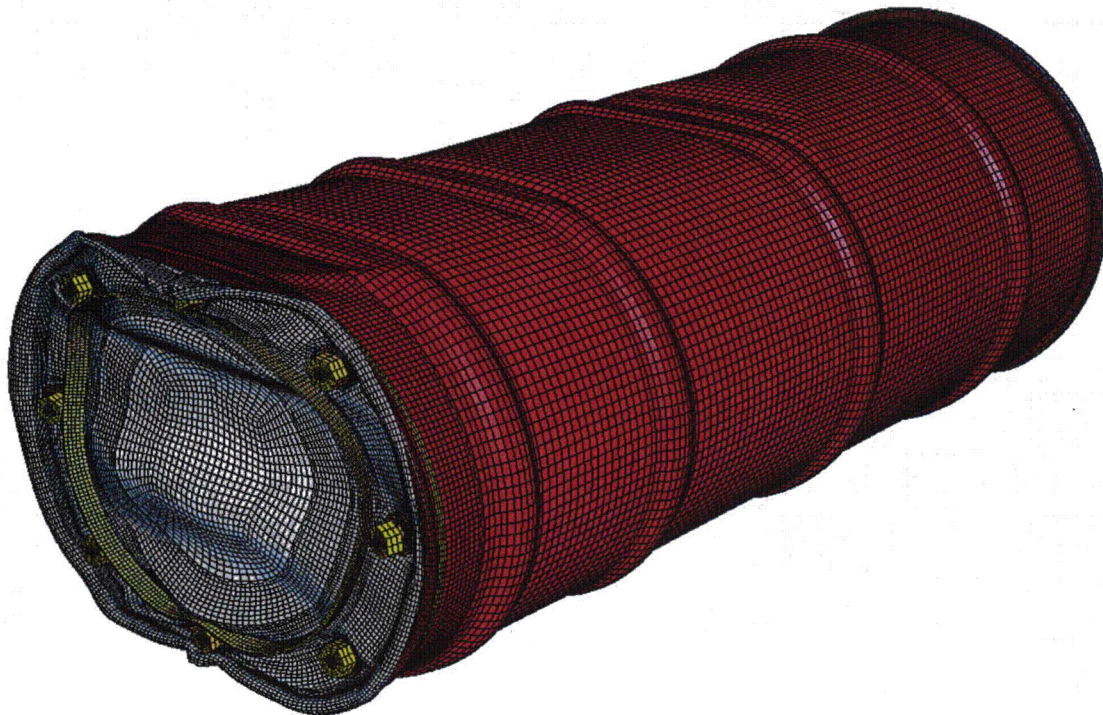
Figure 3.12.1.4 - Run4g, View of the Crush Damage With the Crush Side Up

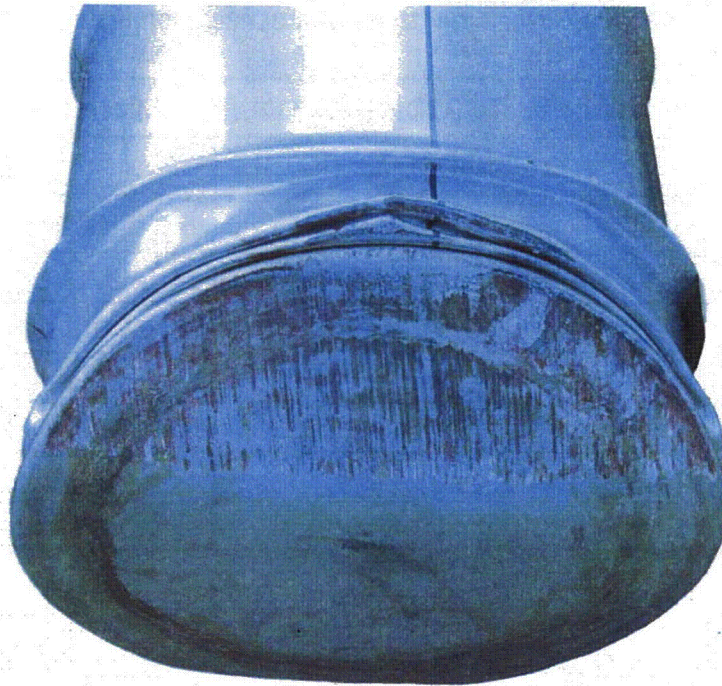
Figure 3.12.2.3 - TU3, Damage to the Bottom Head in the Crush Impact

The final images after the crush impact are shown for the test and the analysis. Figure 3.12.2.3 shows the final shape of the crushed bottom on the test specimen (4ft + 30ft + crush impacts) and Figure 3.12.2.4 shows a similar view of the analysis (30ft + crush impacts).

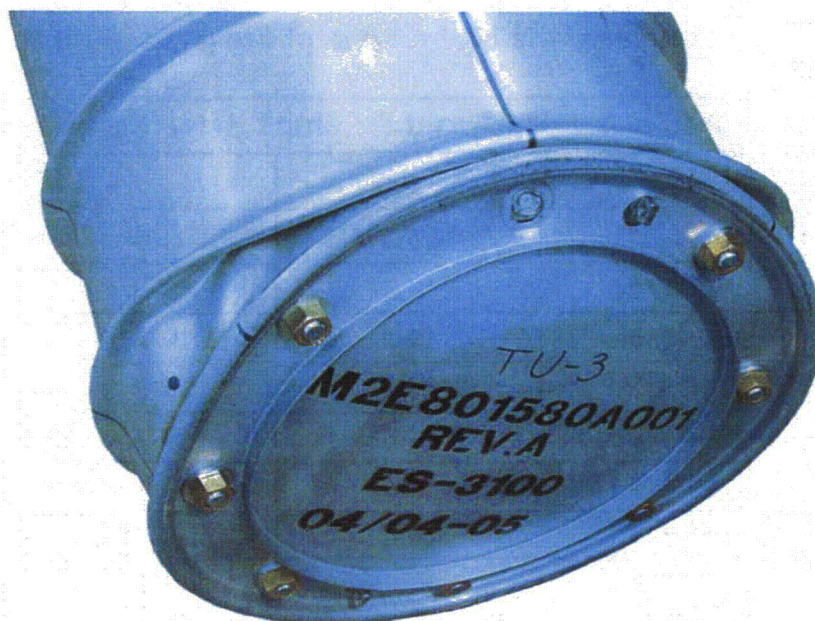
Figure 3.12.2.5 - TU3, Lid Damage from the Crush Impact

The damage to the lid region at the end of the crush impact is shown in Figure 3.12.2.5 for the TU3. The damage to the lid region in the analysis run2e is shown in Figure 3.12.2.6. Note that the stud at the initial 30-foot impact onto the rigid surface has failed in the test. Elevated plastic strains throughout the stud shank are noted in Section 3.5 along with discussion about the stud.

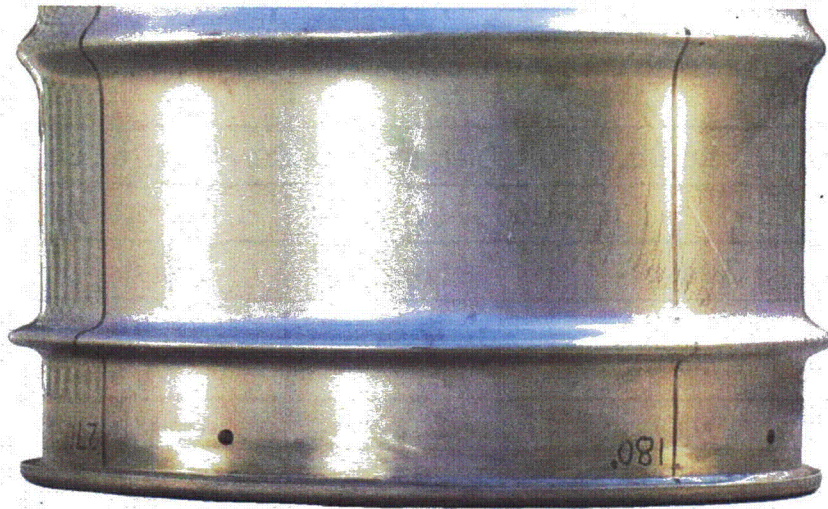
Figure 3.12.3.1 - TU4, 30-Foot Impact Damage

Figure 3.12.3.1 shows the configuration of the TU4 after the 30-foot impact (4ft + 30ft). Figure 3.12.3.2 shows the analysis model configuration after the 30-foot impact in a similar orientation to the test unit.

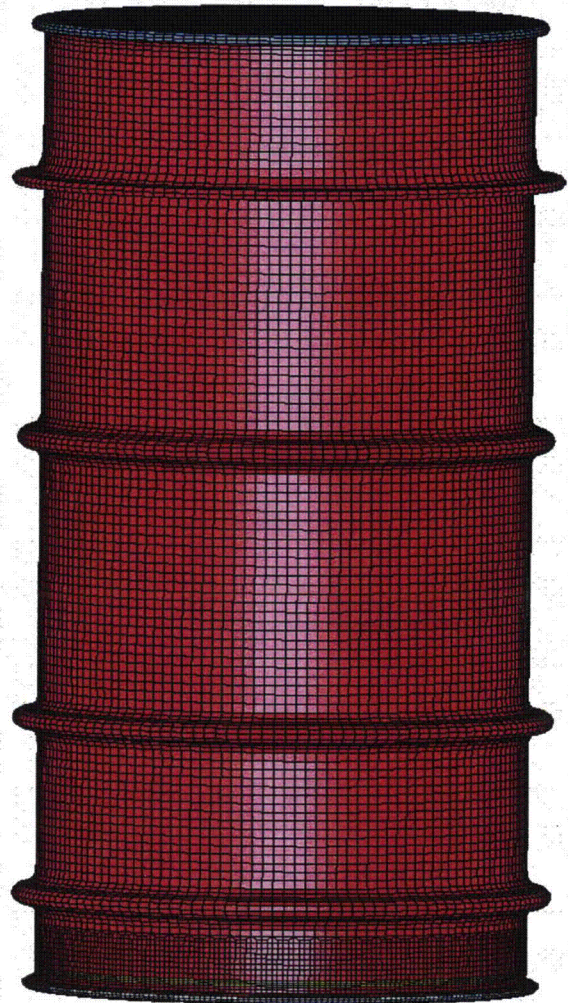
Figure 3.12.3.4 - Run3b, Crush Damage

Figure 3.12.3.3 shows the TU4 at the end of the crush impact (4ft + 30ft + crush), while Figure 3.12.3.4 shows the configuration of the run3b model (30ft + crush).

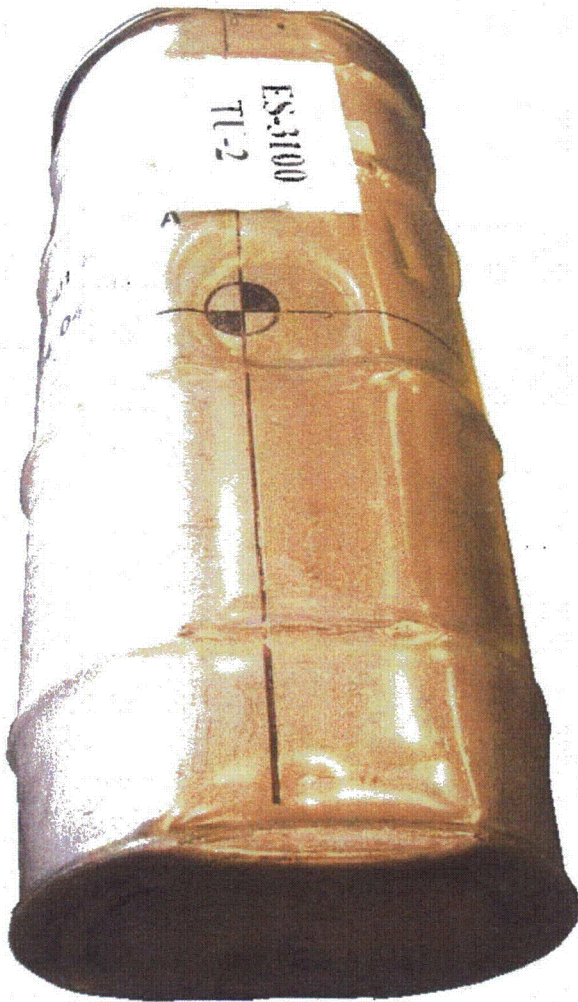
Figure 3.12.4.1 - TU2, Cumulative Damage After the Punch Impact, Rigid Surface Side

A visual comparison of the cumulative damage on the rigid surface side after the four impacts is shown in Figures 3.12.4.1 (test) and Figure 3.12.4.2 (analysis).

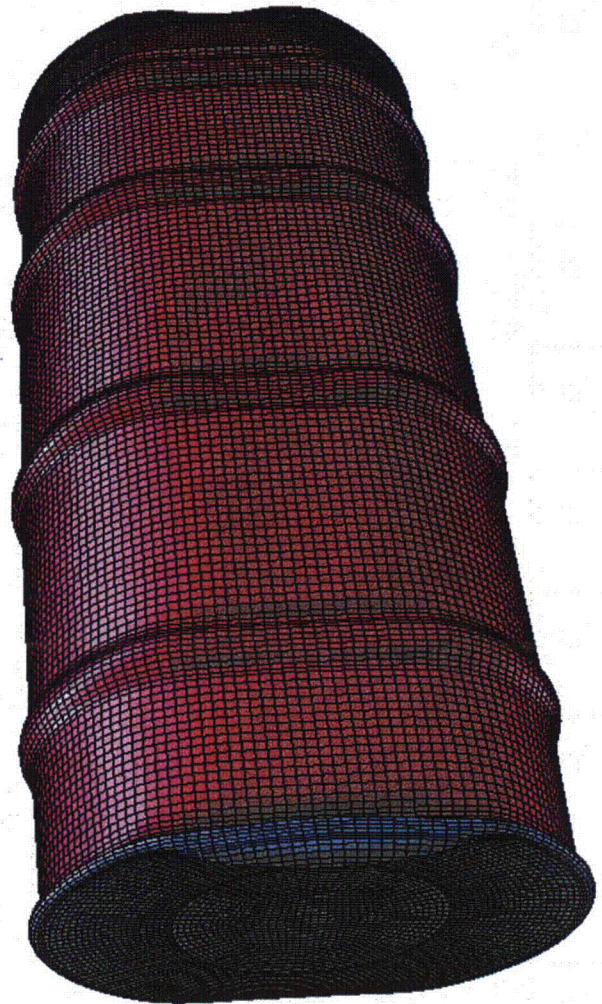
Figure 3.12.4.2 - Run1hh, Cumulative Damage After the Punch Impact, Rigid Surface Side

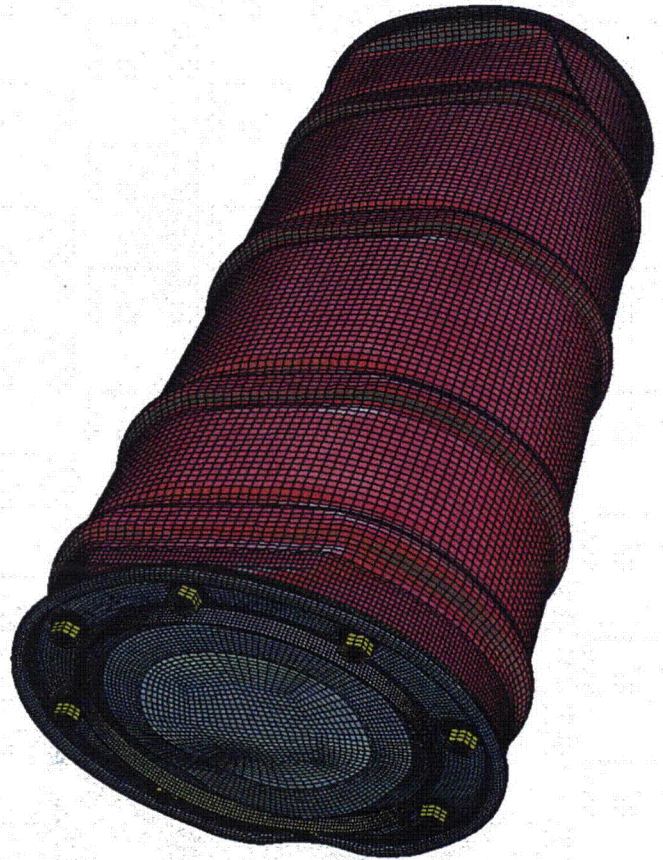
Figure 3.12.4.4 - Run1hh, Cumulative Damage After the Punch Impact, Crush Plate Side

A visual comparison of the cumulative damage on the crush side after the four impacts is shown in Figures 3.12.4.3 (test) and Figures 3.12.4.4 (analysis).

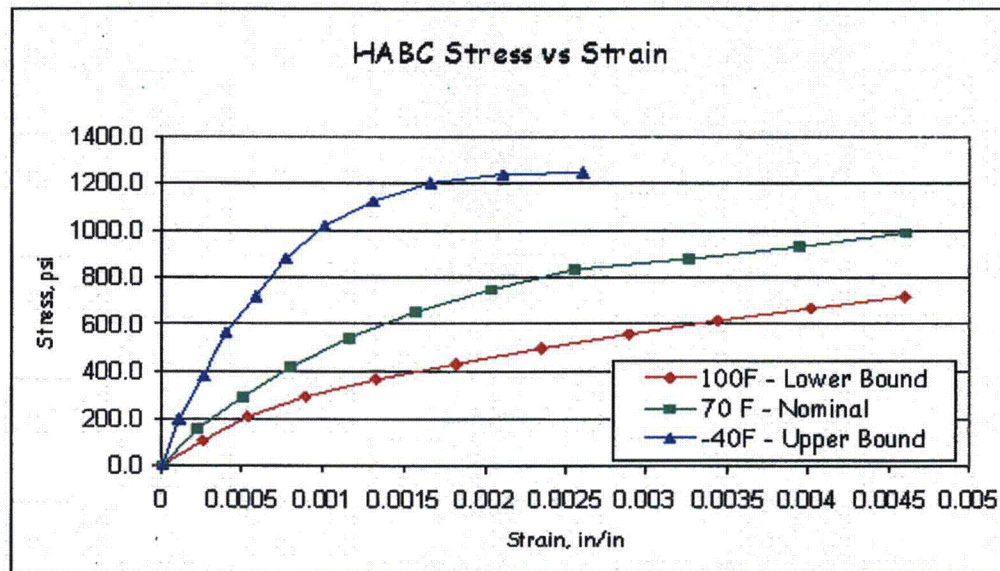
Figure 6.2.1 - HABC Stress vs Strain Curves

The borobond material was replaced with the catalog 277-4 high alumina borated cement material which is described in this section and sub-sections. The LS-Dyna material model used for the HABC material is the *MAT_SOIL_AND_FOAM model. The material data was obtained from testing performed at Y12 in the Fall of 2004. Figure 6.2.1 shows the stress vs strain curves obtained in the test.

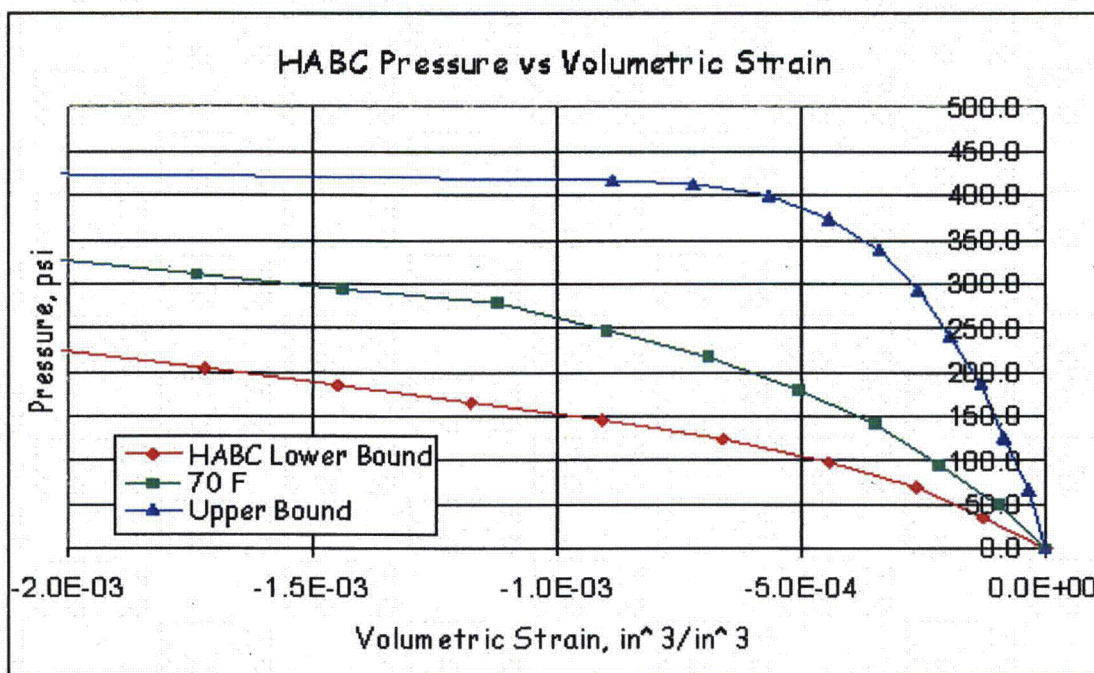
Figure 6.2.3.1 - Volumetric Strain vs Pressure Curves for the HABC Material

The volumetric strain vs pressure curves used by the analytical models are plotted in Figure 6.2.3.1 for the lower values.

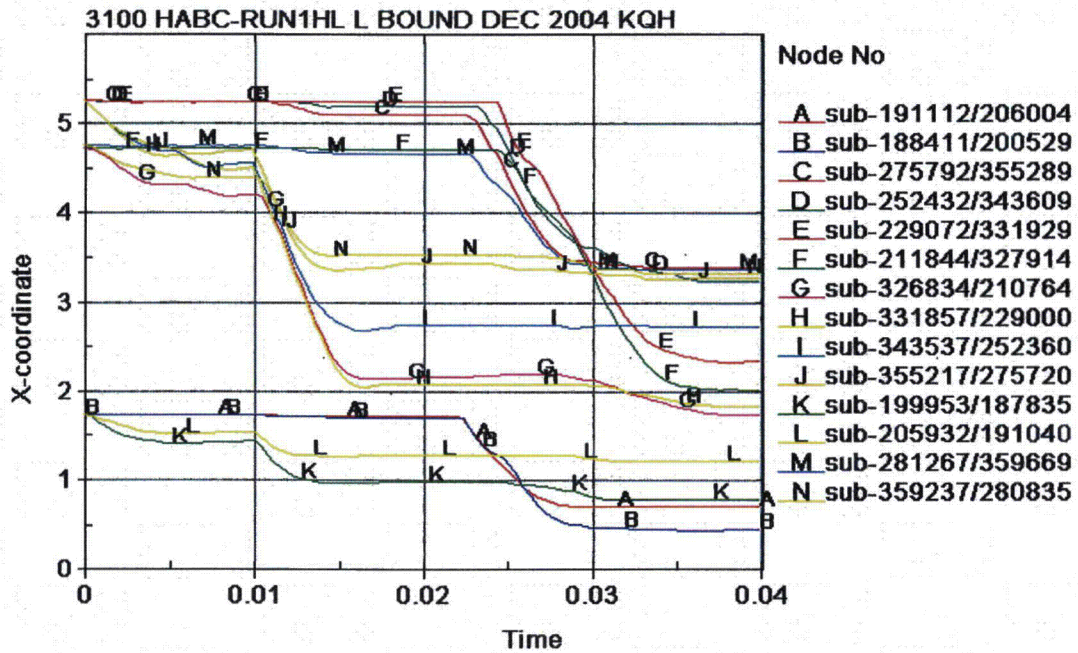
Figure 7.1.17 - HABC-run1hl, Kaolite Thickness Time History
