Site: NORTH ANNA COL.  
Location: CPT-910a

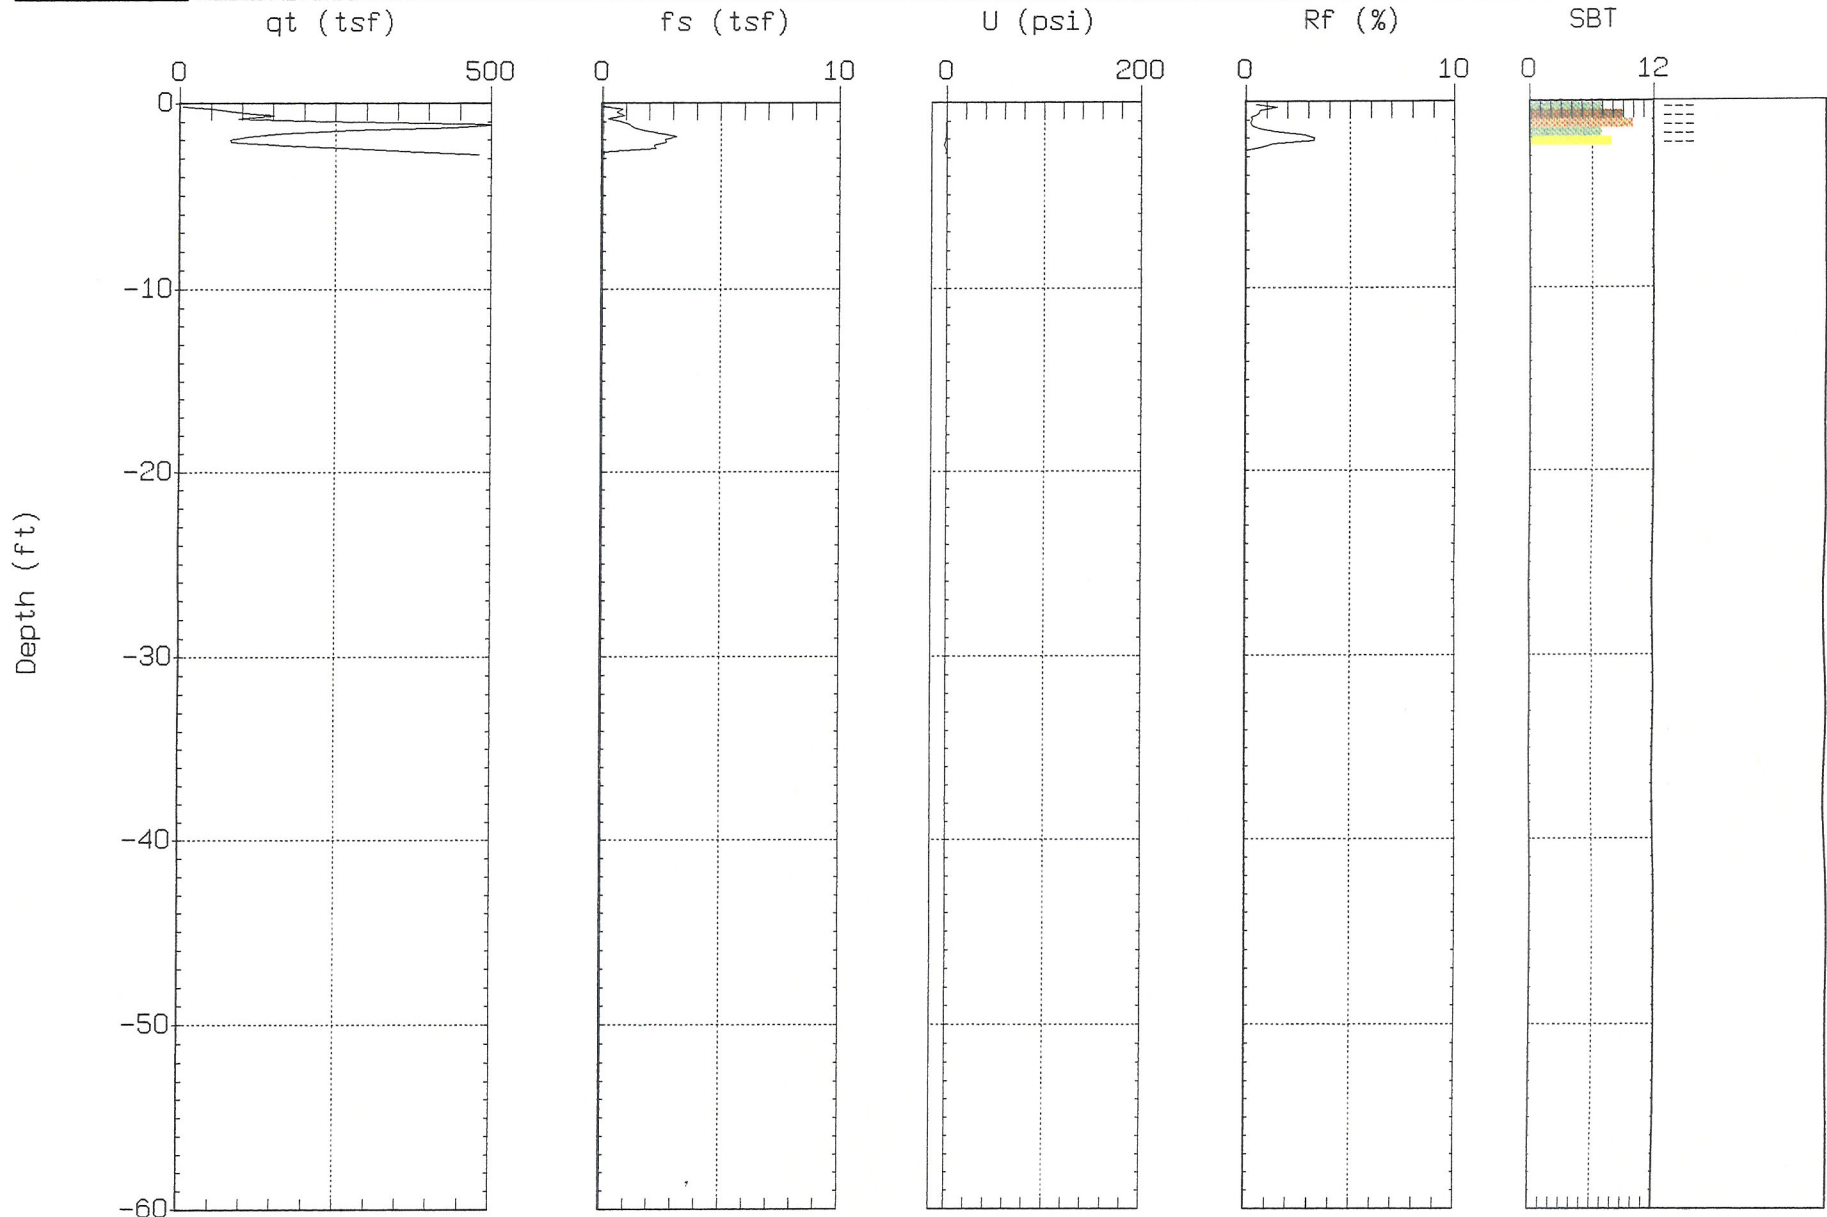
Site: NORTH ANNA COL.  
Location: CPT-912

Max. Depth: 2.79 (ft)  
Depth Inc.: 0.164 (ft)

SBT: Soil Behavior Type (Robertson 1990)

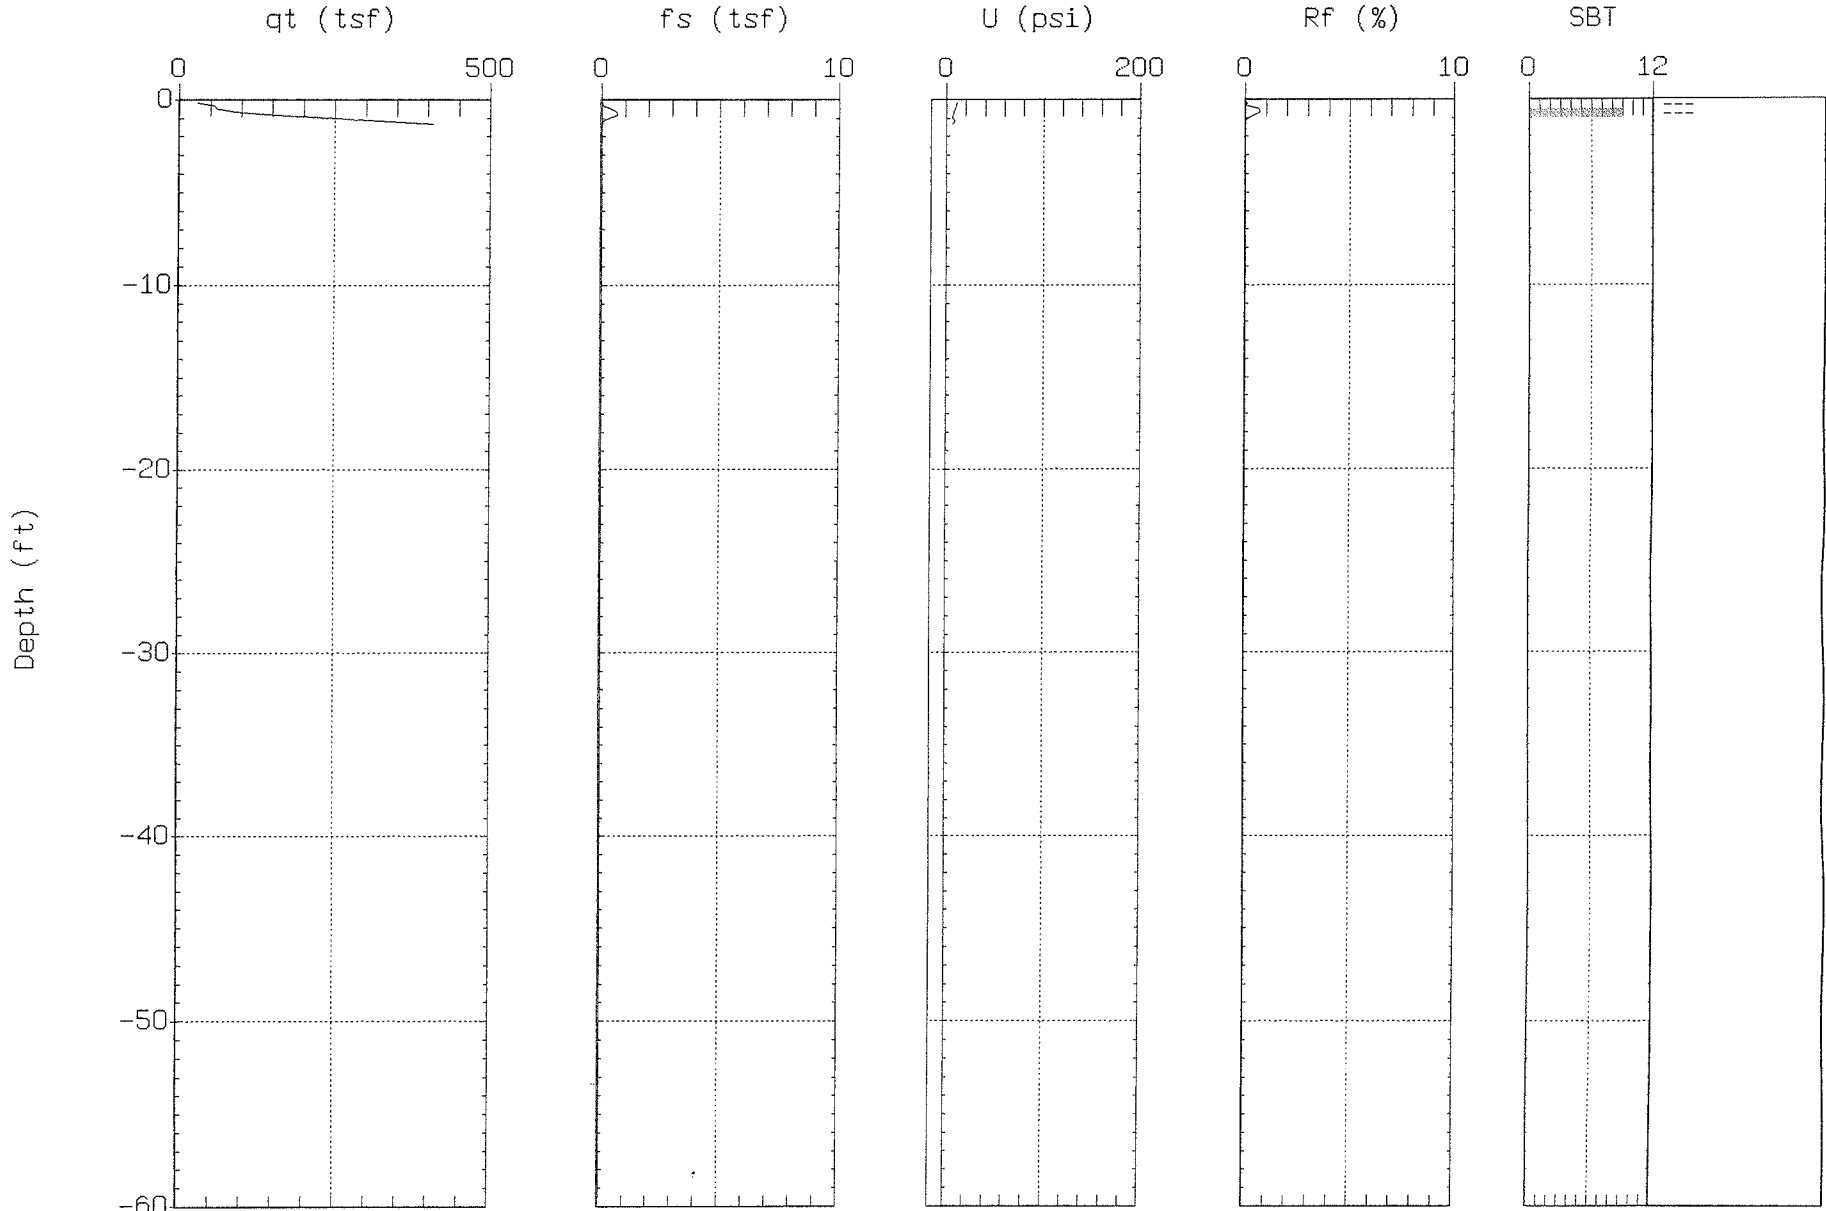
Site: NORTH ANNA COL.  
Location: CPT-913

Max. Depth: 1.31 (ft)  
Depth Inc.: 0.164 (ft)

SBT: Soil Behavior Type (Robertson 1990)

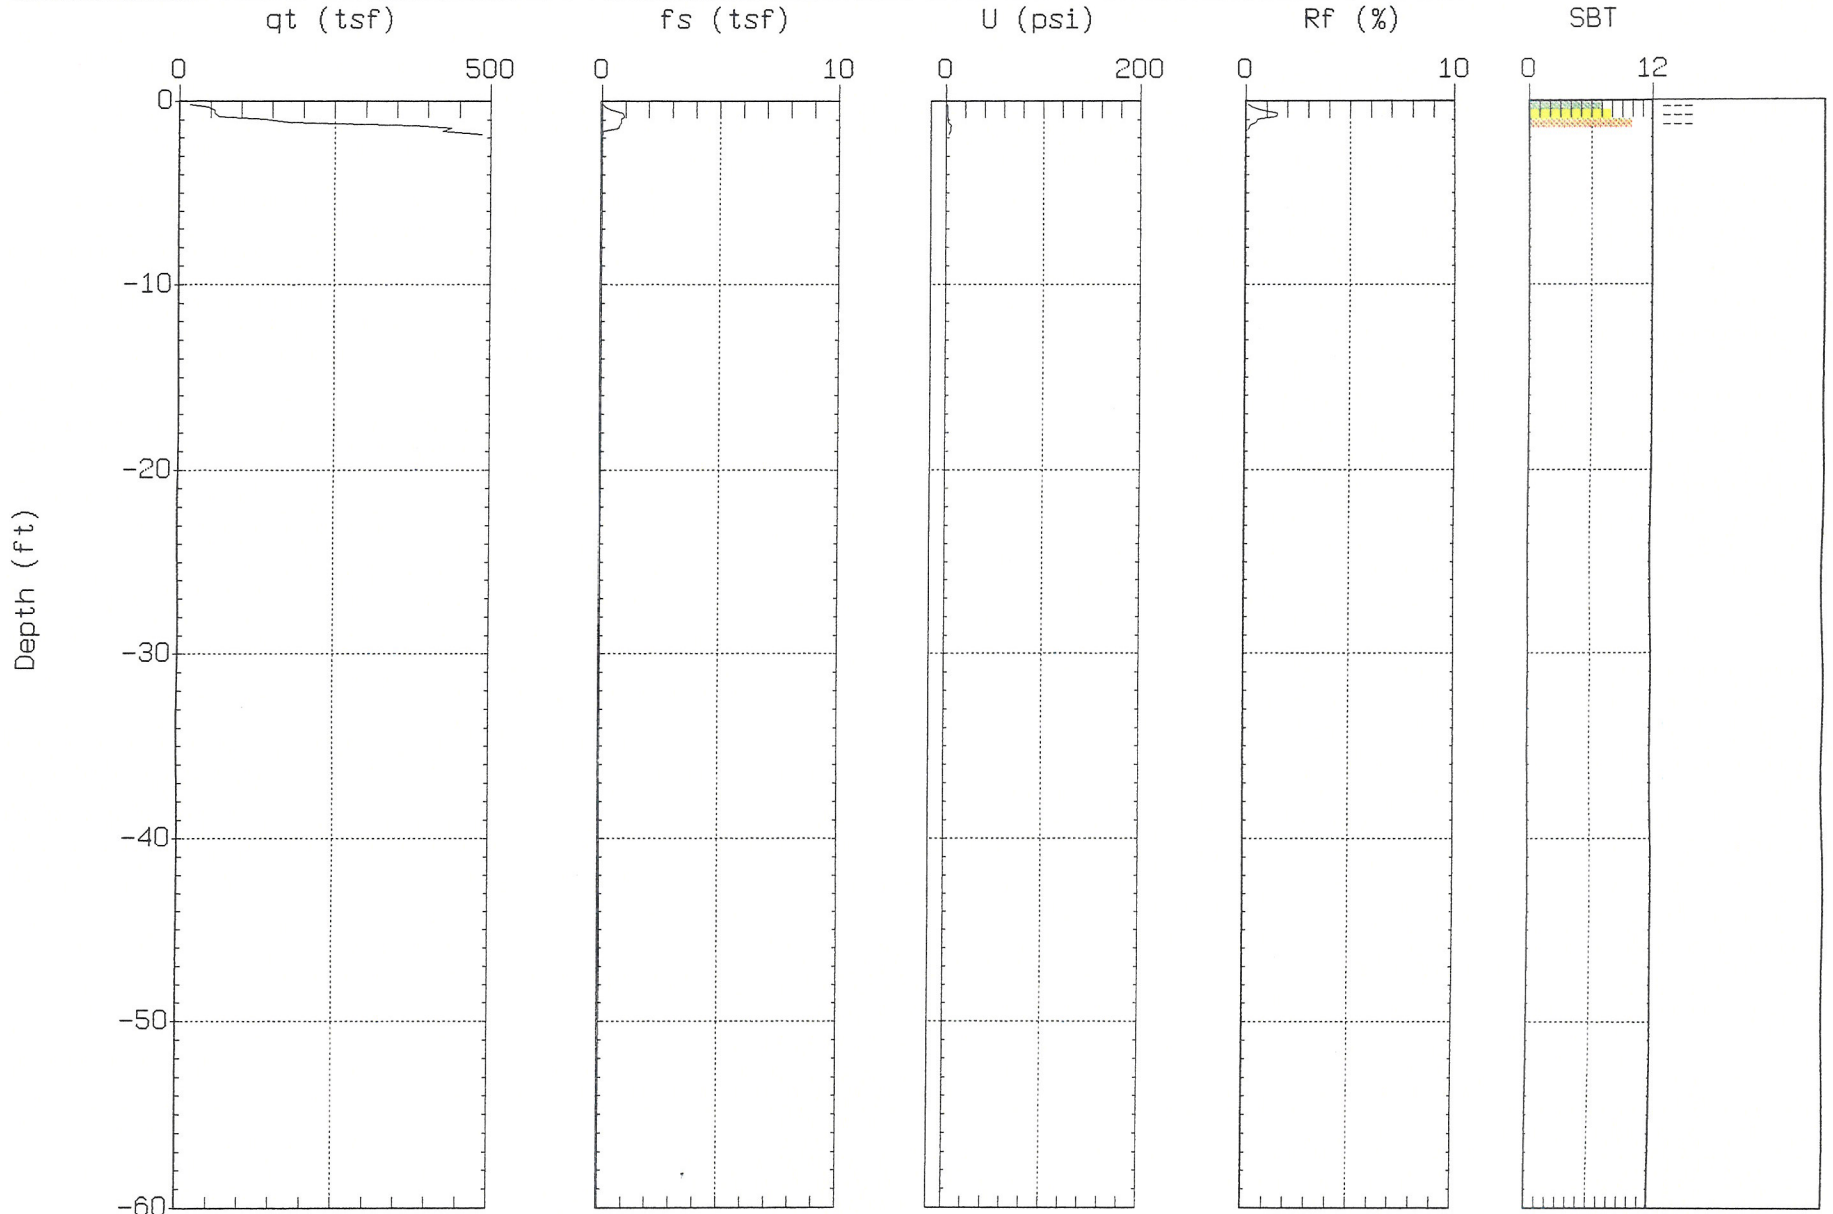
Site: NORTH ANNA COL.  
Location: CPT-913a

Max. Depth: 1.80 (ft)  
Depth Inc.: 0.164 (ft)

SBT: Soil Behavior Type (Robertson 1990)

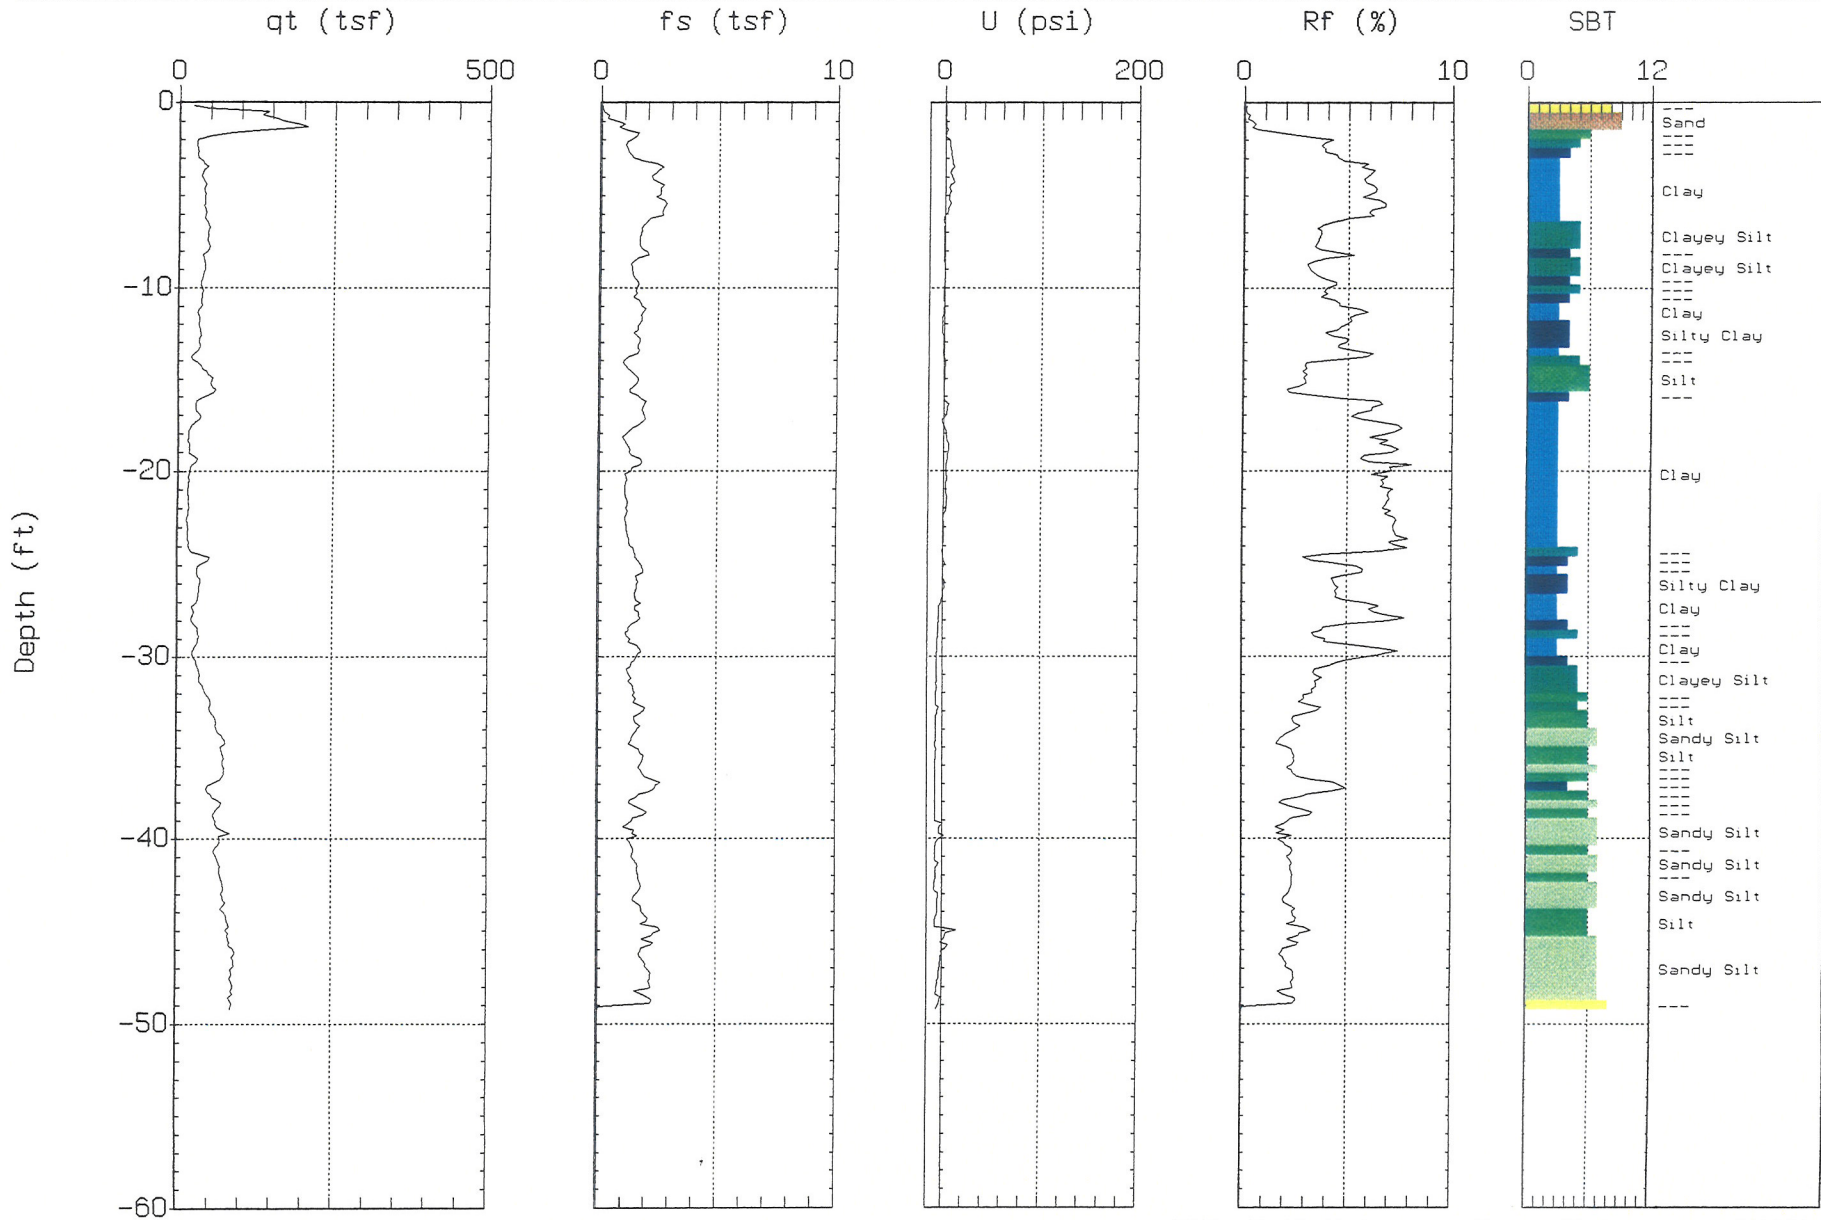
Site: NORTH ANNA COL.  
Location: CPT-917

Max. Depth: 49.21 (ft)  
Depth Inc.: 0.164 (ft)

SBT: Soil Behavior Type (Robertson 1990)

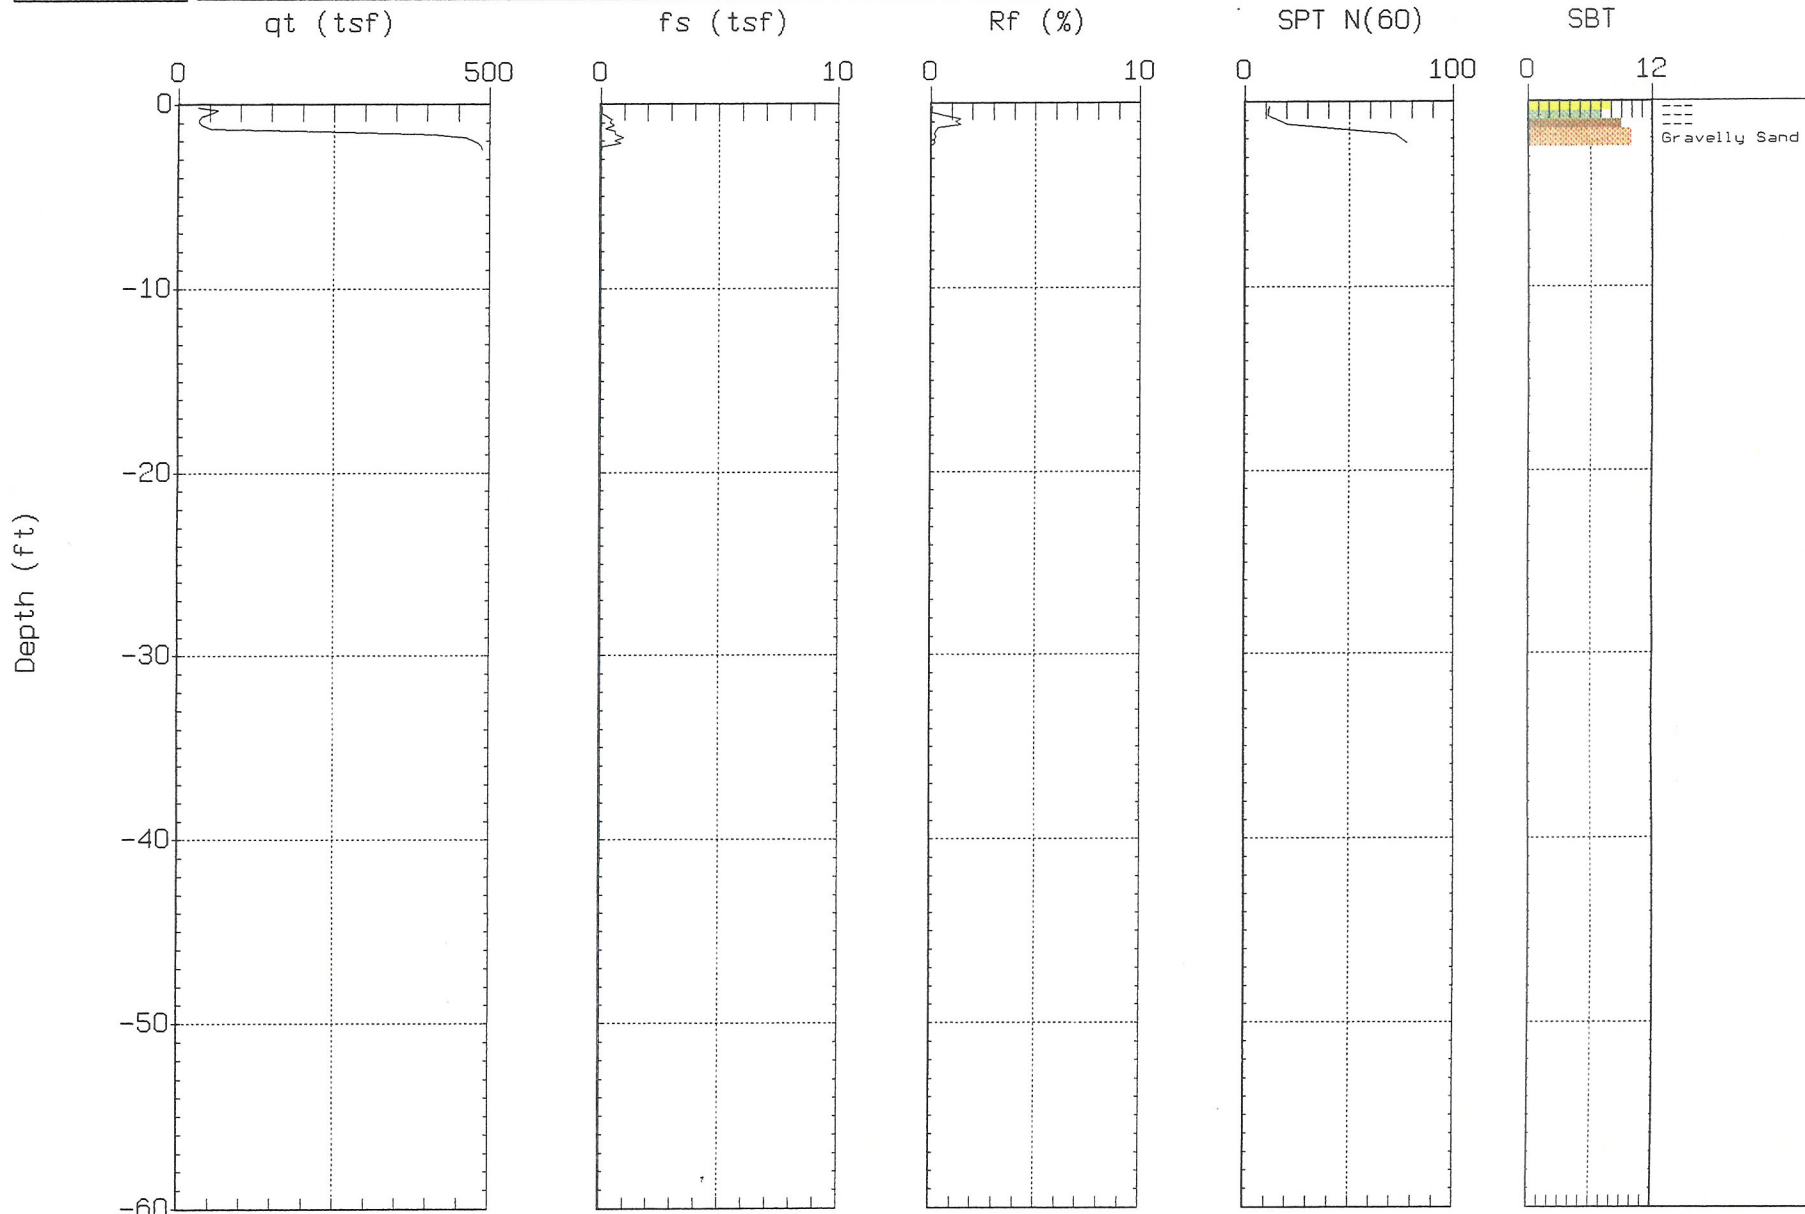
Site: NORTH ANNA COL.  
Location: CPT-904

Max. Depth: 2.46 (ft)  
Depth Inc.: 0.164 (ft)

SBT: Soil Behavior Type (Robertson 1990)
