WILLIAM STATES LEE III
NUCLEAR STATION UNITS 1 & 2

Discharge Rating Curve,
Ninety-Nine Islands Dam

FIGURE 2.4.3-213 Rev 0

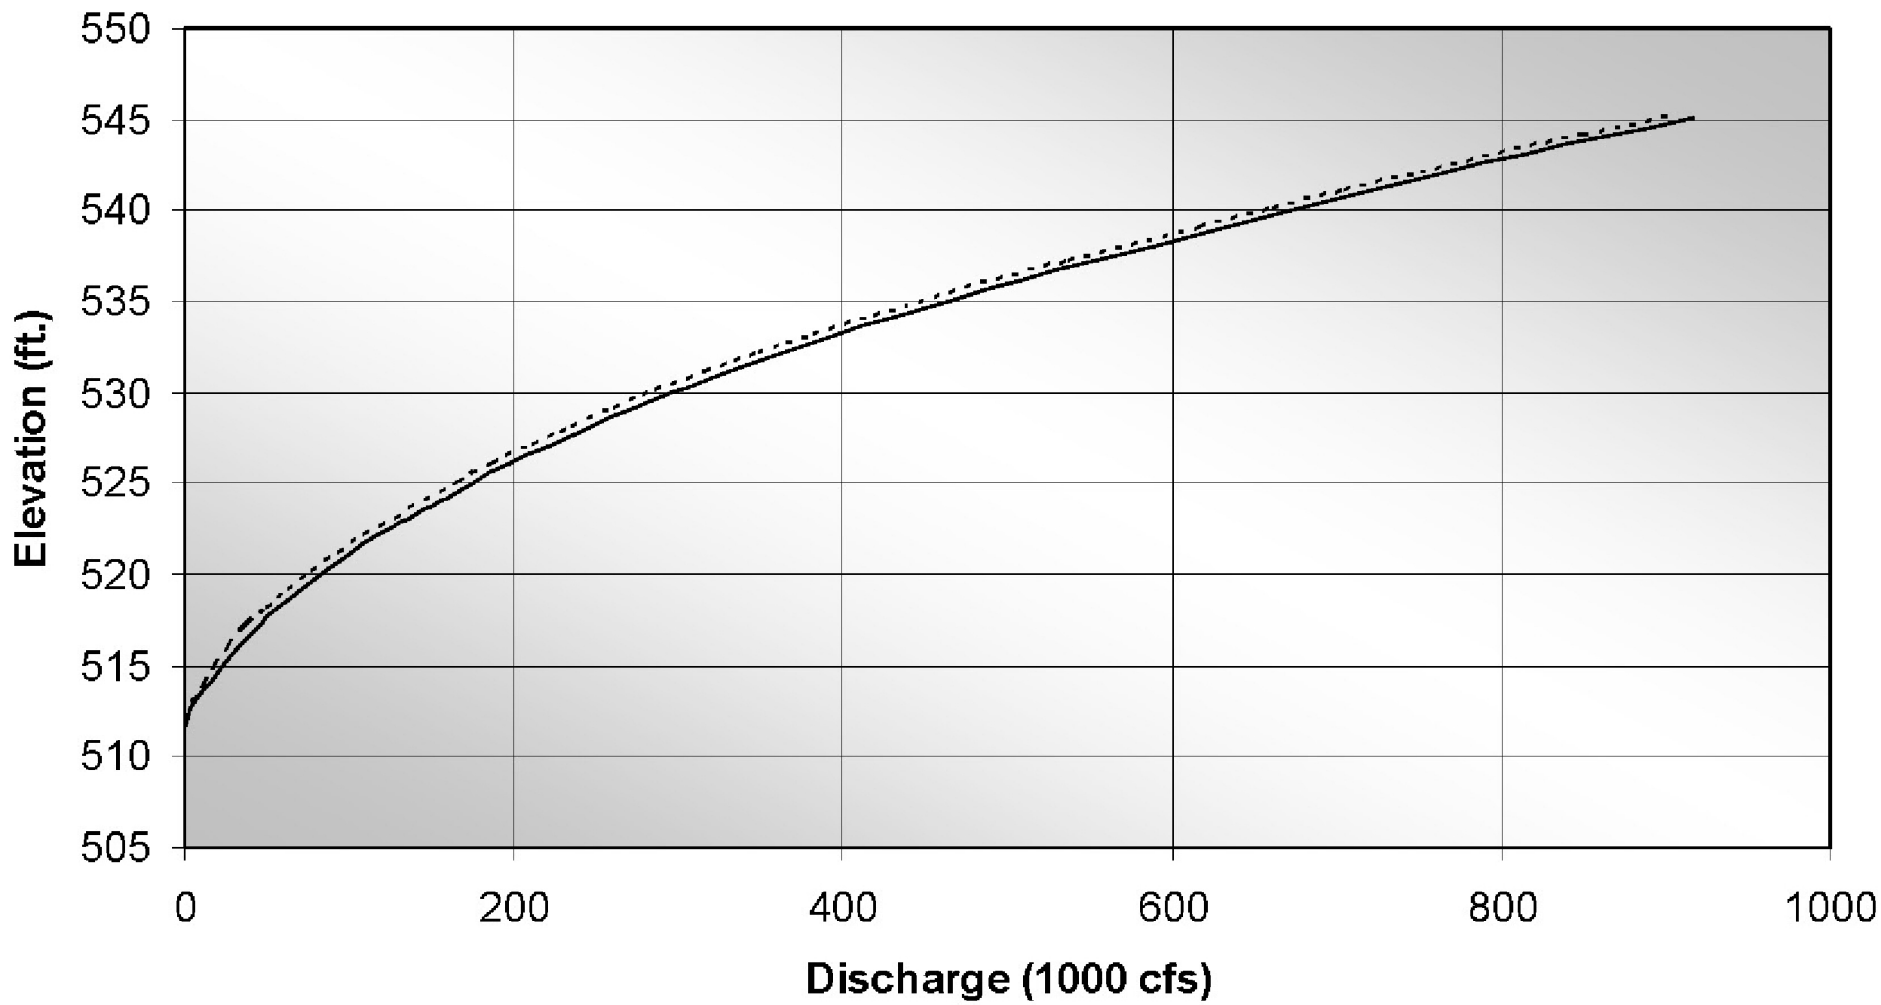
— flashboard failure at 6 ft. - - - - - no flashboard failure
