WILLIAM STATES LEE III
NUCLEAR STATION UNITS 1 & 2

FIGURE 2.4.3-231 Rev 7

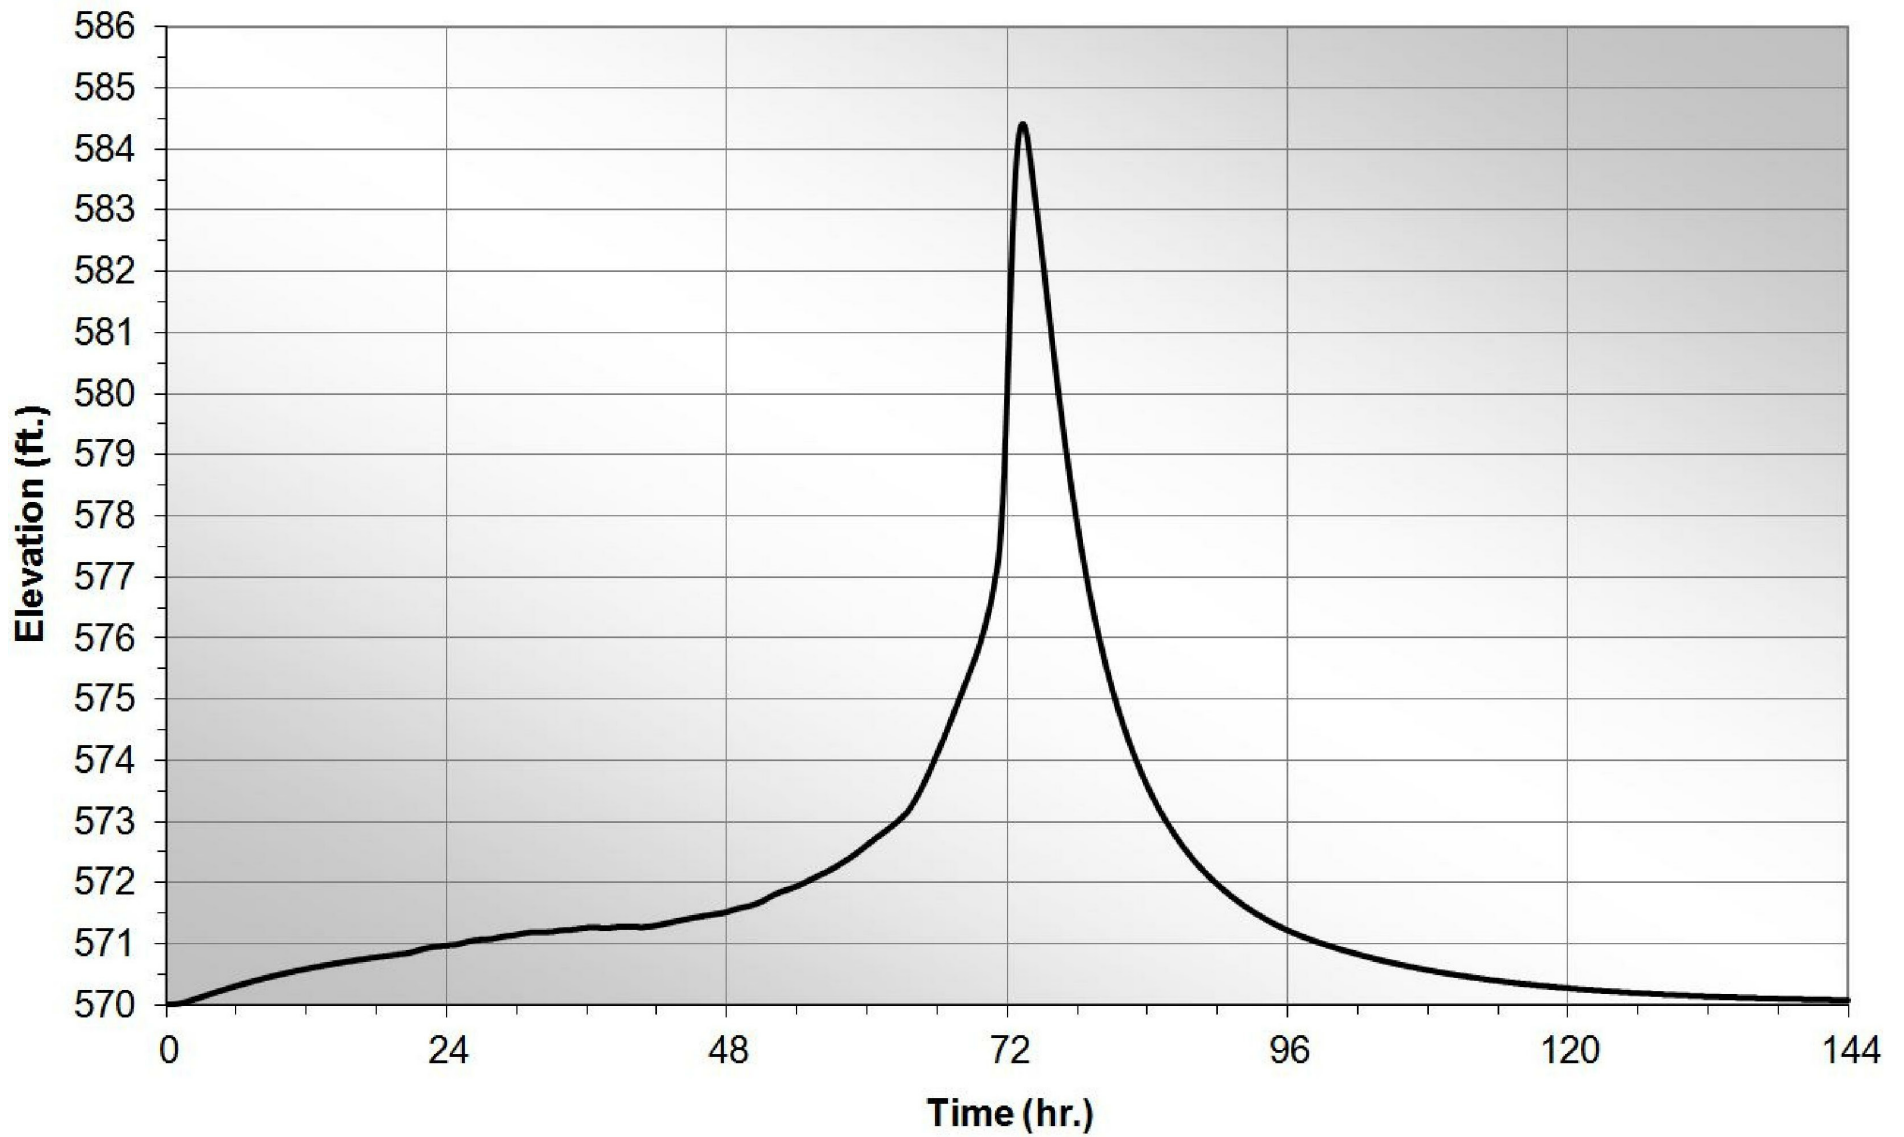
Flood El. Hydrograph Make-Up Pond B
Without Upper Arm Dam Failure,
72-hr. Local Intense Precipitation
