**SUBJECT: WATERBURY CLOCK COMPANY-5 – REQUEST FOR INITIAL SITE VISIT
AND TO PERFORM RADIOLOGICAL SURVEYS**

Waterbury Clock Company: Site Summary

1998 Radiological Survey Results for the former Waterbury Clock Buildings (ATSDR PHA, 1999)

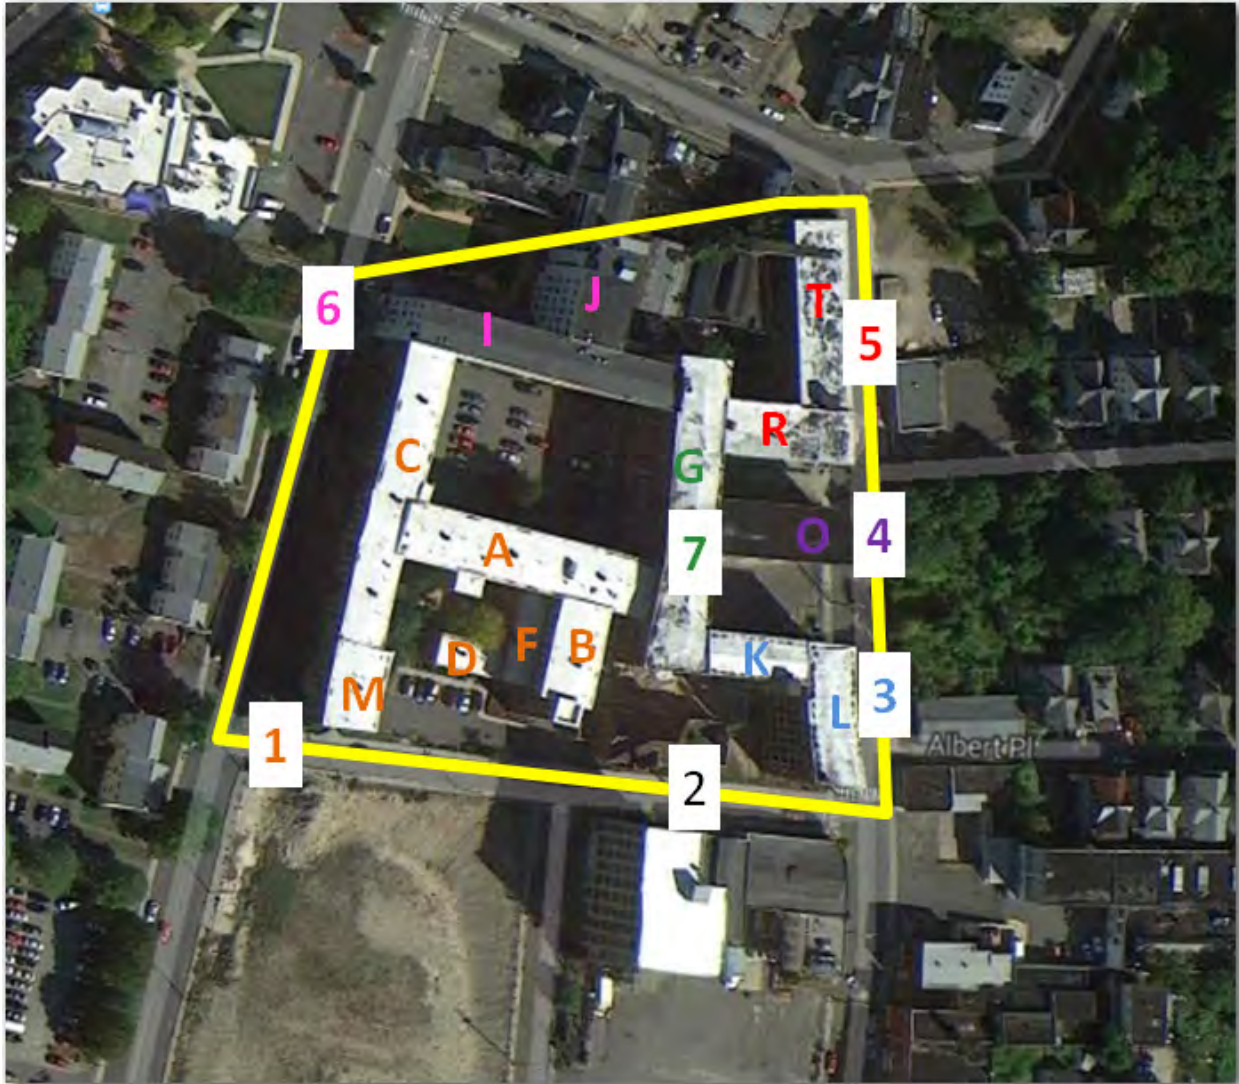
Figure 1. Location of Waterbury Clock Company Facilities and surrounding Affected Facilities (1 – 13 Cherry Ave, buildings A, B, C, D, F, and M, Enterprise Apartments; 2 – 0 Cherry Ave, building #7, vacant; 3 – 177 Cherry St, buildings K and L, vacant; 4 – 205 Cherry St, building O, Ville Swiss Automatics; 5 – 215 Cherry St, buildings R and T, vacant; 6 – 232 N Elm St, buildings I and J, NOW; 7 – 39 Cherry Ave, building G, formerly Belco, now vacant and owned by NOW) (Google Earth, 2015)
