Detroit City Airport: Site Summary

Site Description/History

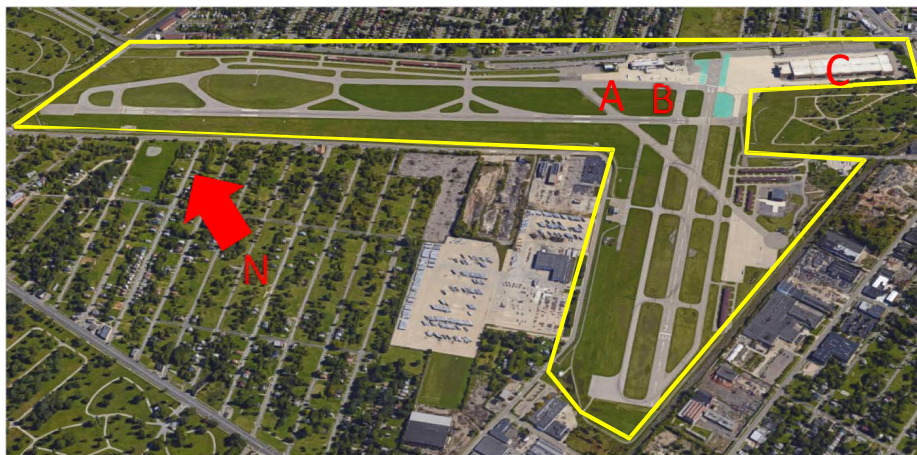
Figure 1. Coleman A. Young International Airport, formerly Detroit City Airport (Google Earth, 2017).
A. Control Tower; B. Current Terminal (built in 1966); C. Executive Terminal (built in 1930).

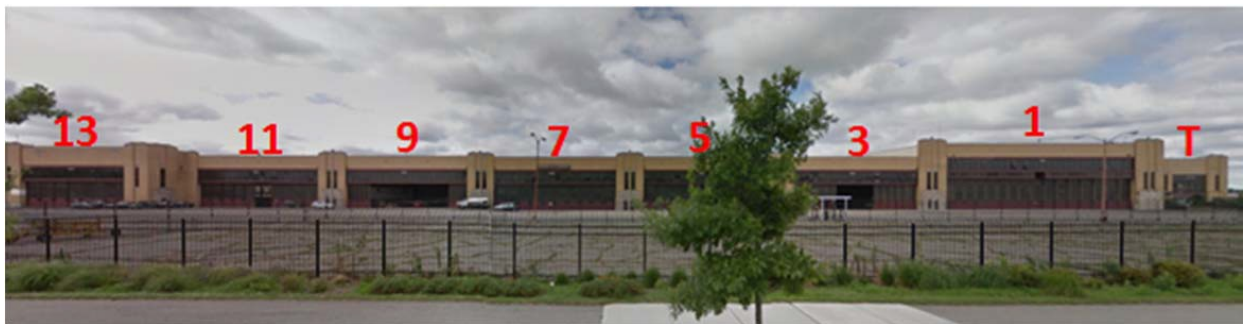
The Executive Terminal (see Figures 2 and 3), which consists of 14 hangar bays and the old terminal/administration area, has a footprint of approximately 205,000 ft². The executive terminal extends 1,014 feet in length parallel to Conner Street (Figure 3). Its width measures 250 feet wide at the southeast end, 204 feet wide for the middle 786 feet, and 127.5 feet wide for the 114 foot-long bay on the northern end. The two-story structure sits on a concrete pile foundation. The Executive Terminal has been used for many different purposes since 2000.

Figure 3. Executive Terminal, view from Connor Street, showing location of original terminal/administration area (T) and approximate locations of odd-numbered hangars (Google Earth, 2017).

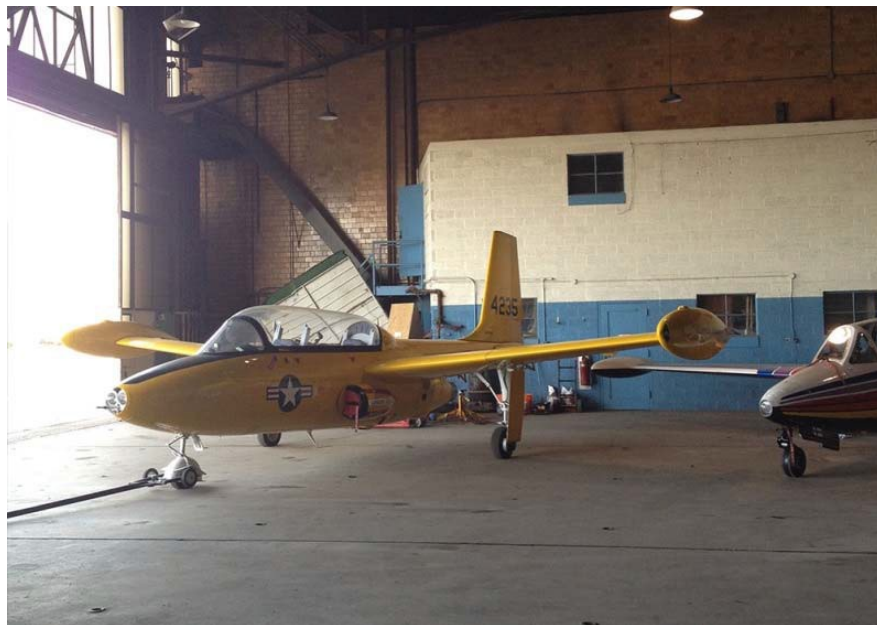
Figure 5 shows an image inside one of the hangars; a concrete block structure with two floors of rooms is visible in the background. Other information indicates one and two level structures in some of the hangars were wooden or sheet metal, and it is suspected these rooms were for storage and/or aircraft maintenance activities.

Figure 5. Example of “rooms” inside hangars of the Executive Terminal at Detroit City Airport. Note the blue and white two-story block structure in the hangar bay.
