## Questions from the October 26, 2022, Email

### **Additional Questions from the November 3, 2022, Teleconference**

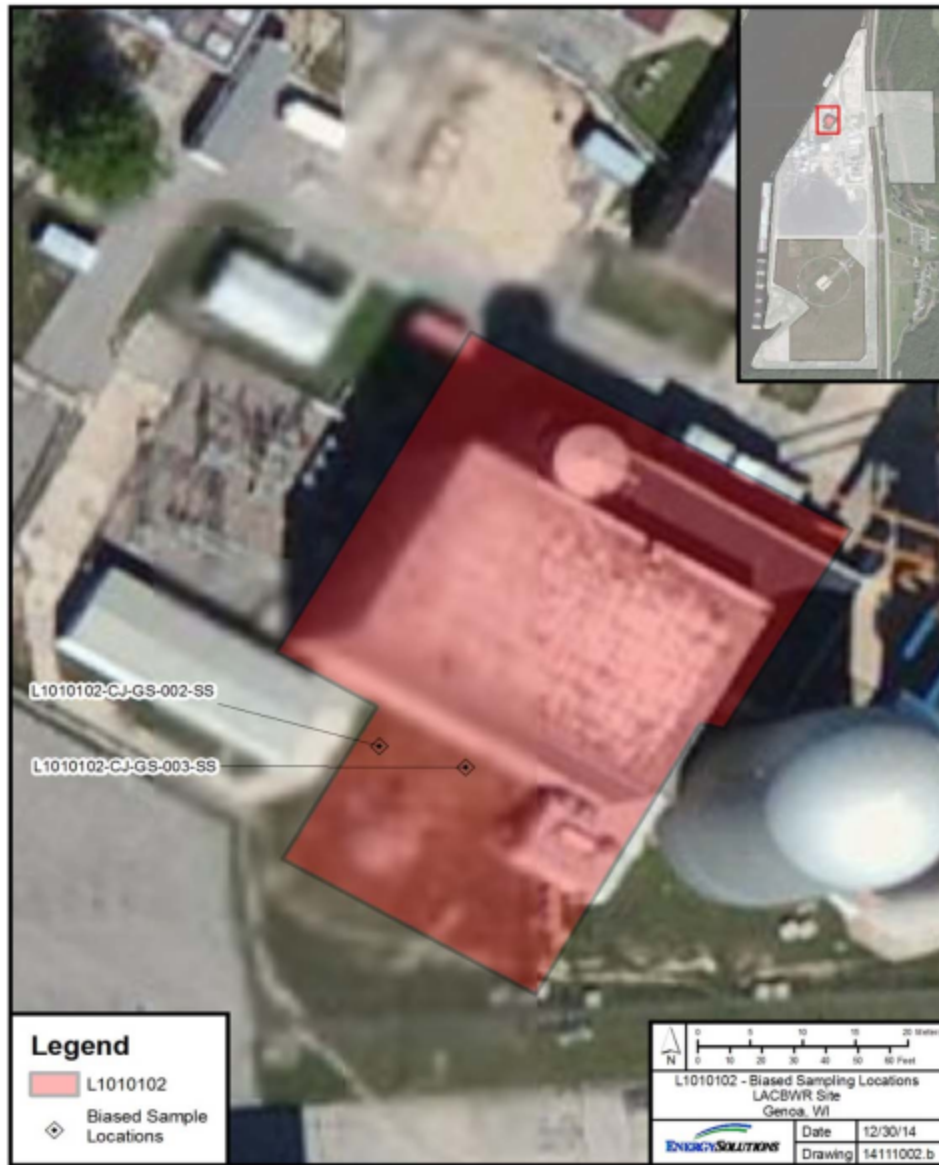
**Figure 9-2 L1010102 Biased Sampling Locations**

The figure below (Figure 9-2 of GG-EO-313196-RS-RP-001) shows the locations of the soil samples depicted in the above table. **Note: only two locations are shown in the figure below. Samples 007, 008, and 009 are subsurface of location 002. 011, 012, and 013 are subsurface of location 003.**

*Subsurface characterization of the areas around and beneath the Turbine Building show that there was no significant surface or subsurface soil contamination. Table 9-4 of the Characterization Survey Report for 2014 (GG-EO-313196-RS-RP-001, Revision 0), below, shows the results of the subsurface soil analysis performed in survey unit L1-010-102, which were to a maximum depth of 4 meters.*

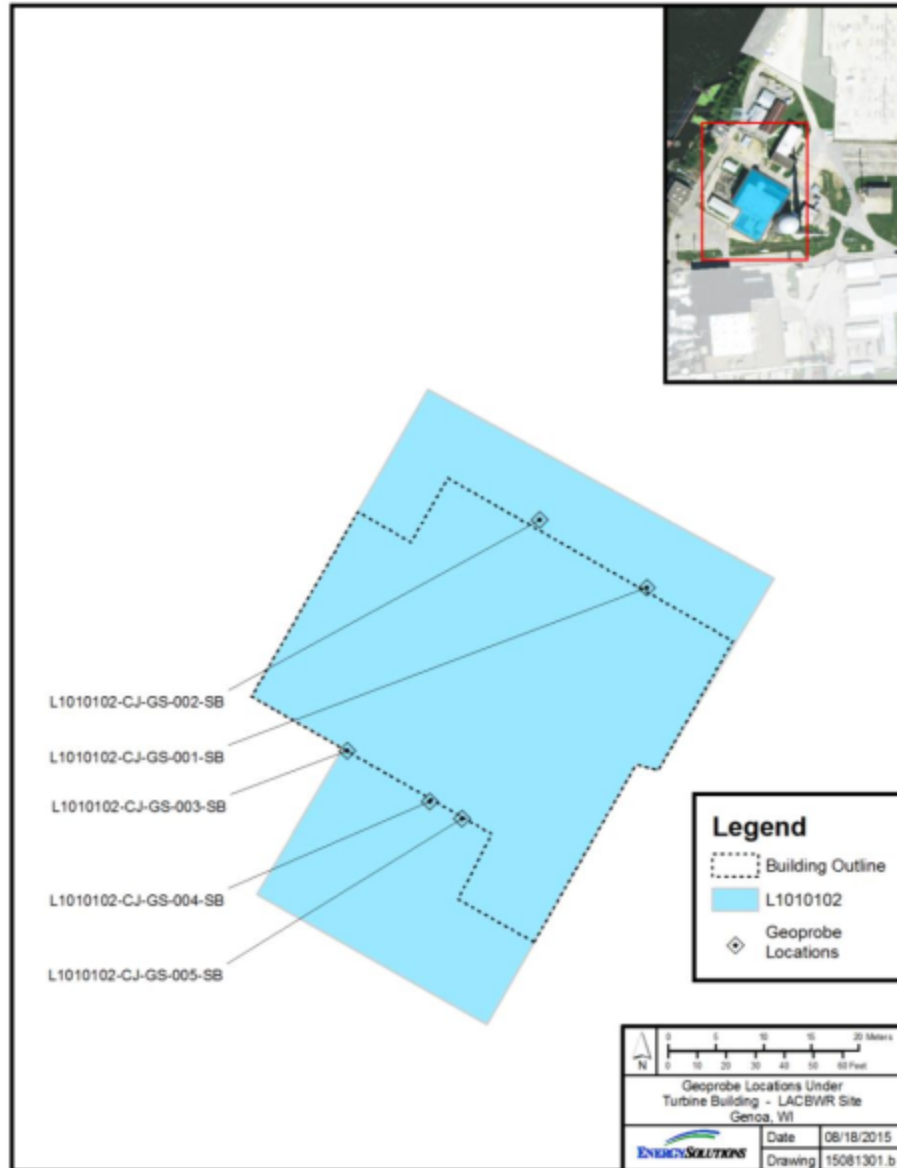
**Figure 9-4 Turbine Building Geoprobe Soil Scanning Locations**

The figure below (Figure 9-4 of LC-RS-PN-164017-001) shows the locations of the soil samples depicted in the above table.

Table 9-6 of the Characterization Survey Report for 2015 (LC-RS-PN-164017-001, Revision 0), below, shows the results of the subsurface soil analysis performed in survey unit L1-010-102, which were angled bore samples to a maximum depth of 20 feet beneath the Turbine Building.

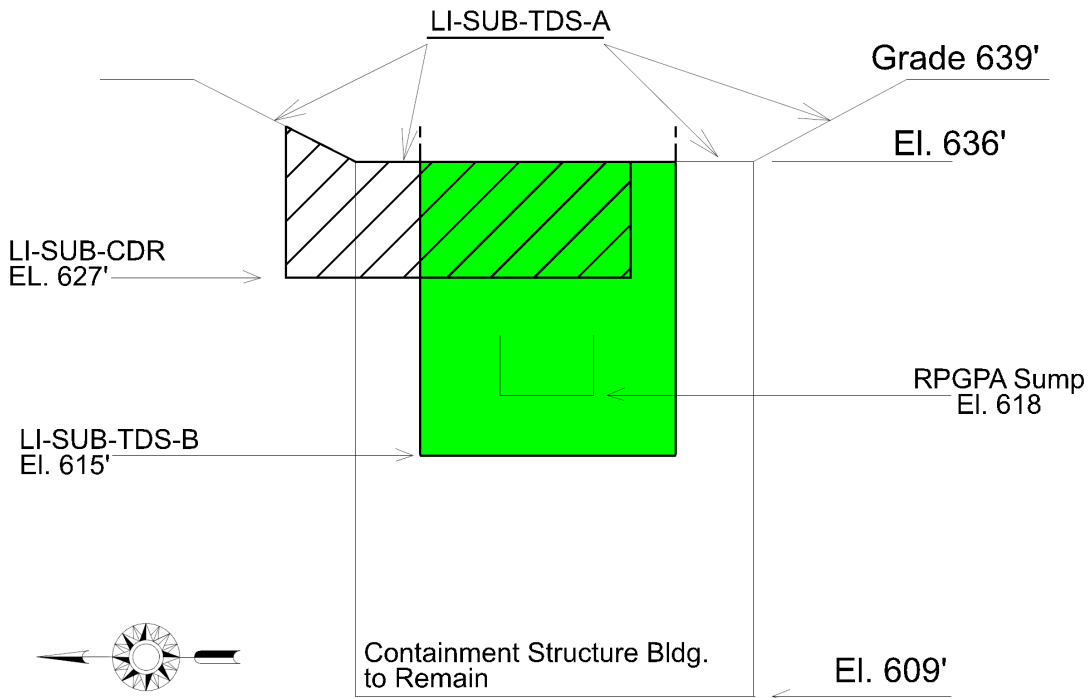
#### East-Facing Layout of CDR, TDS-A, and TDS-B Excavations

CDR Facing East

*Excavation and demolition of the Pipe Tunnel/RPGPA (L1-SUB-CDR) was completed in August to September 2017. L1-SUB-CDR was excavated to approximate elevation 627' and L1-SUB-TDS-B was excavated to approximate elevation 618'. Backfill of the area was*

completed between 09/20/2017 and 09/26/2017, except for the RPGPA/Sump area (L1-SUB-TDS-B) which was backfilled 04/18/2019. L1-SUB-CDR was backfilled to approximate elevation 629', and L1-SUB-TDS-B was backfilled to approximate elevation 636'.

Portions of L1-SUB-TDS-A consisted of sloping to enable FSS Technicians to access L1-SUB-TDS-B. L1-SUB-TDS-A never reached the extent of where L1-SUB-CDR was excavated to. In the vicinity of L1-SUB-CDR and L1-SUB-TDS-B, the elevation of L1-SUB-TDS-A ranged from approximate elevations 639' to 632'. The FSS of L1-SUB-TDS-A was performed 06/26/2019 through 07/12/2019. L1-SUB-TDS-A is at different elevations than L1-SUB-TDS-B, the majority of which is higher than L1-SUB-TDS-B.

As explained above, no excavation affected the final surface (subject to FSS) of another excavation. These survey units overlap in some areas on the (x,y) axis, but when taking into account the depth (z) of each excavation, the surfaces subjected to FSS do not interact. All isolation and control measures were adhered to, the main mechanism being the use of backfill, to ensure survey results were not compromised.
