Humboldt Bay
Independent Spent Fuel Storage Installation
Site-Specific License Renewal Application

Pacific Gas and Electric Company

Revision 0 July 2018
NRC Docket No. 72-27

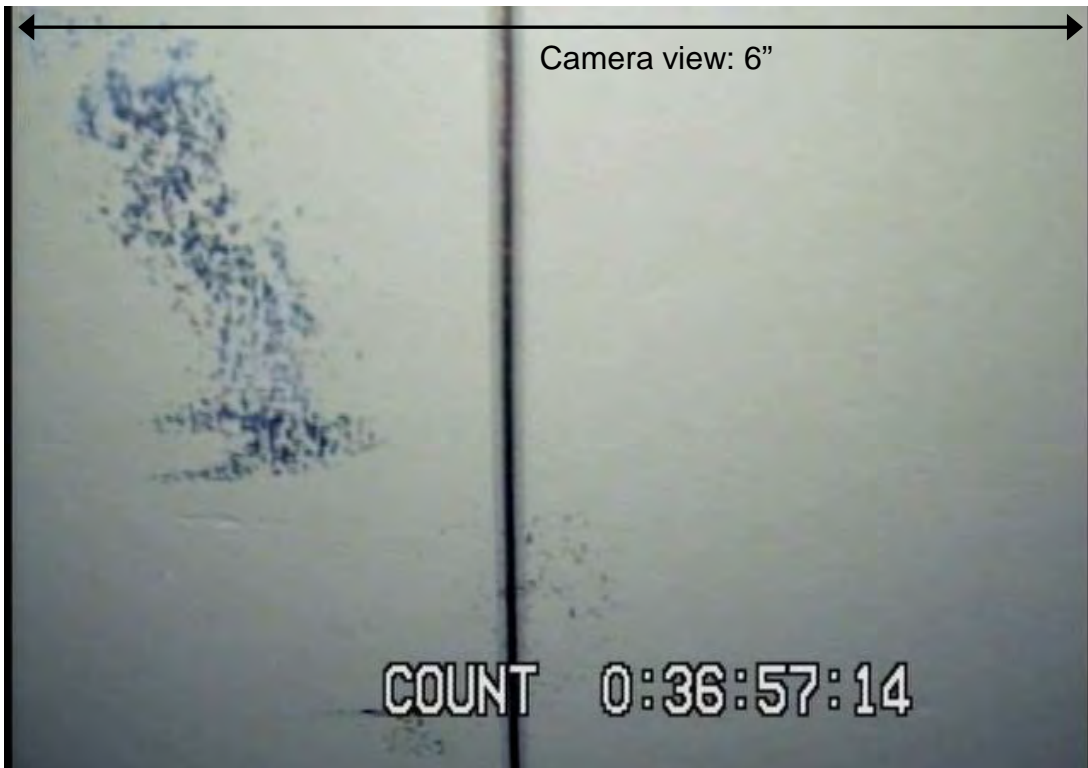
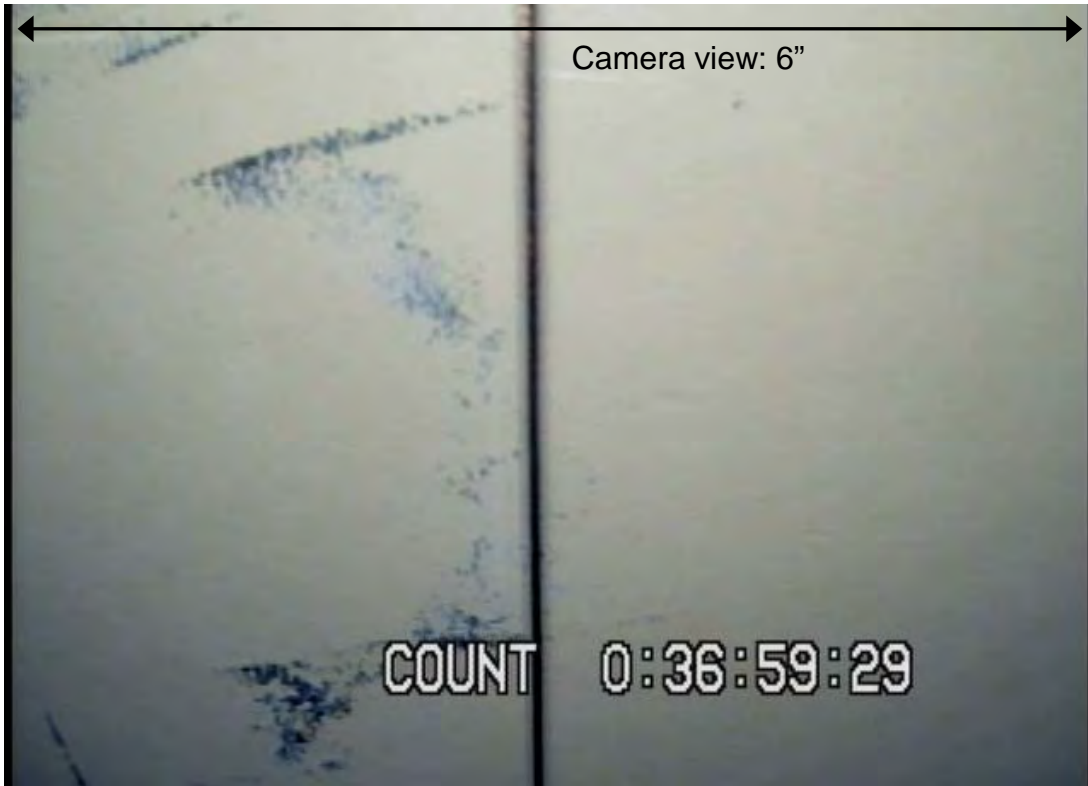
25. Scan 22 rub mark

26. Scan 22 rub mark

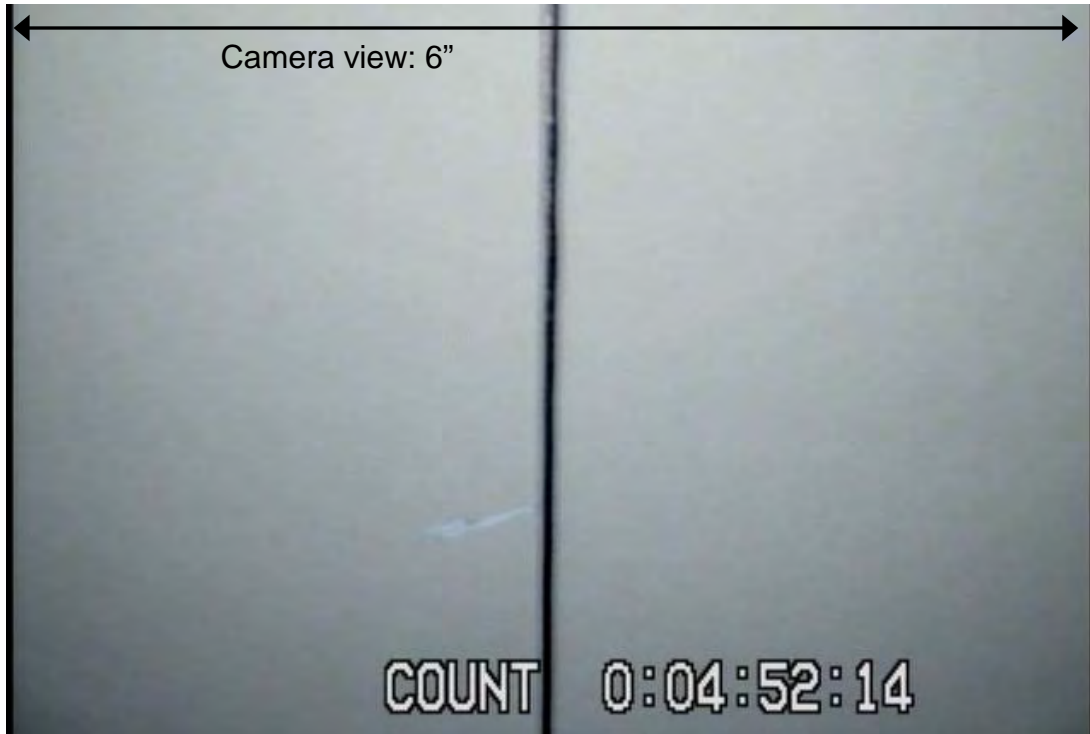
32. Scan 38 coating scrape

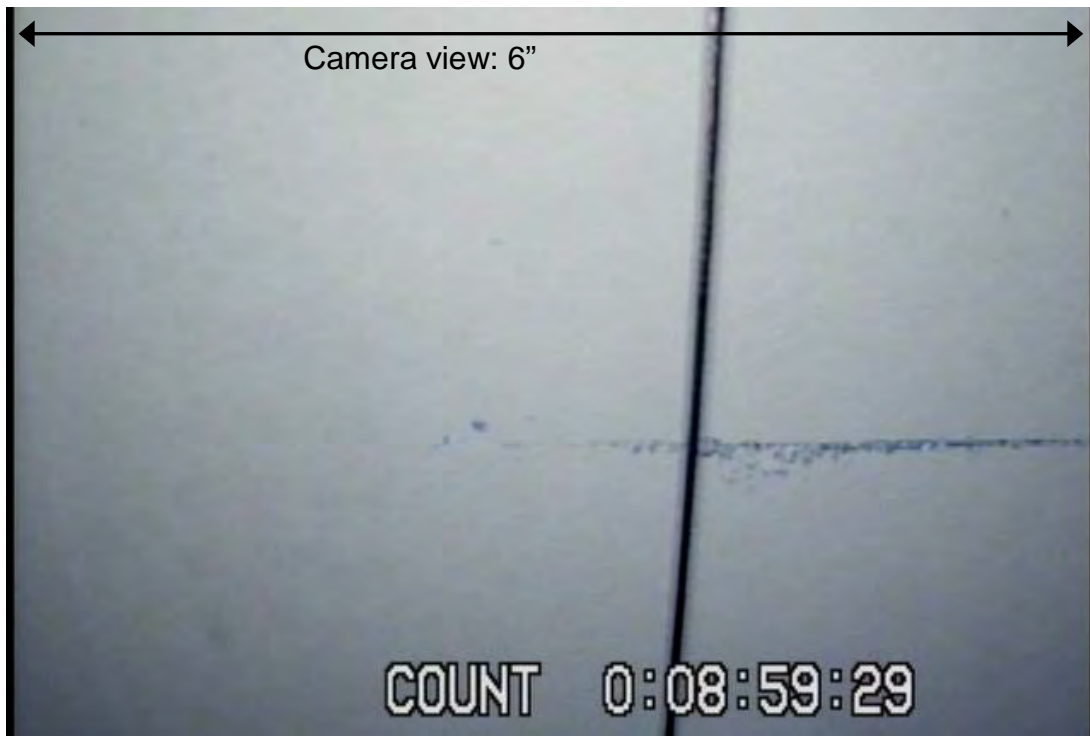
33. Scan 40 coating scrape

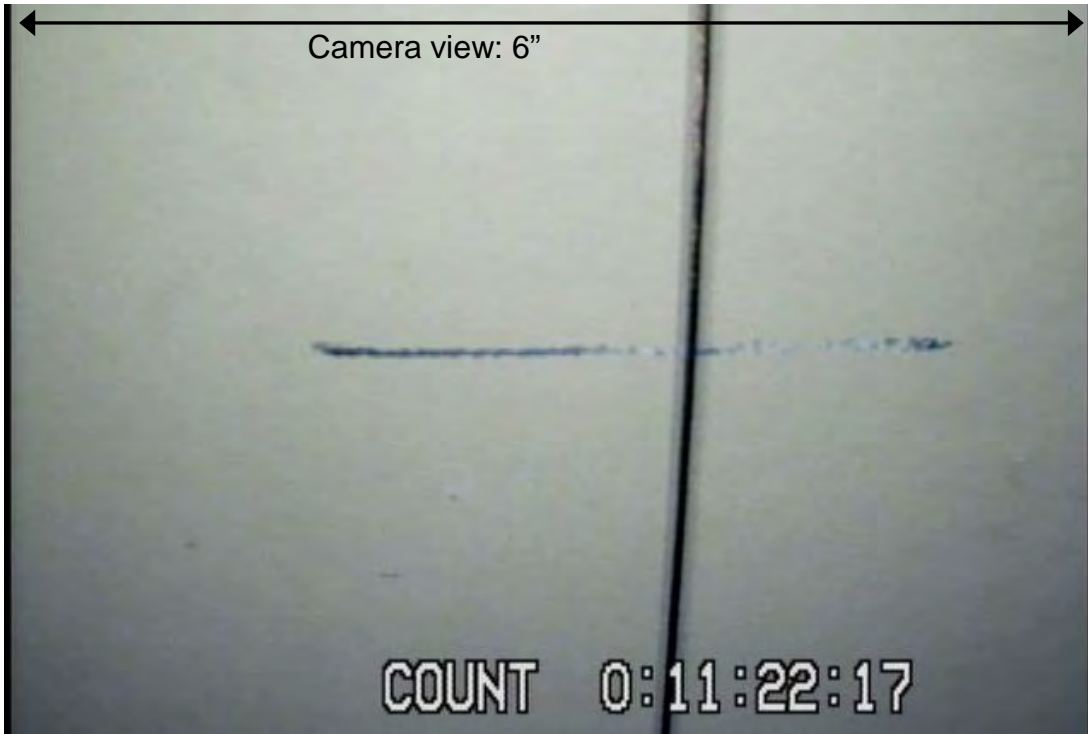
34. Scan 42 coating scrape

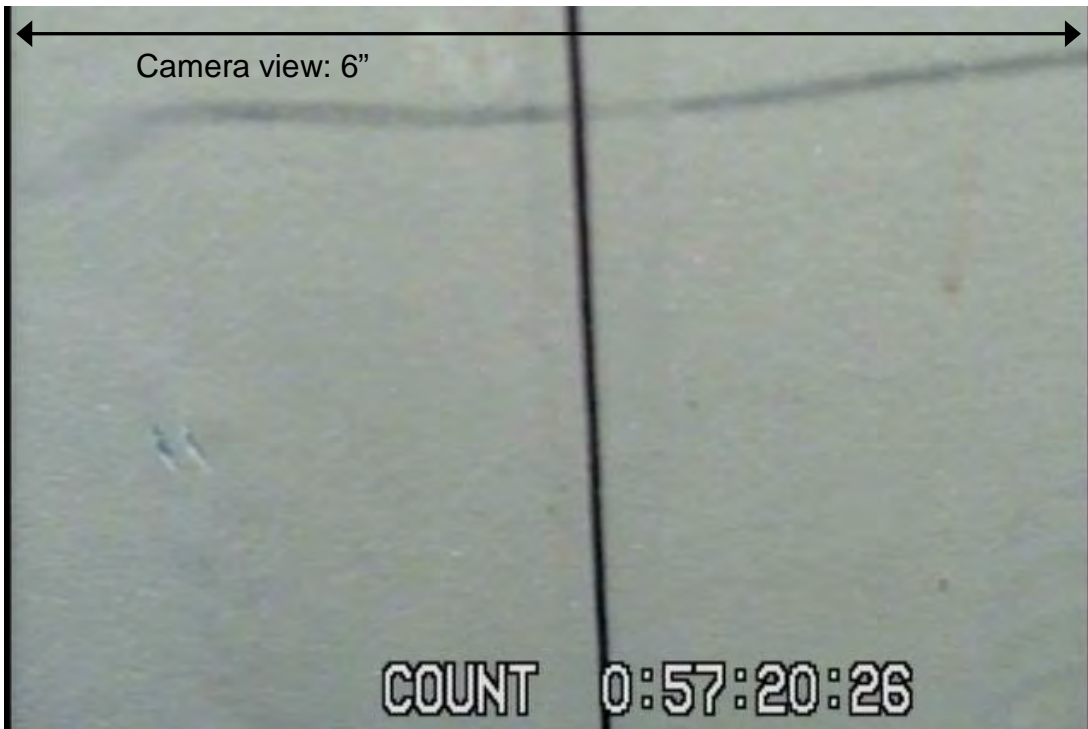
37. Scan 77 coating chips, no discoloration

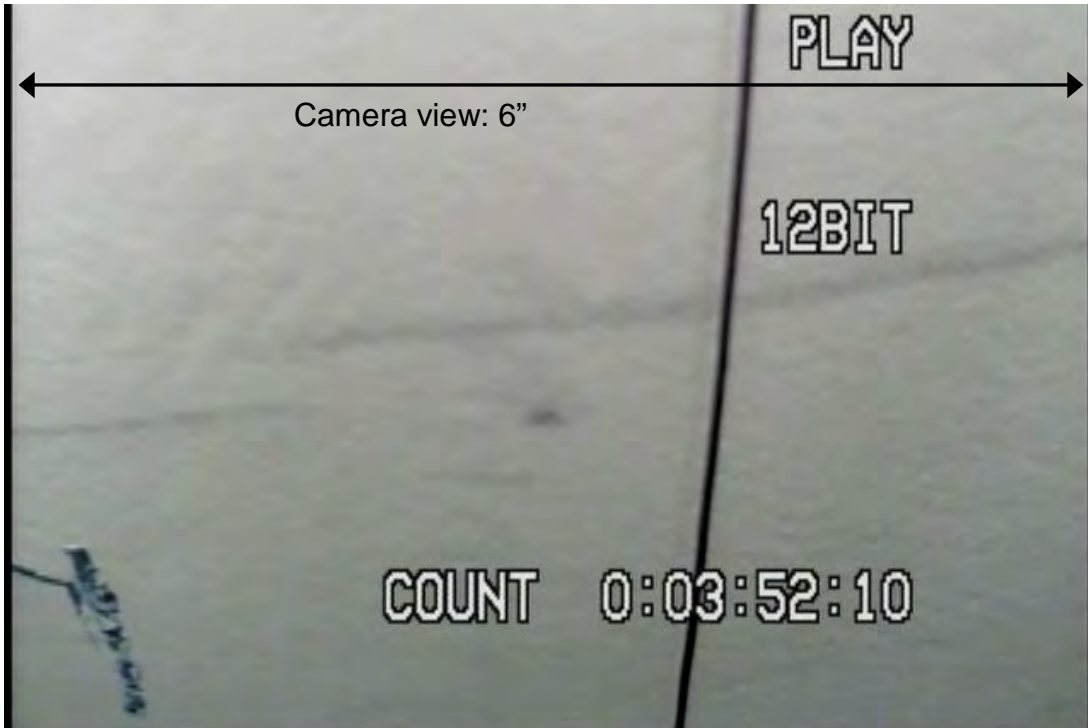
38. Scan 80 coating scrape

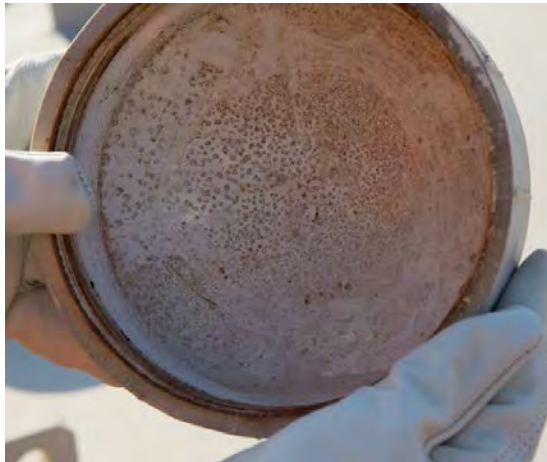
63. Underside of bolting pipe cap showing evidence of condensation

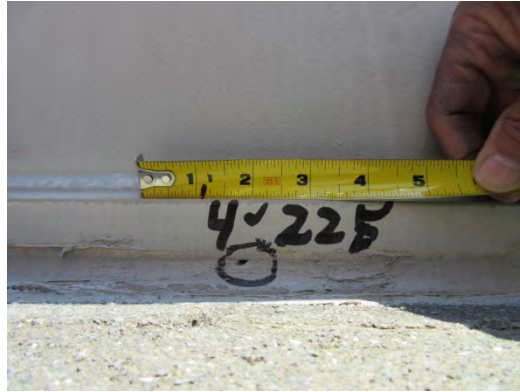
3. Cell 2 Caulking As-Found

In addition: 8/1/2017 Examination of as-found caulking around interface between vault lid and lid ring. No service-related degradation noted, cells 1, 2, 4, & 5 had areas of incomplete adhesion between caulking and metallic components. Cell 4 area had measurable depth less than depth to inner interface. Illumination check 8/1/2017 @ 1300.

8/3/2017 Examination of caulking around interface between vault lid and ring. Exam performed on initial caulking application for cell 2 after lid re-installation. Cells 1, 4, & 5 in areas where incomplete application was previously noted after additional caulking added to those areas. Illumination check 8/3/2017 @ 0945.

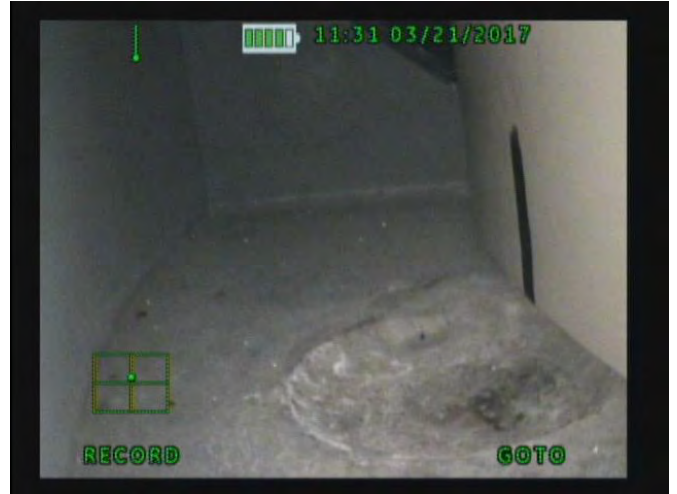
2. As discussed in Sections 3.1, 3.2, 3.3, 3.5, and 3.6, white deposits were noted around the floor drains in cells 1, 2, 3, 5 and 6. The deposit appearance is crystalline with no apparent discoloration, similar to concrete efflorescence or leaching. The boroscope video does not provide enough detail to establish the condition of the drain. It should be noted that the floor drain is not important to safety because of a defense-in-depth design and is not in the scope of license renewal. Although identification of the white deposits are not addressed in the exam acceptance criteria, this finding was entered into CAP as an observation (SAPN 1429074, Task 33) for further evaluation.

21. Vault drain

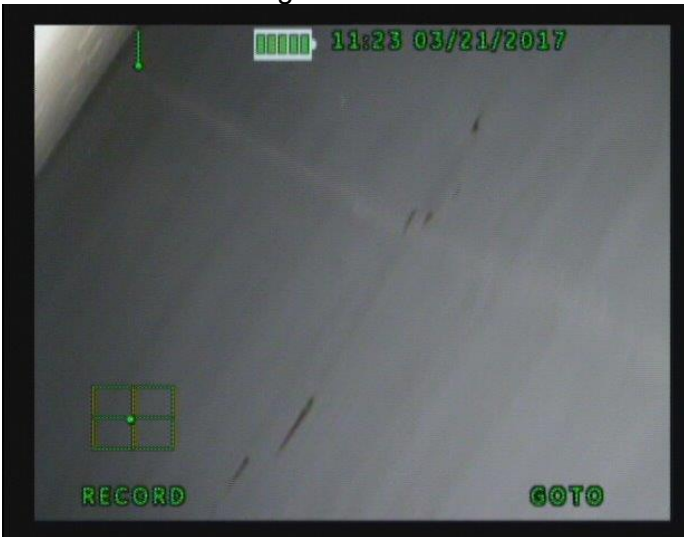
1. As discussed in Sections 3.1 and 3.2, markings were identified on the overpack and vault liner. These markings do not fail acceptance criteria, but will be entered into the CAP as observations (SAPN 1429074, Task 32).

28. Vault liner markings

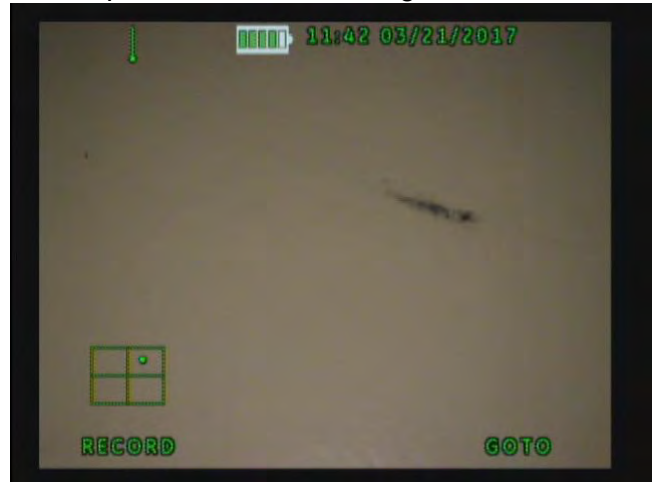
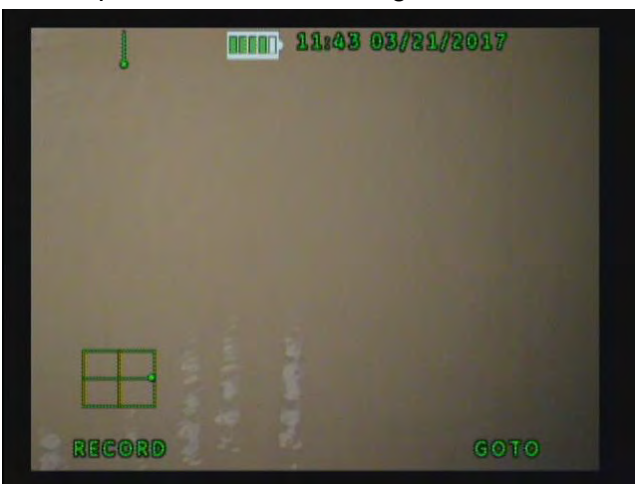
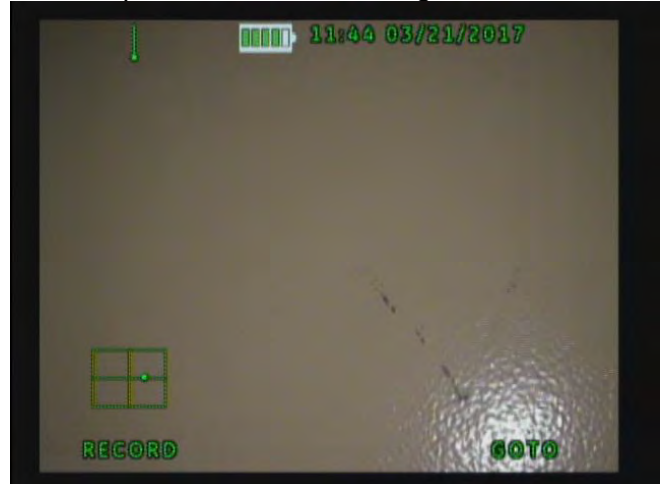
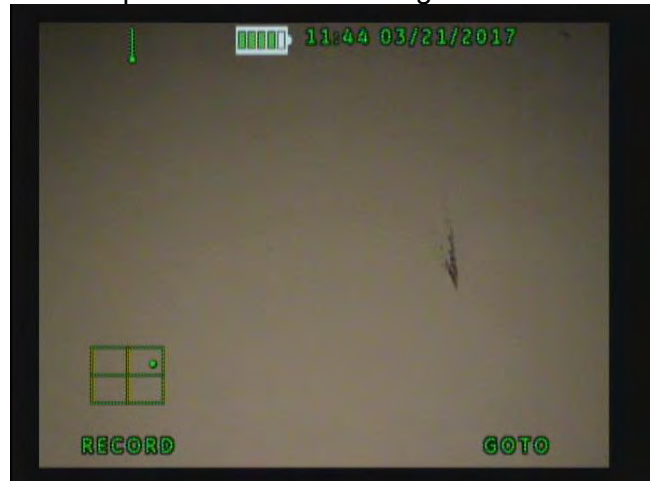
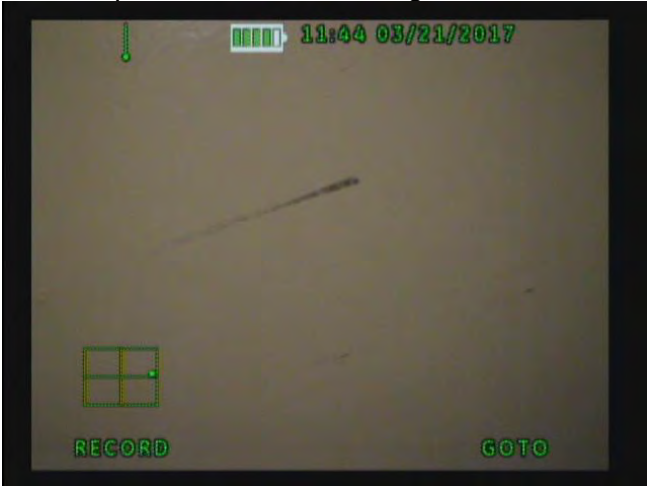
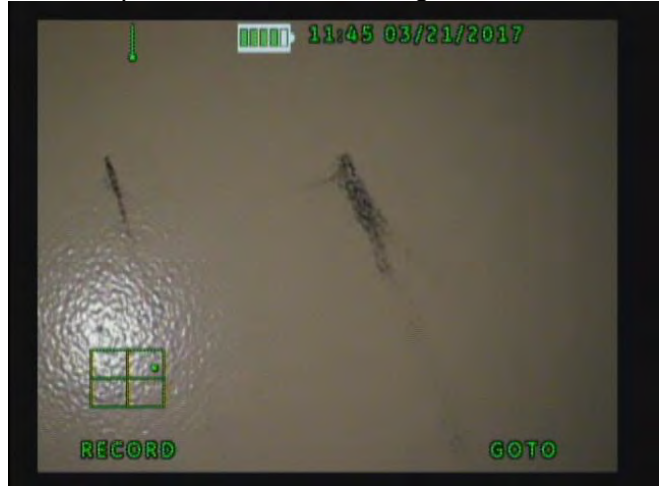
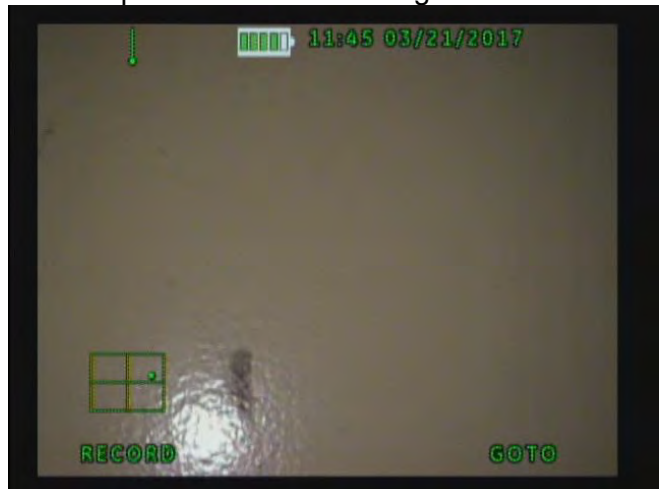
7. Overpack with Scuff Marking

Because of the similar condition of all cells, but the additional mechanical markings noted in cell #2, it is recommended that cell #2 be inspected in the July/August inspection (note that cell #2 also has operating experience with previous water intrusion which may have provided an environment more suitable for degradation).

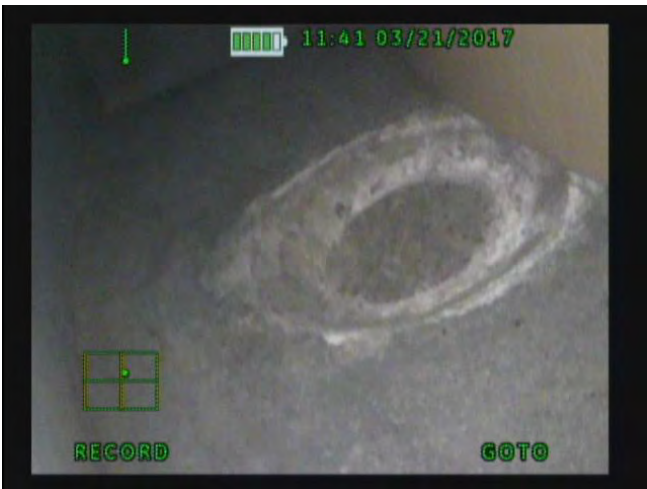
15. Vault Drain

The July/August inspection scope has been modified to ensure that that inspection crawler captures as-found and as-left images of the drain in vault #2 so that drain functionality can be further evaluated. Further, provisions will be available to clean the white deposit from the drain screen, to the extent possible, for future trending purposes.

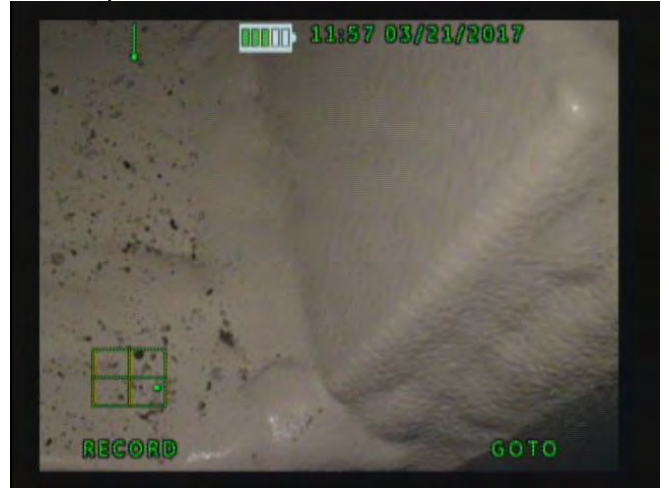
2. Overpack with Debris

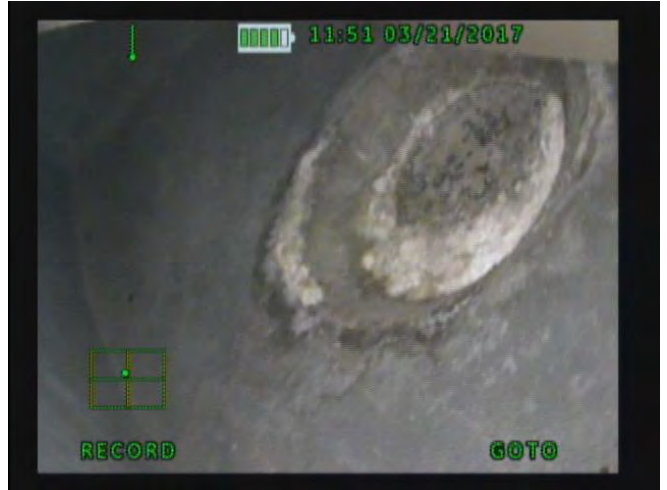
8. Vault Drain

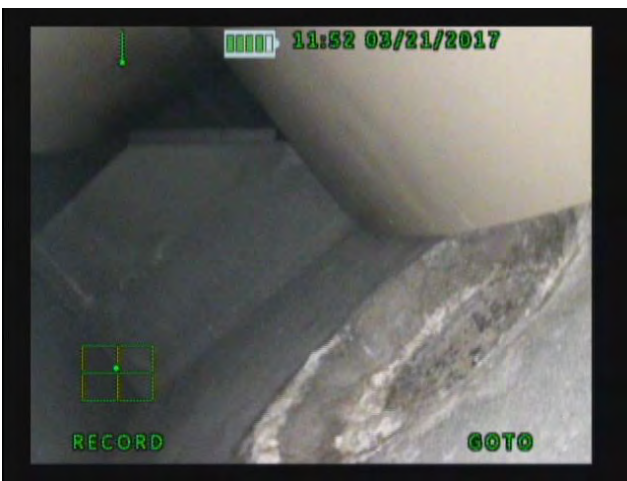
9. Overpack and Vault Drain

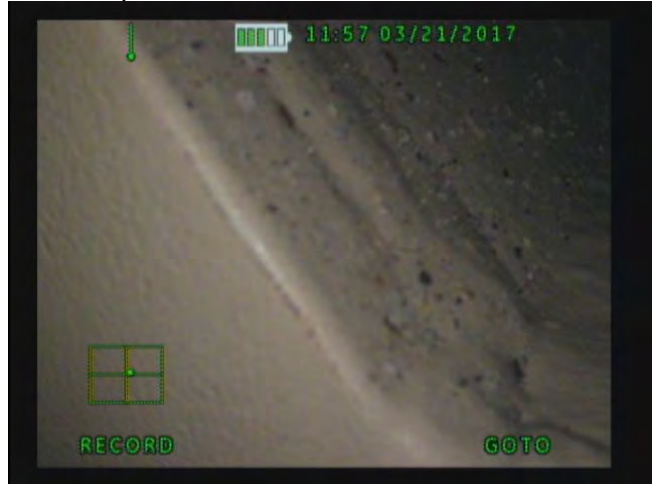
14. Overpack with Debris

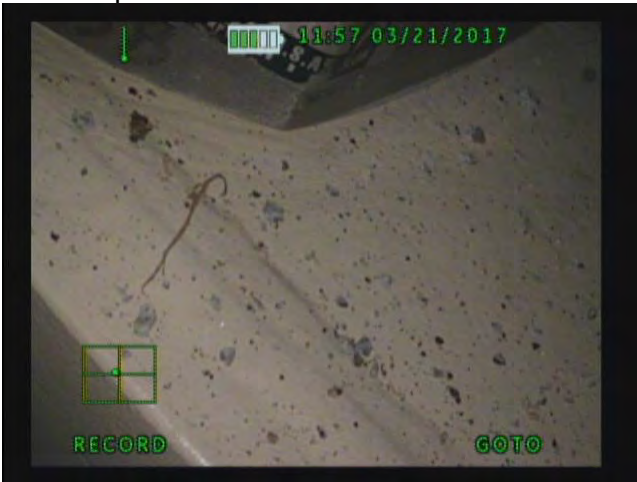
15. Overpack with Debris

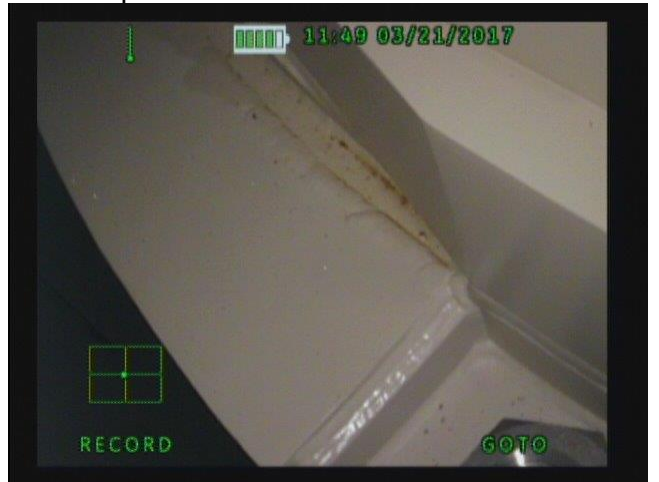
3. As discussed in Section 3.3, orange discoloration was noted at an overpack weld. Because the discoloration does not meet exam acceptance criteria, this finding was entered into CAP (SAPN 1429074, Task 30) for further evaluation.

16. Overpack weld

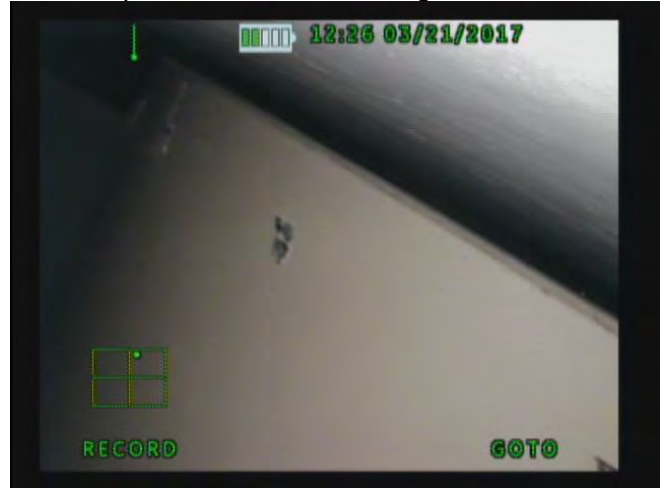
14. Overpack with Scuff Marking

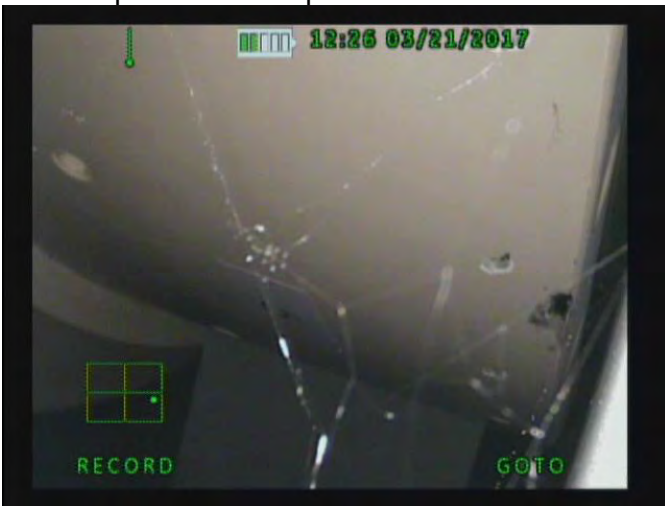
15. Overpack with Scrapes

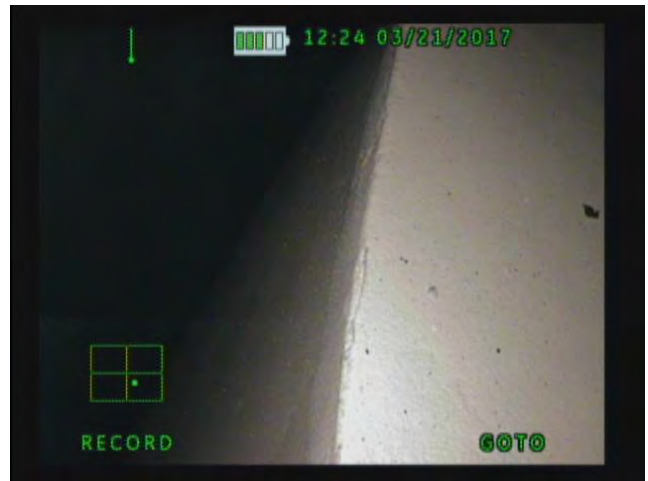
16. Overpack with Debris

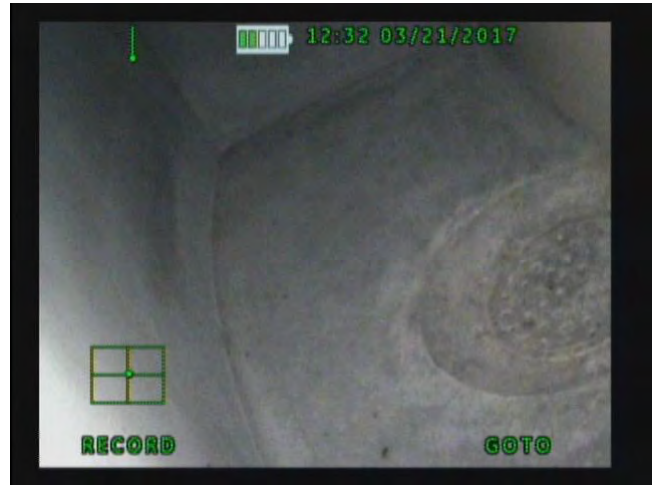
4. Vault Liner Bottom and Vault Drain
